**SHROPSHIRE HOUSE
STRUCTURAL ROBUSTNESS
ASSESSMENT REPORT
LONDON BOROUGH OF ENFIELD**
June 2022

SHROPSHIRE HOUSE STRUCTURAL ROBUSTNESS ASSESSMENT REPORT LONDON BOROUGH OF ENFIELD

June 2022

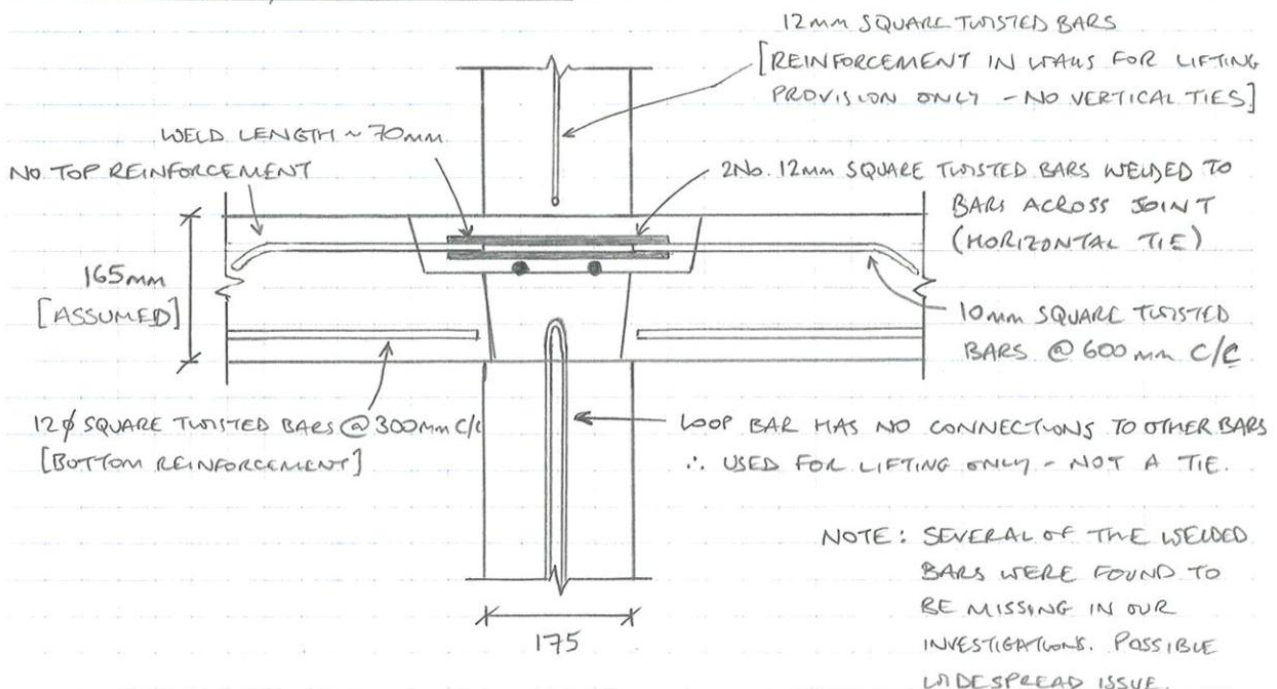
Figure 4 – Cross wall / floor slab joint

*We noted that the centres between the horizontal tie details was different in Flat 153 than in Flat 61. Flat 153, shown above, had ties set at 600mm c/c whereas Flat 61 these were found at 400mm c/c. The worst case (600mm c/c) has been adopted in our assessment.

*Also at least one horizontal tie in cross wall joint found to be defective, with no welded bars to form the connection.

- Two horizontal ties (in different flats) in the cross wall joints were found to be defective. In one of the flats the bar was found to be in a pocket surrounded by polystyrene, rather than concrete (a thin layer of concrete was on top of the polystyrene). The bar was therefore not protected by the concrete and the end of the bar had subsequently suffered from corrosion, with a small degree of sectional loss. The bar was also noted to be missing the two welded bars which pass through the cross wall, rendering this redundant and would place the surrounding ties under increased stresses in the event of an accidental event. It is unclear whether this is a wider issue throughout the block.

* However, we would note that at least one horizontal tie was found to be defective during our investigation. We found that the 10mm bar protruding from the slab did not have any bars welded to it to form the connection (the bar was also suffering from surface corrosion). If this is a wide spread issue in the block, it is possible that the effectiveness of the ties will the ties adequately constructed will not be sufficient to prevent disproportionate collapse.

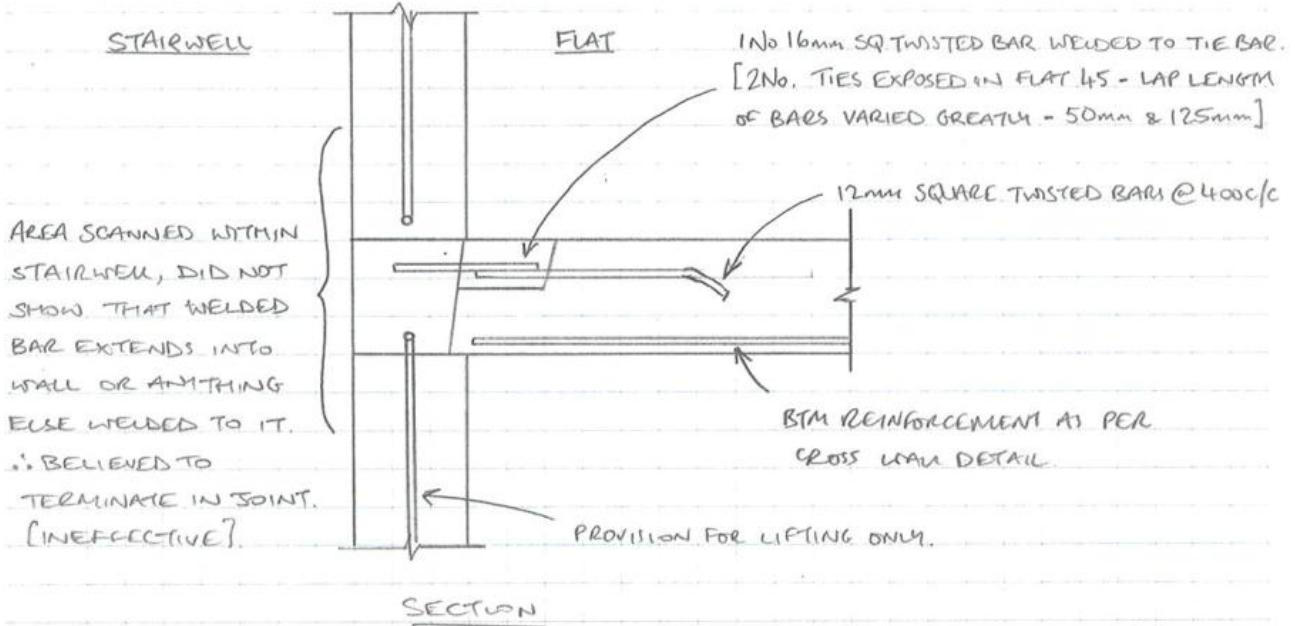
Figure 5 – Cross wall / floor slab joint (stairwell)

APPEARS TO FOLLOW SAME PRINCIPAL AS STANDARD CROSS WALL DETAIL, EXCEPT THERE IS NO FLOOR SLAB OTHER SIDE OF WALL SO WELDED CONNECTION IS REDUNDANT AS NOTHING TO WELD TO ON STAIRWELL SIDE.

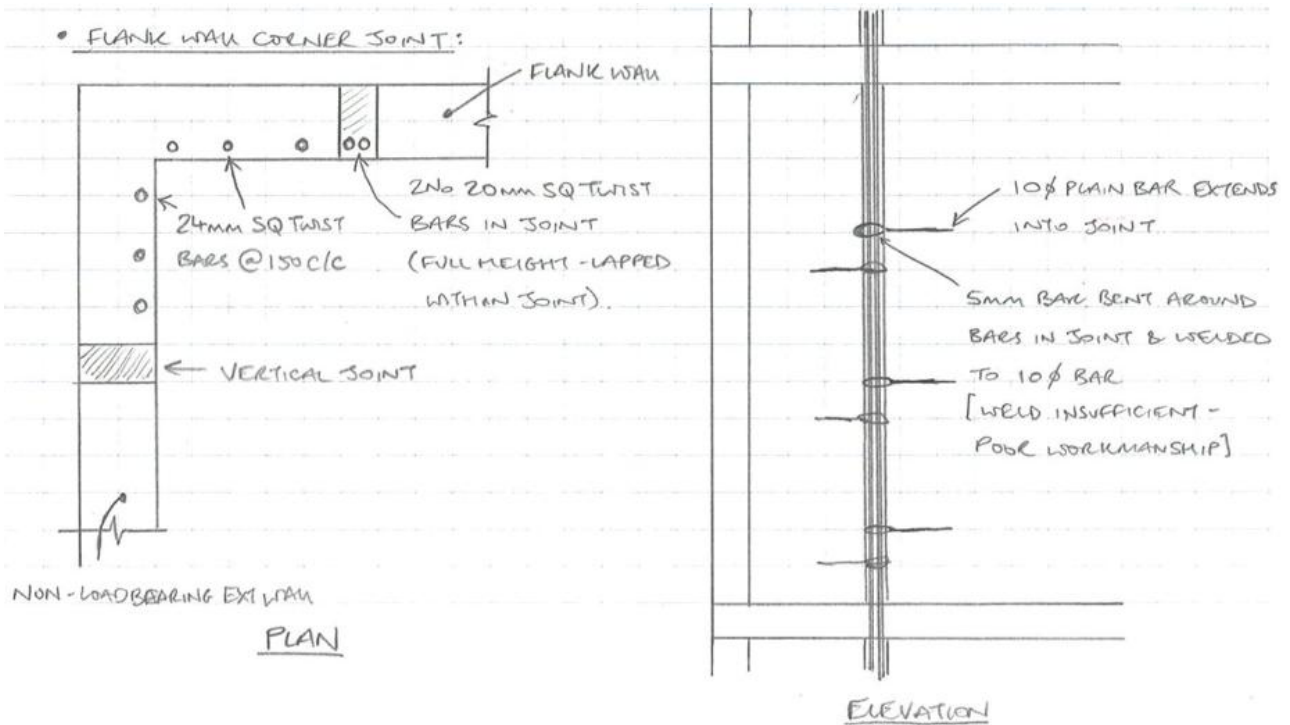
Figure 7 – Flank wall corner panel

* Flank corner panel found to fail due to no mechanical ties, only main panels pass assessment.

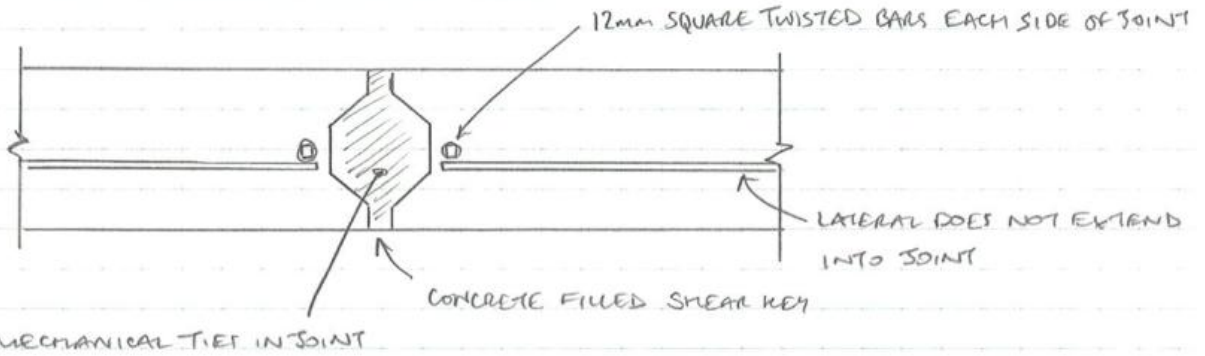
Figure 10 - Cross wall / cross wall joint

However, the U-bars protruding from each panel are in the other orientation and therefore do not connect 'loop around' the vertical lacer bar.
