BROOMFIELD HOUSE

Gazetteer

March 2016

GAZETTEER – HOUSE AND STABLE YARD CURTILAGE BUILDINGS

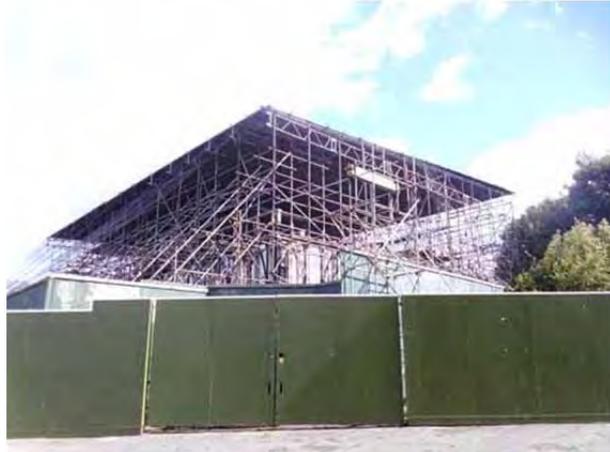
- i. **Roof covering over main house**, the fires of 1984, 1993 and 1994 destroyed the roof covering and much of its supporting structure. The temporary roof covering is provided by corrugated steel sheeting fixed to a scaffold frame, erected as part of the temporary protective works, which does not offer enough support for lateral winds and driving rain.

Significance: None. The house is currently roofed by a temporary roof held by scaffolding. It may be noted that this element obviously does not add to the character or historic integrity of the house and therefore may be deemed to be **detrimental**.

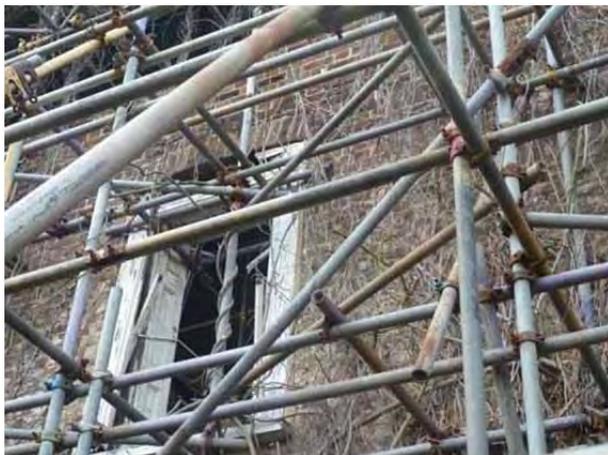
- vi. The ground floor painted timber sash window is of two sashes, each with four panes. The glazing of the panes is missing or damaged throughout, though the timber mullions survive. There are no external architraves present, only shallow timber boards to the cheeks and head, and timber cills to the base. The heads of the openings are arched, with un-gauged brick arches above.

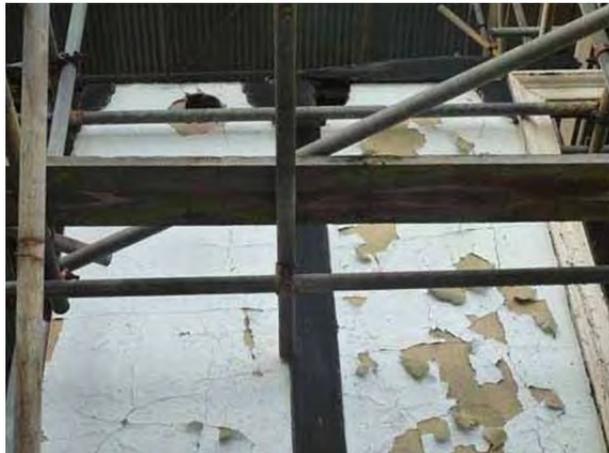
- ii. The façade is of cement render run over a steel mesh, with half timbering simulated by oak boarding attached to the studwork of the early-18th century timber stud framing beyond. The main façade sits on a low level rendered brick wall.

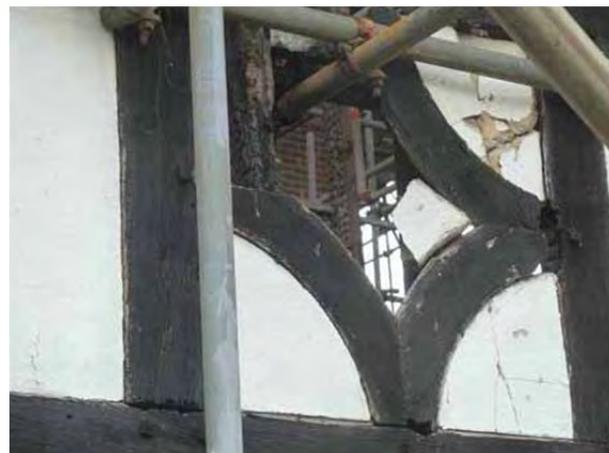
- iii. The cement render is holed and cracked throughout the infill panels, and the paintwork has failed and is peeling in places.

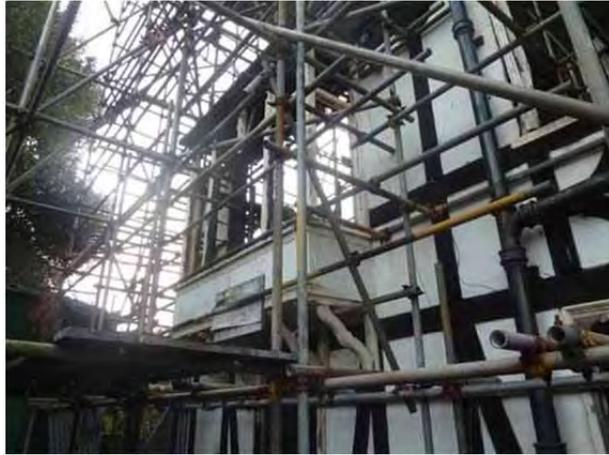
vii. Sash windows are missing and no window architraves are present (over most of this elevation). Several sections remain at ground floor level.

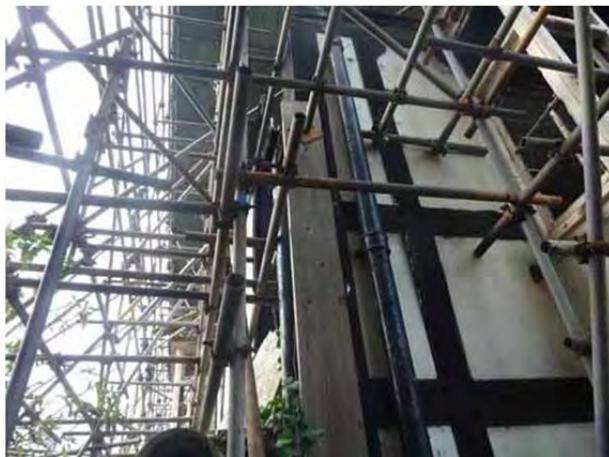
ix. Parapet façade missing, there is no coping and the early-19th century studwork is visible beyond.

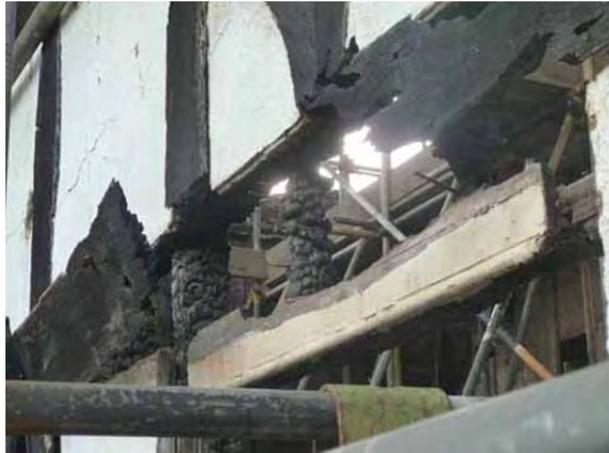
- iv. The cement render is holed and cracked throughout the infill panels, and the paintwork has failed and is peeling in places.

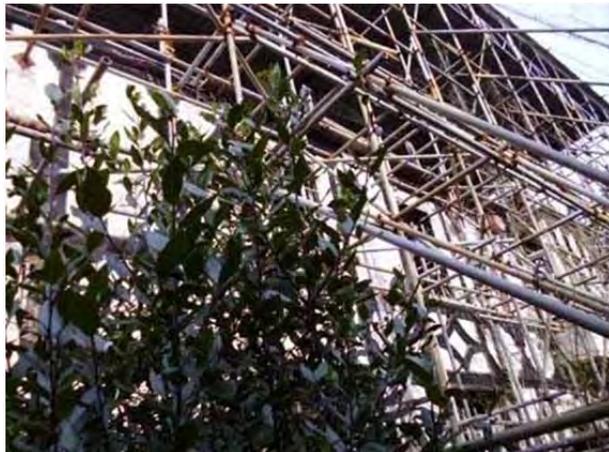
- v. The oak timber boarding mimics the quadrant bracing found in some of the earlier internal timber framing. In places the façade has failed and the fire charred remains of the earlier studwork is visible externally.

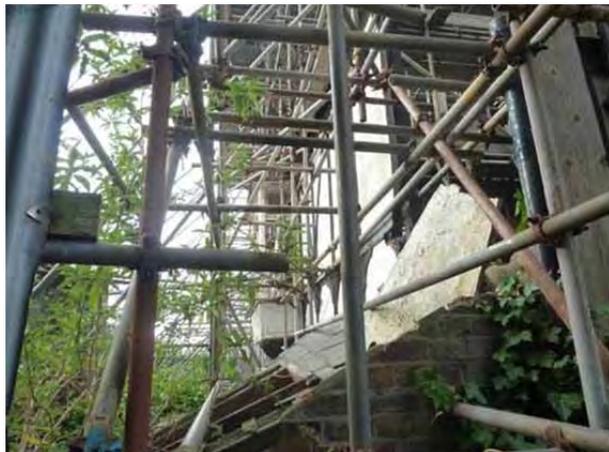
- vi. Sash windows missing, no architrave

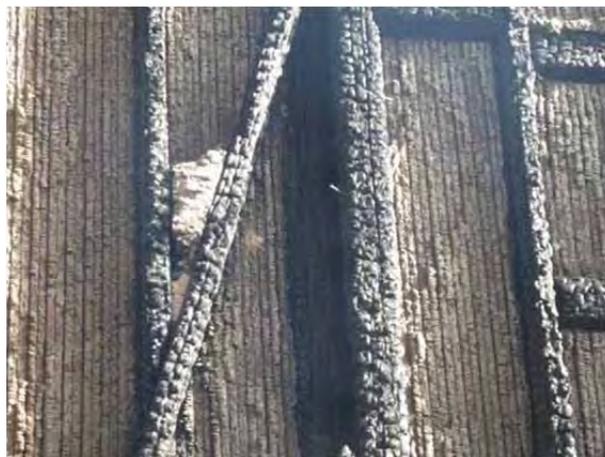
v. Area of fire damaged studwork and steel mesh with concrete render.

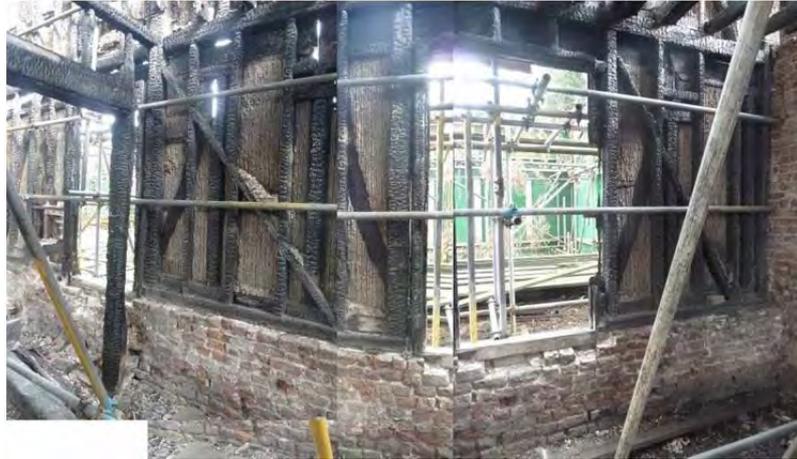
- ii. Room partitions stripped by fire, rooms G5/G7 visible beyond (photo taken facing north).

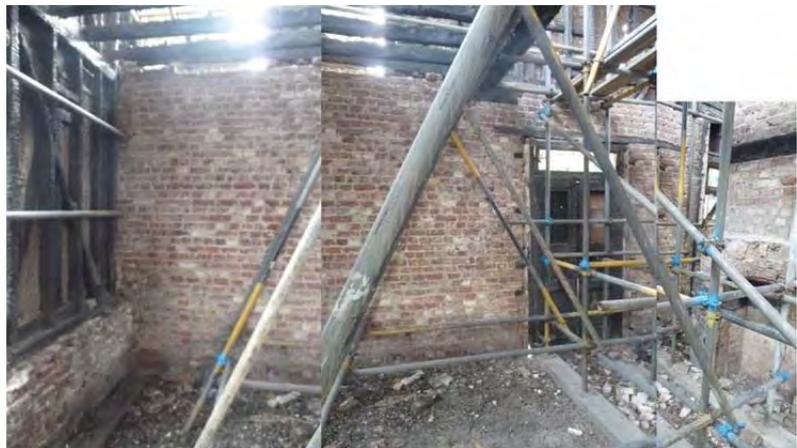
iii. East elevation, missing sash window and fire damaged studwork and render.

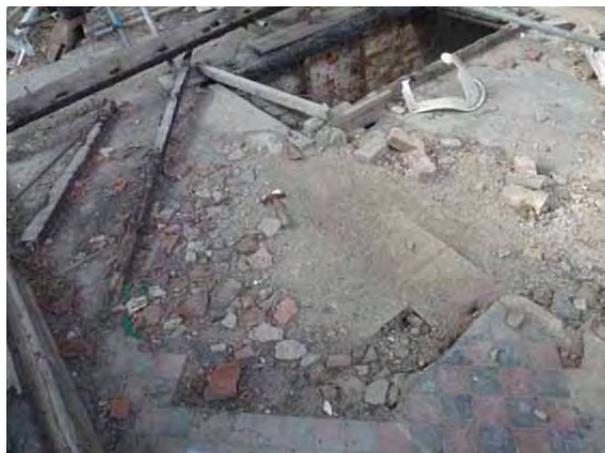
i. Room partitions stripped by fire, adjacent to rooms G6/G9. Remnants of staircase to basement shown.
