Appendix 1: Site Photographs

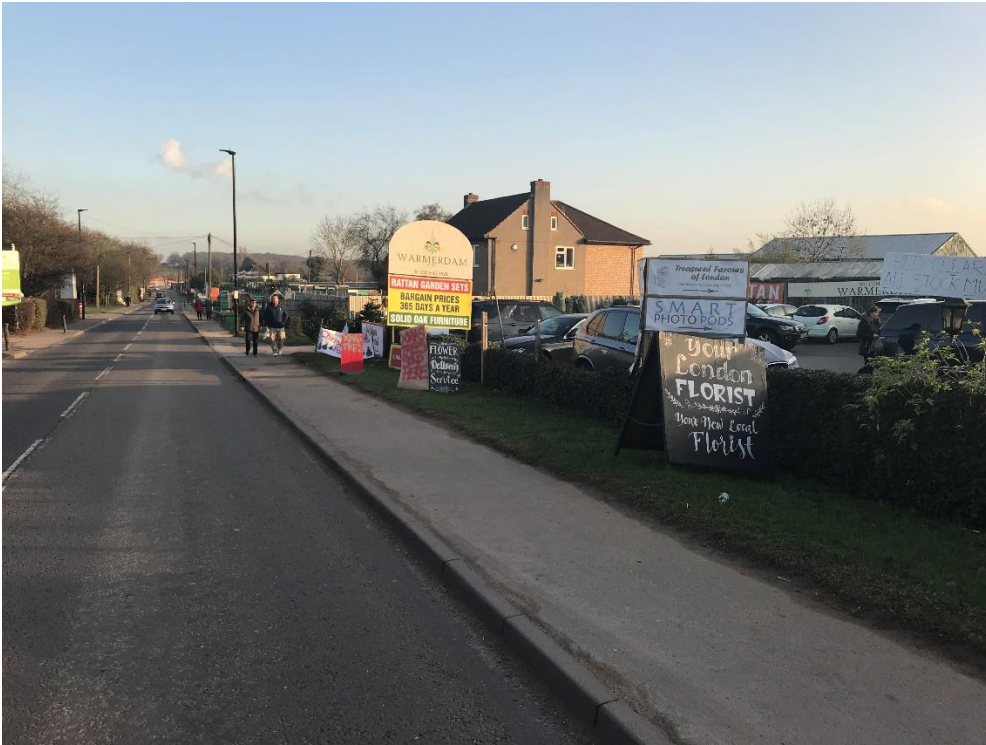
Photo 1: View looking east along Cattlegate Road towards Warmerdam's

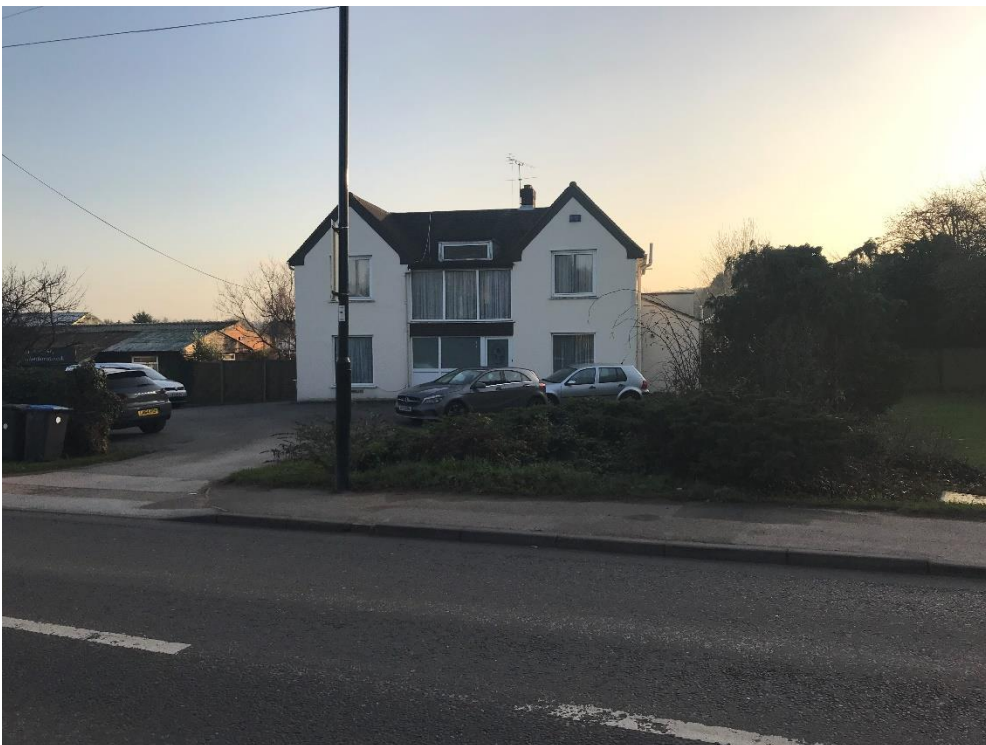
Photo 2: View of the front of the 'Housienda' dwelling at the north of the site

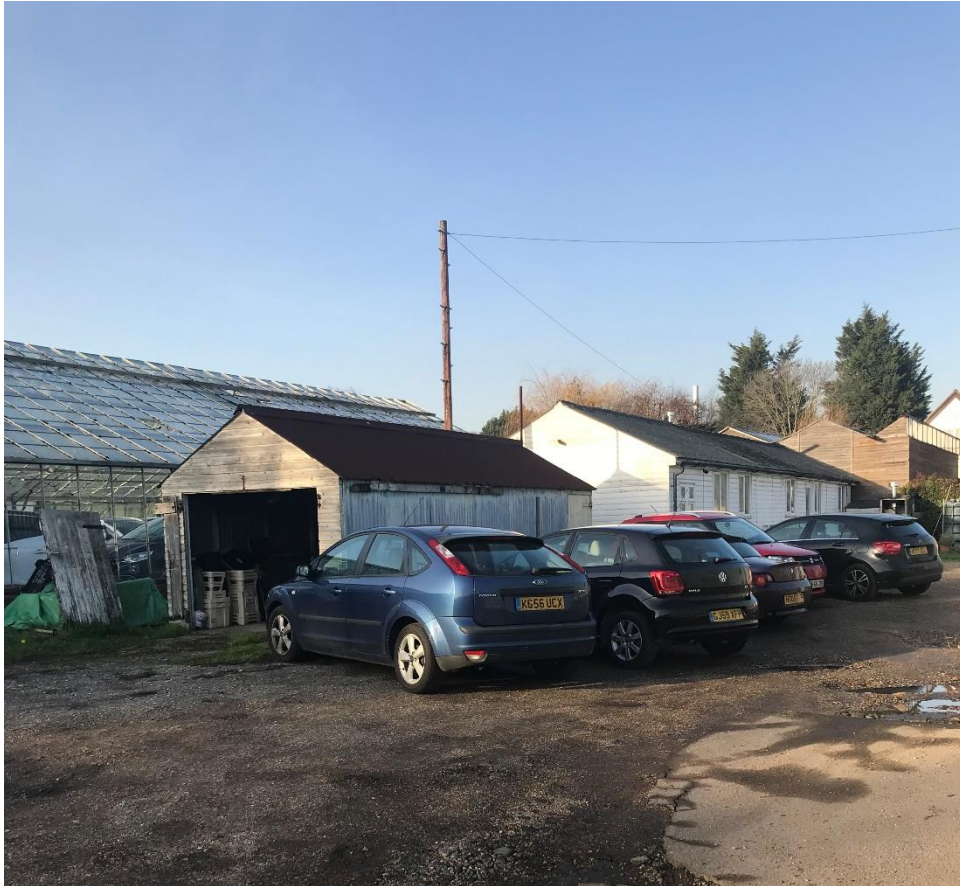
Photo 3: View of the 'Lodge' dwelling located to the west of the site

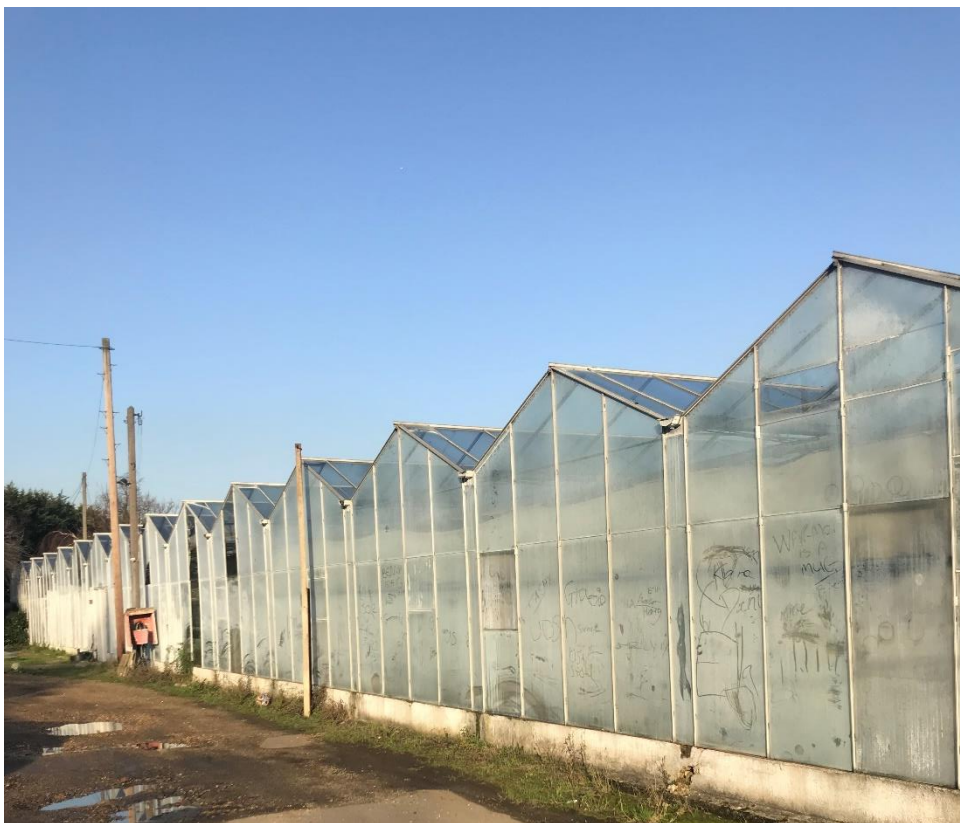
Photo 4: View of the greenhouse (unsafe to use) at the rear of the site

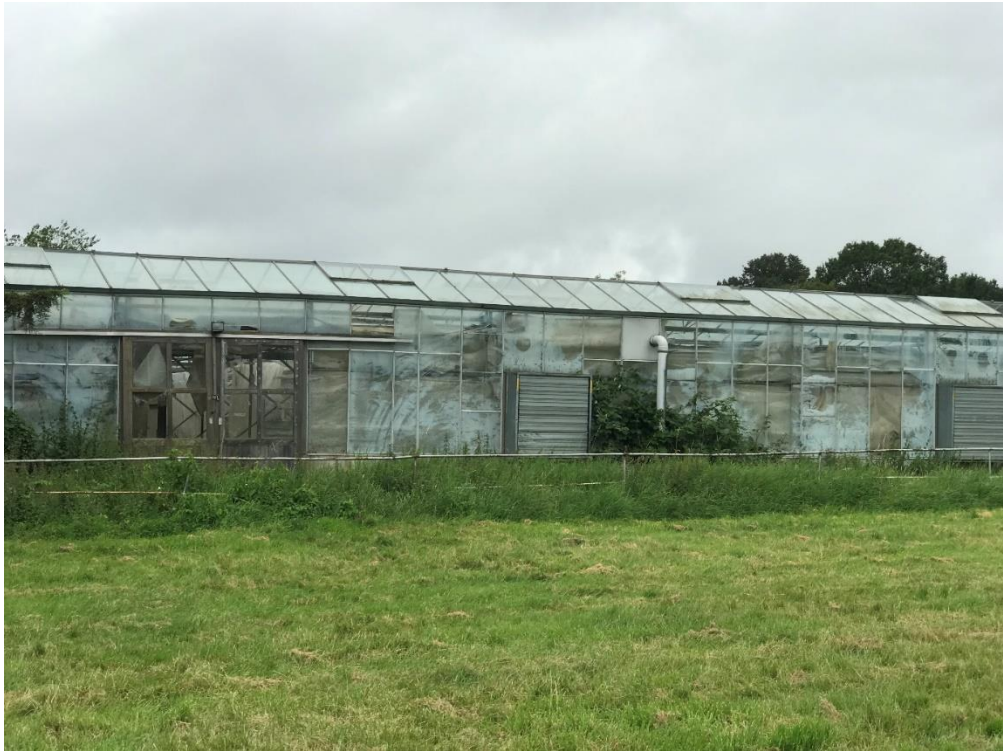
Photo 5: View of the greenhouse (unsafe to use) at the rear of the site

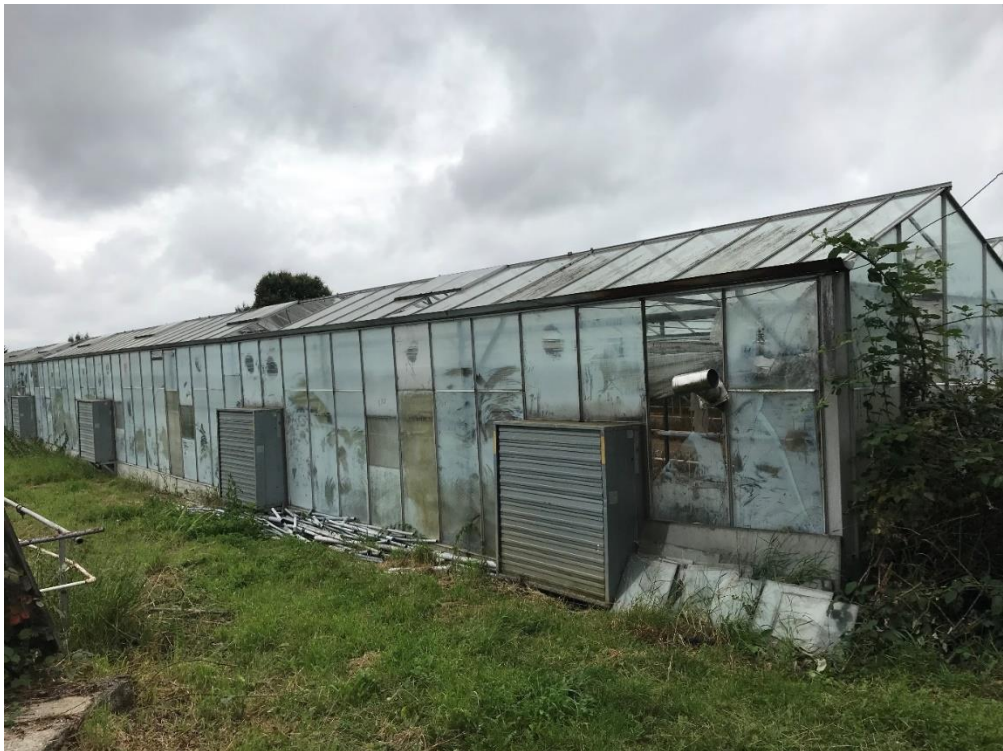
Photo 6: View of the greenhouse (unsafe to use) at the rear of the site

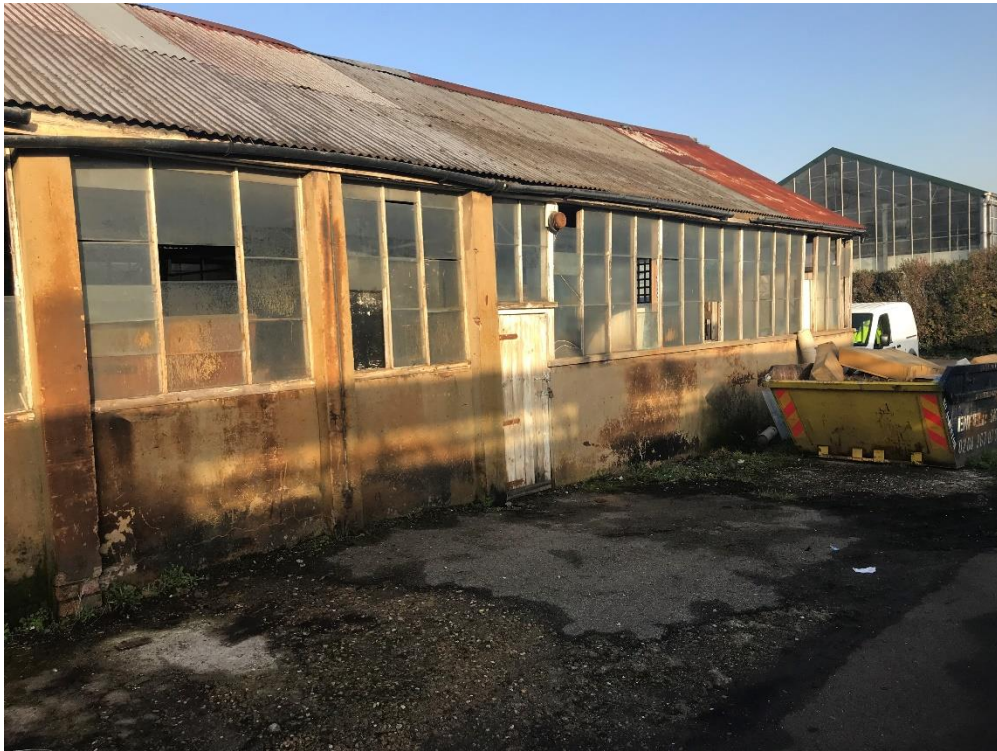
Photo 7: View of a derelict outbuilding at the rear of the site

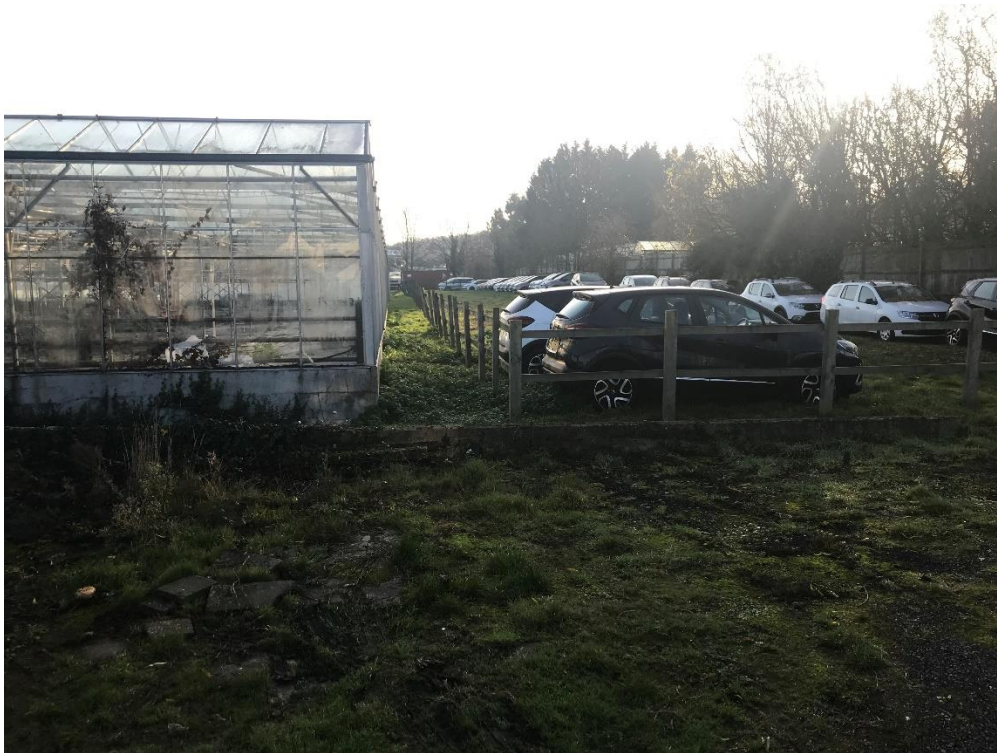
Photo 8: View looking south with a cluster of cars located to the west of the site

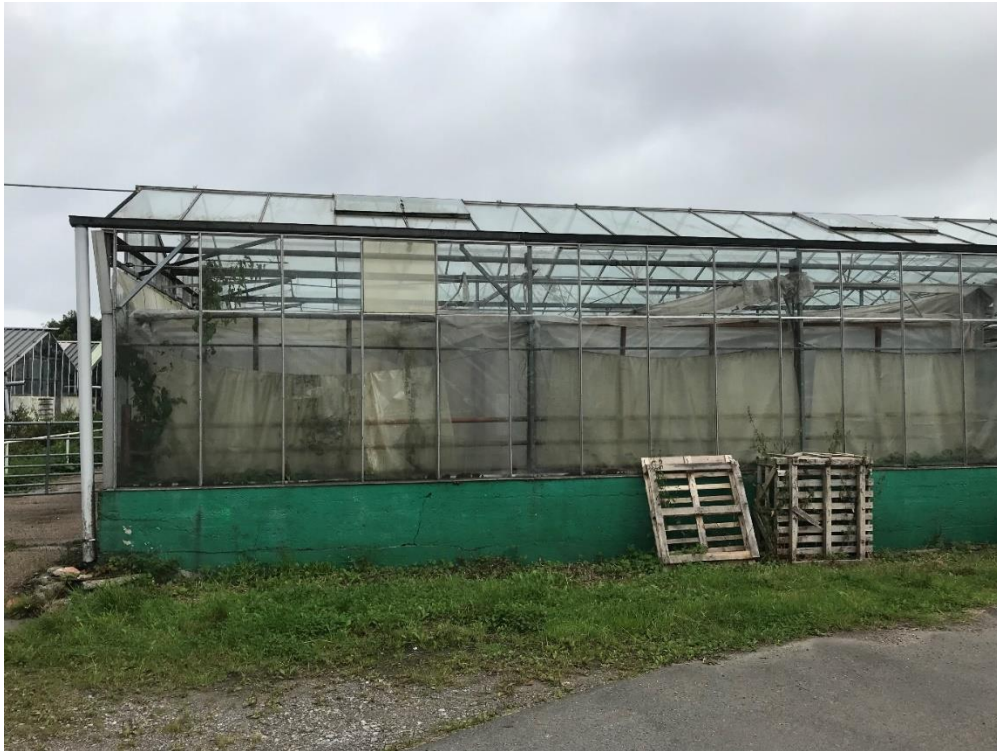
Photo 9: View of the 'Middle Greenhouse' at the site

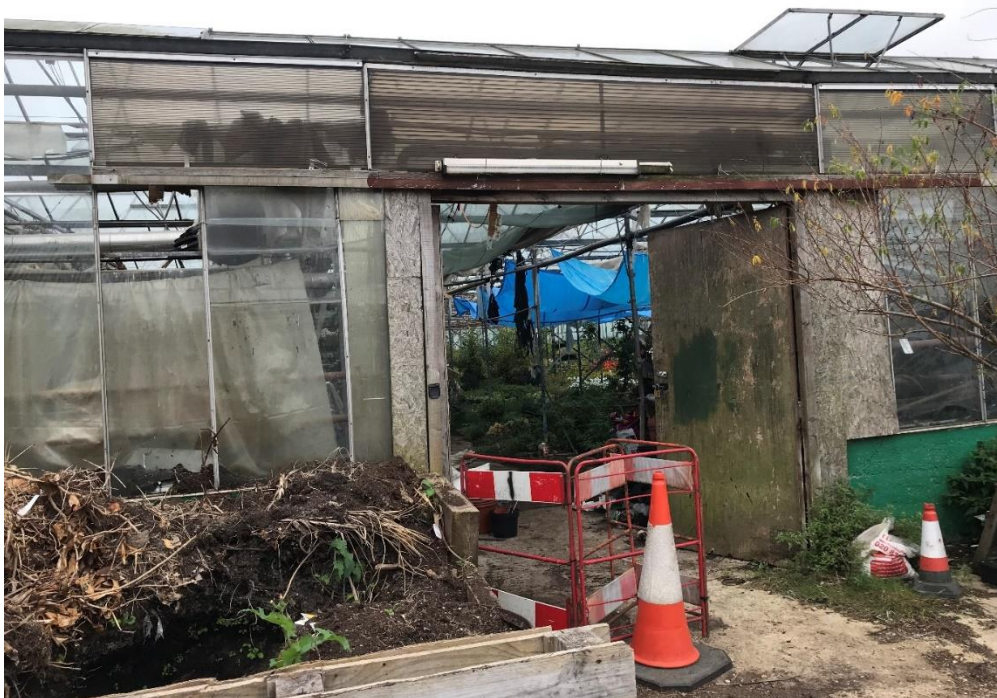
Photo 10: View of the 'Middle Greenhouse' at the site

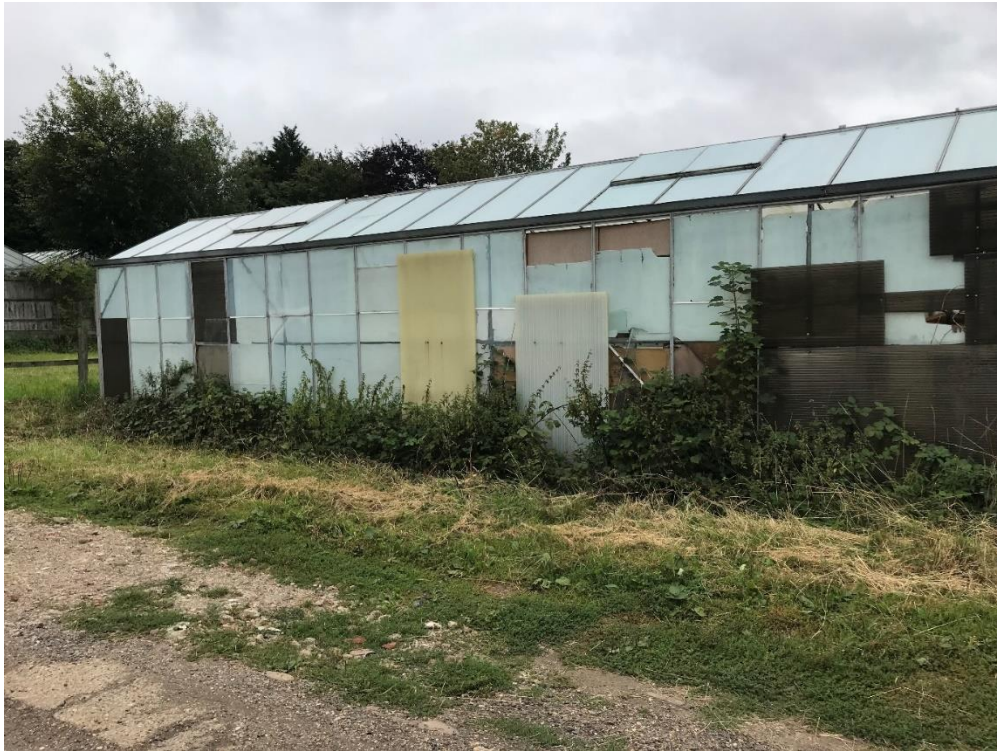
Photo 11: View of the 'Middle Greenhouse' at the site

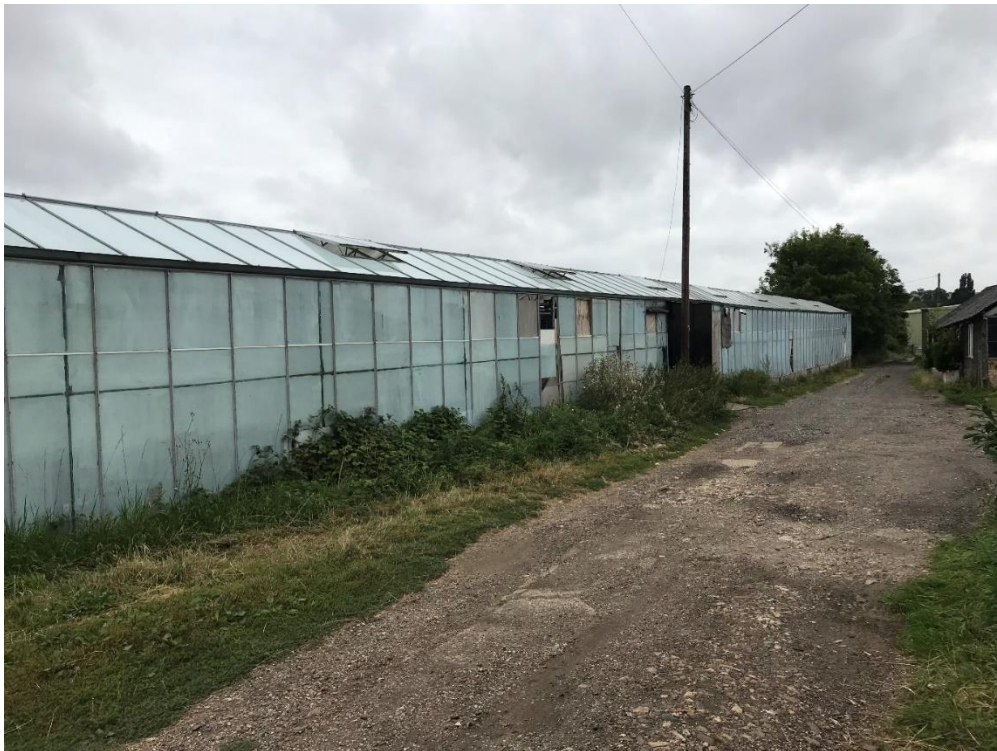
Photo 12: View of the 'Middle Greenhouse' at the site

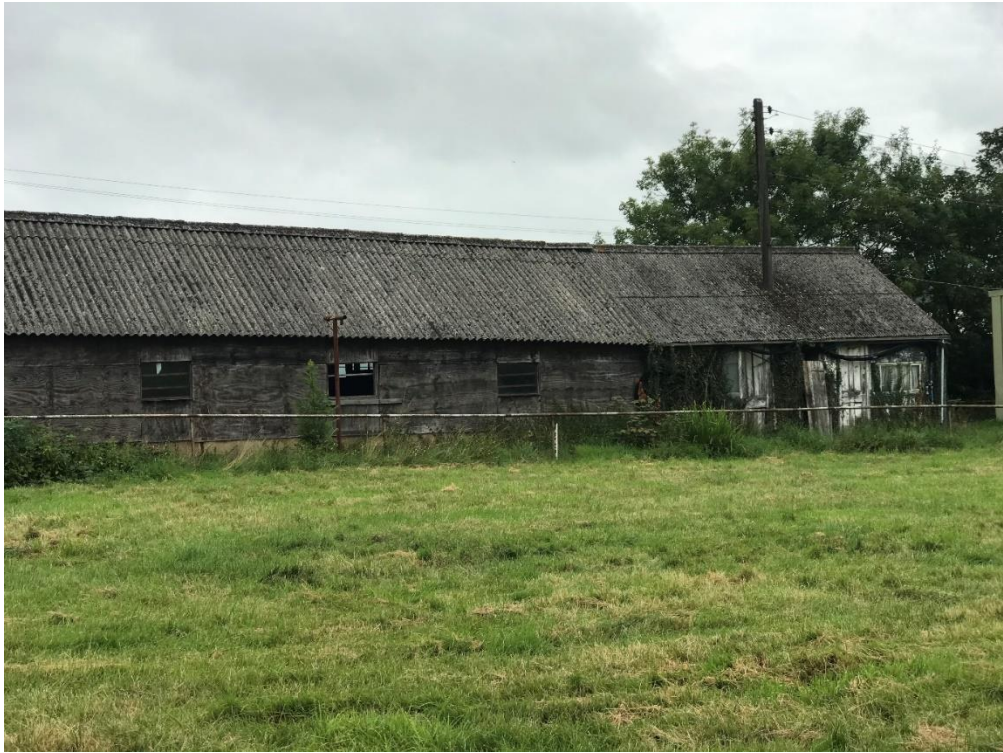
Photo 13: View of Storage Shed at the site

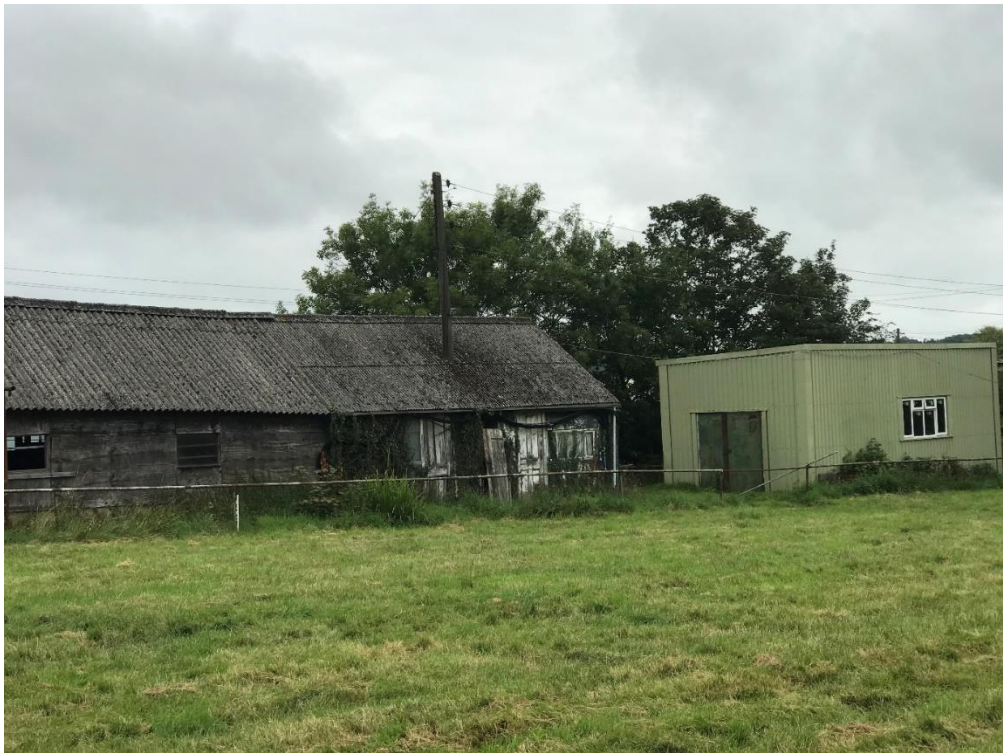
Photo 14: View of Storage Shed at the site

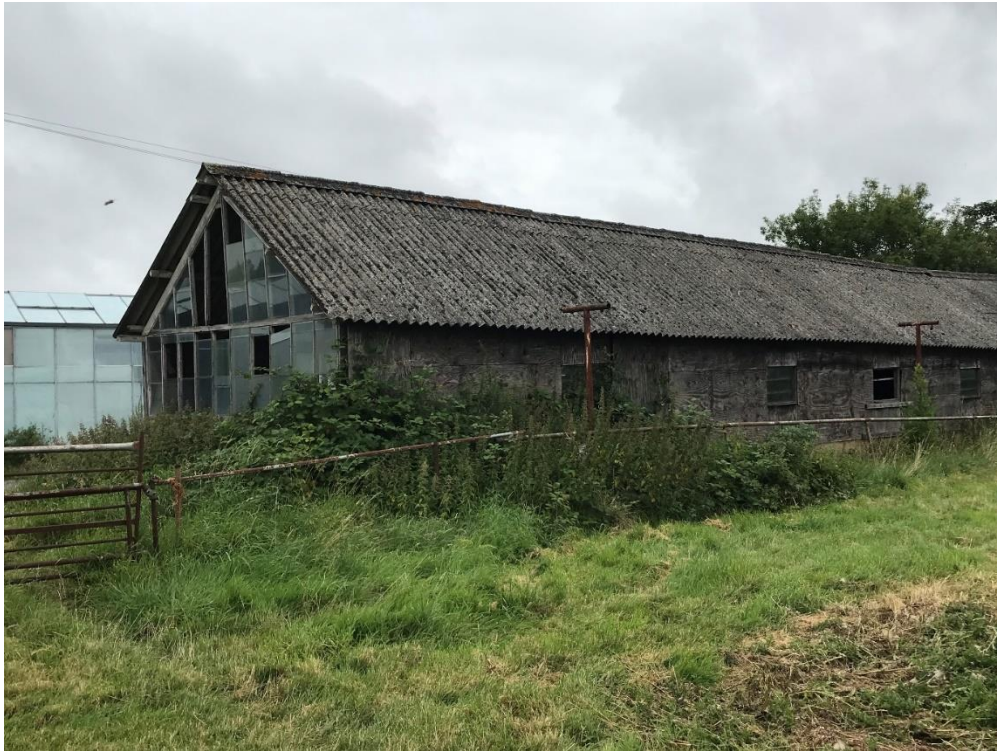
Photo 15: View of Storage Shed at the site

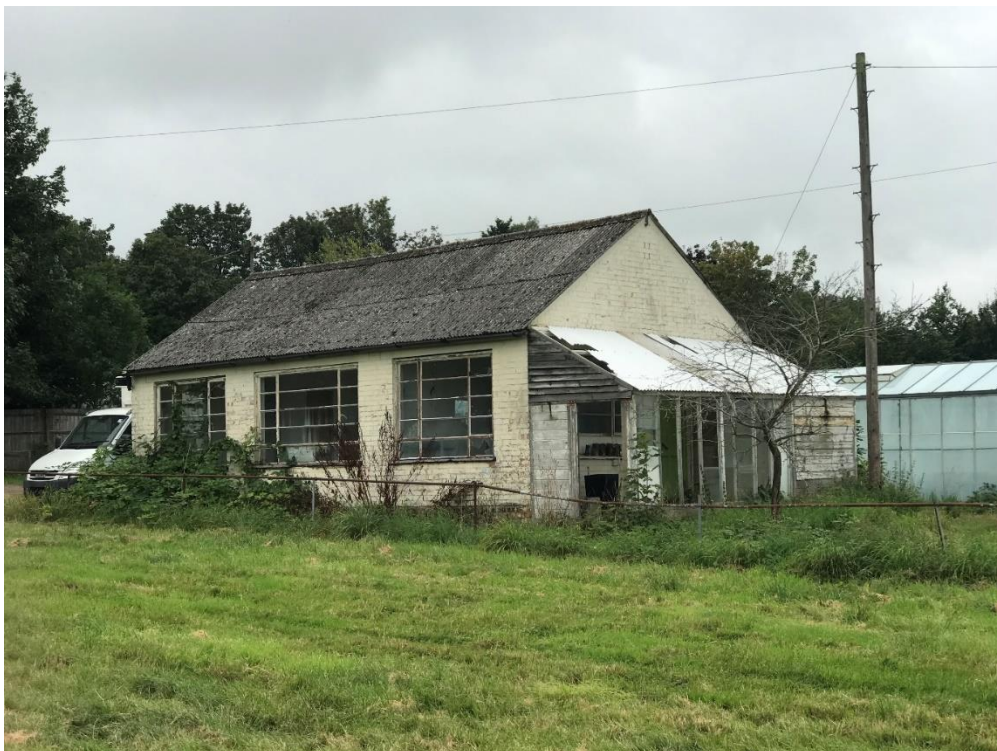
Photo 16: View of a Dilapidated house at the site

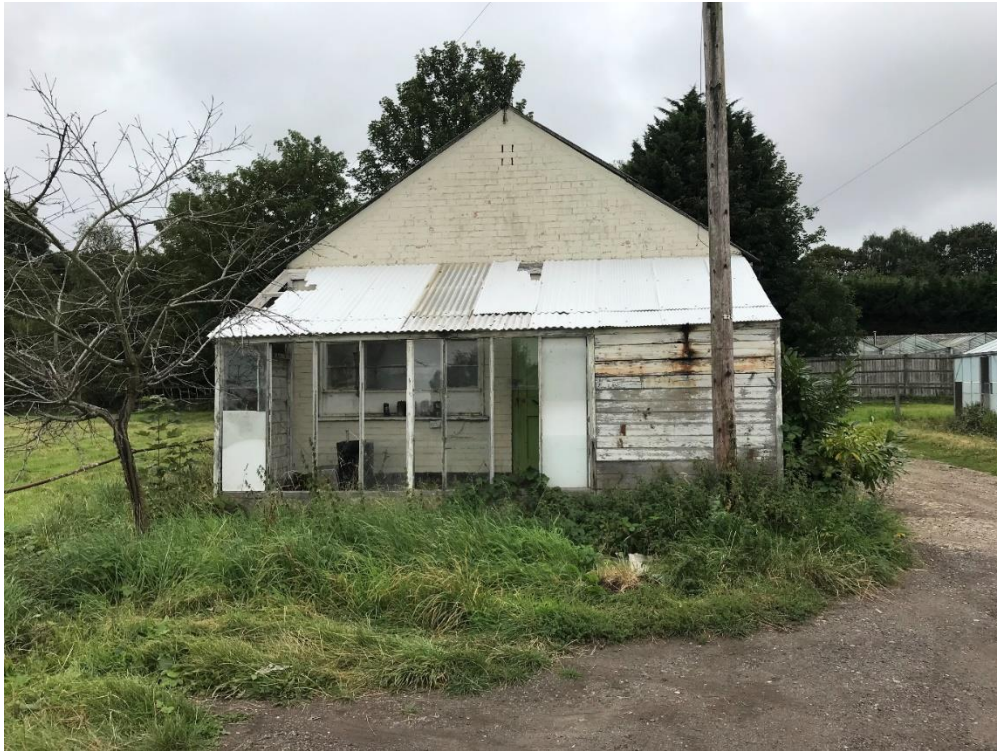
Photo 17: View of a Dilapidated house at the site

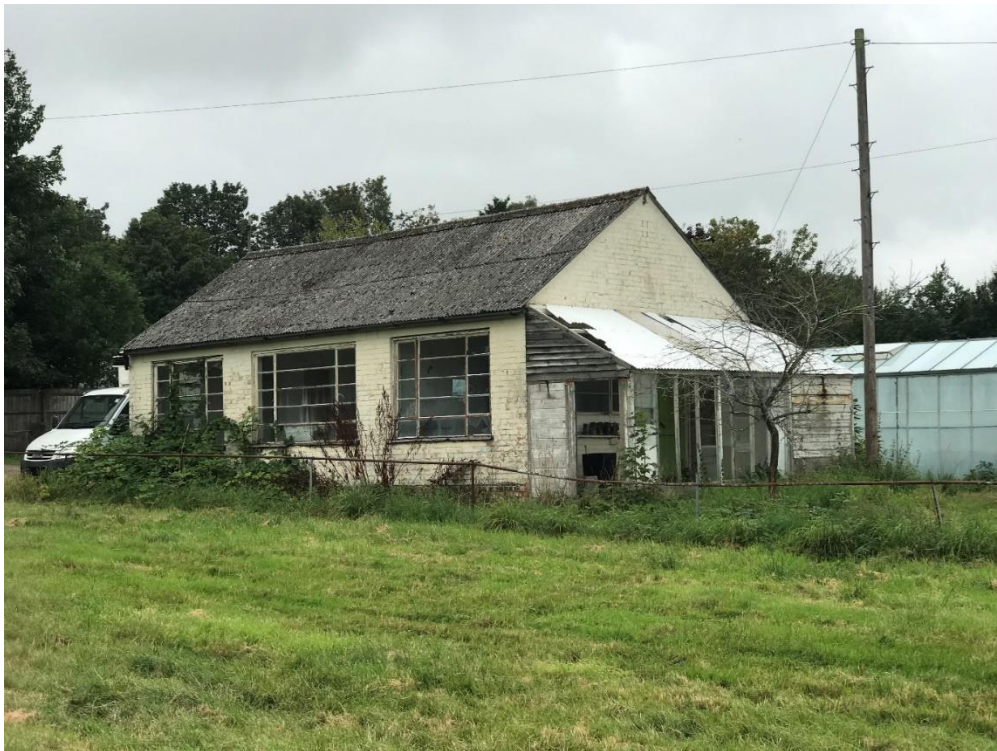
Photo 18: View of a Dilapidated house at the site

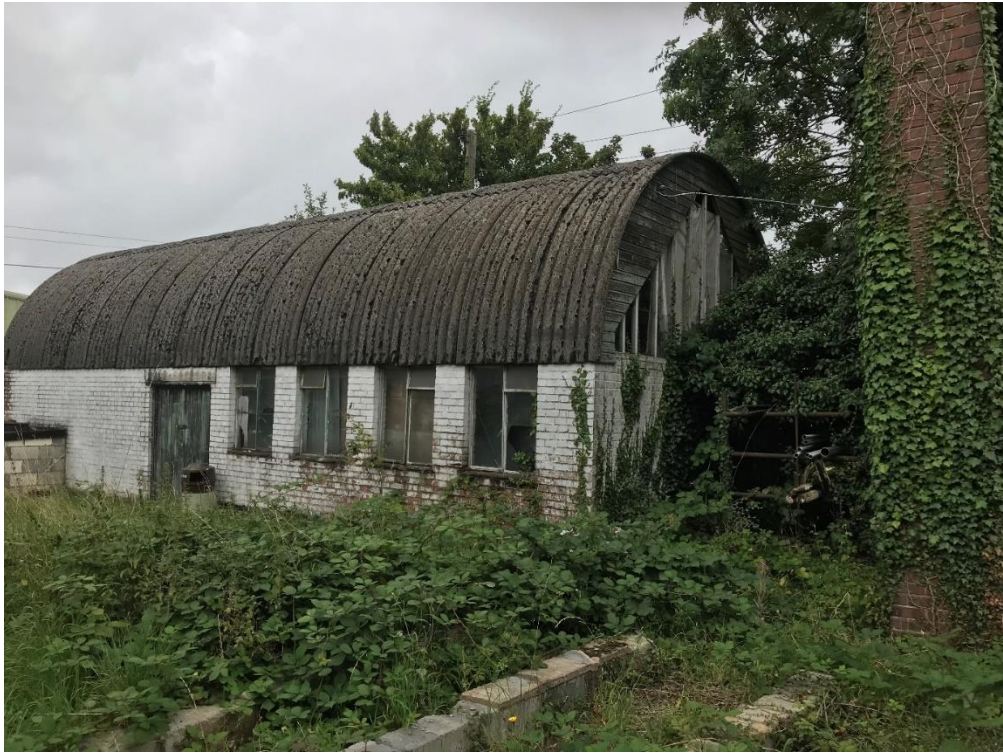
Photo 19: View of 'the Stables' at the site

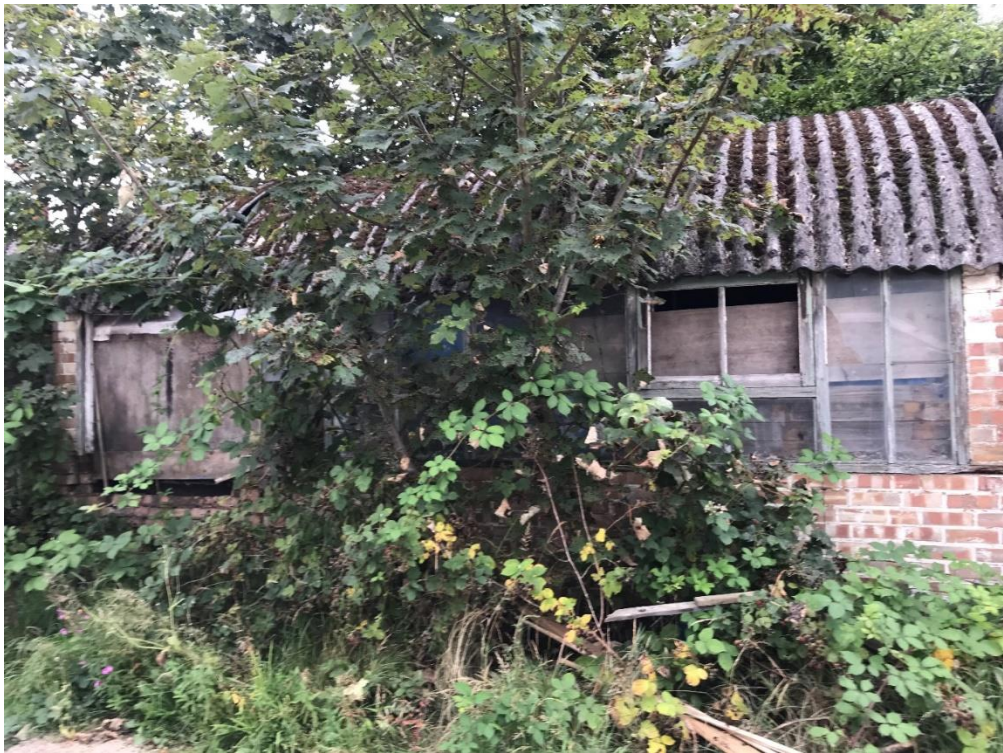
Photo 20: View of 'the Stables' at the site

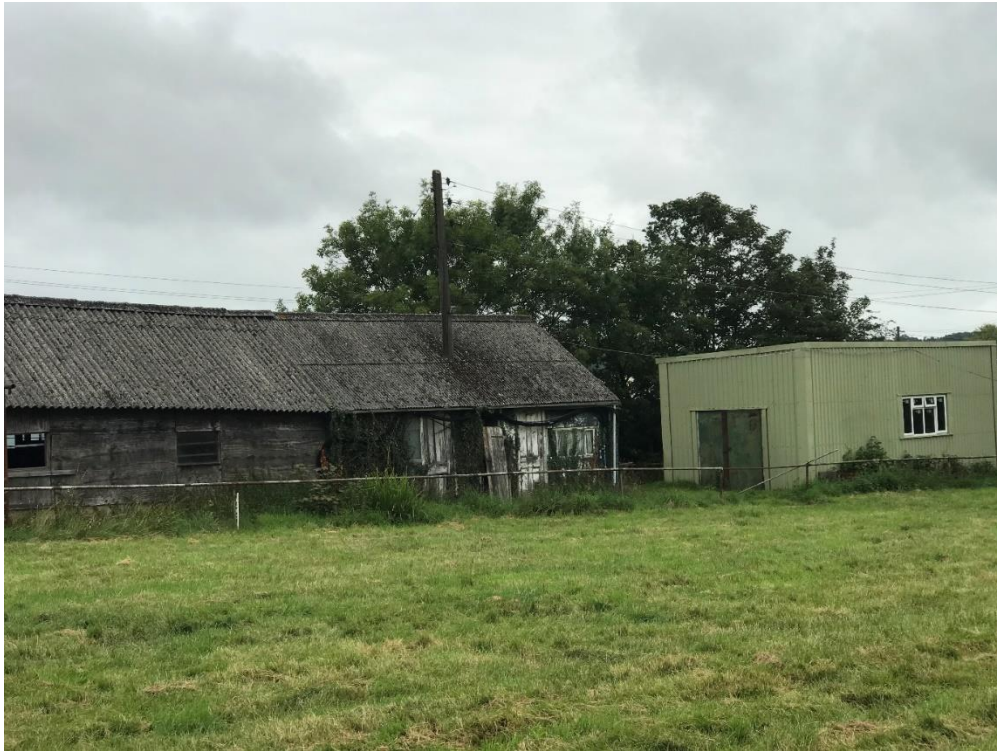
Photo 21: View of the Green Shed at the site

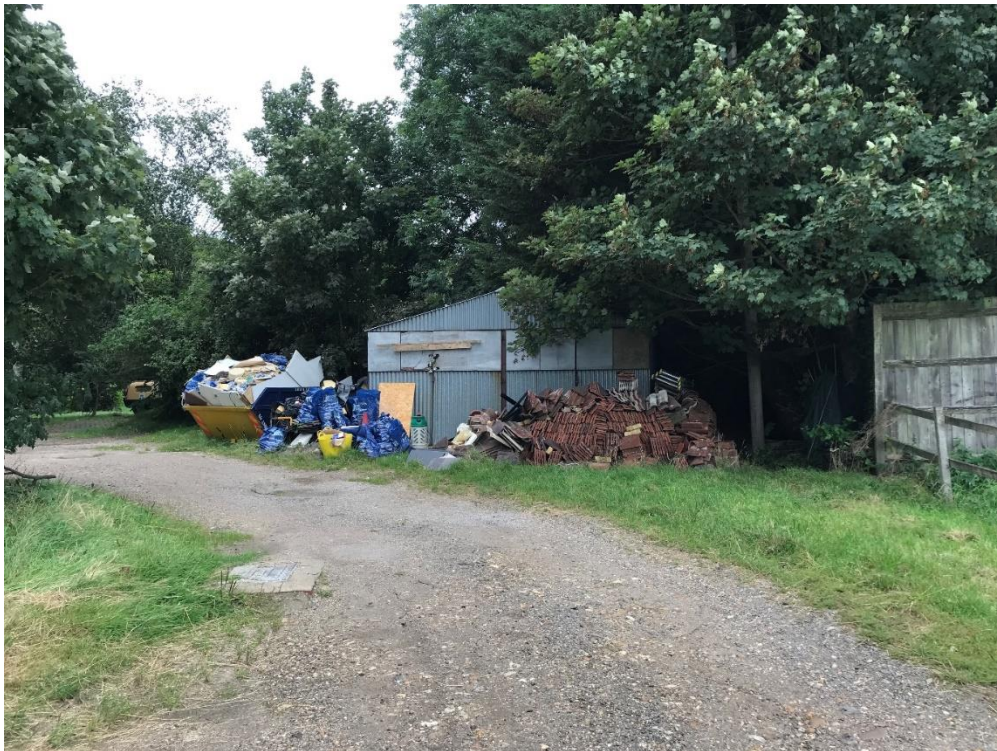
Photo 22: View of small storage shed and area at the site

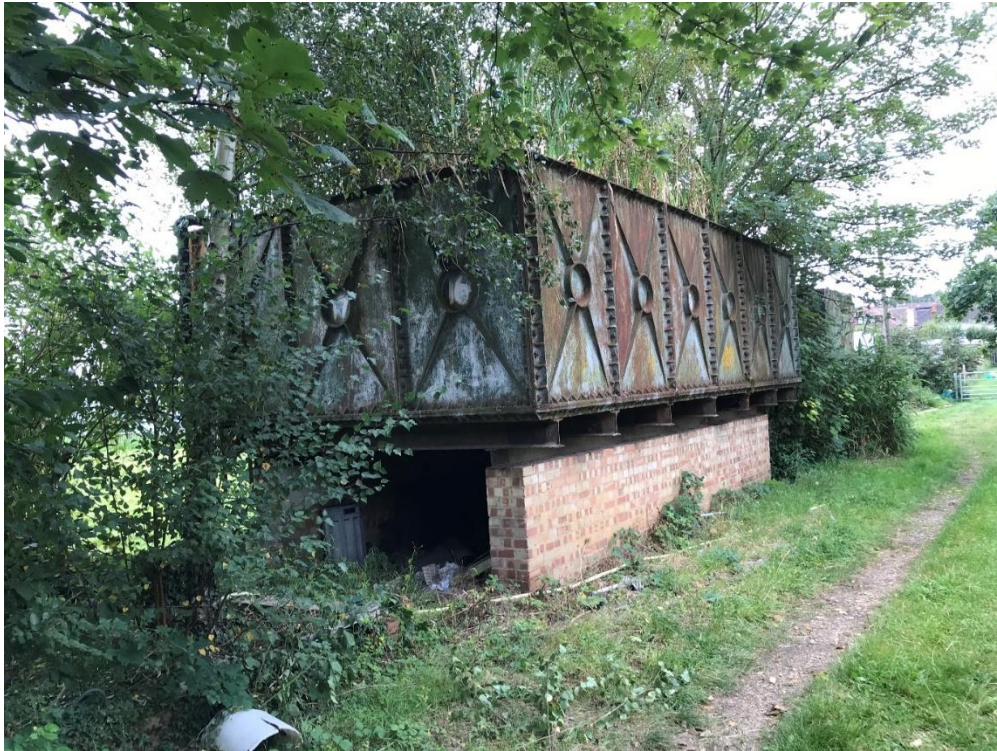
Photo 23: View of derelict water tank at the site

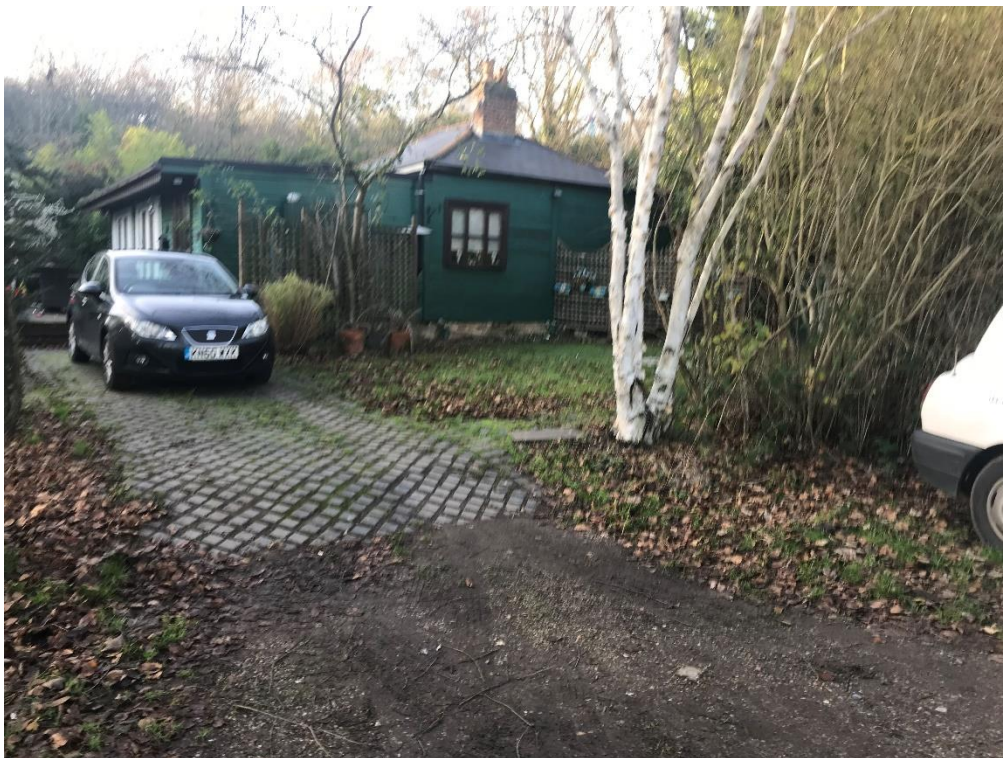
Photo 24: View of the 'Sticks' dwelling located to the west of the site

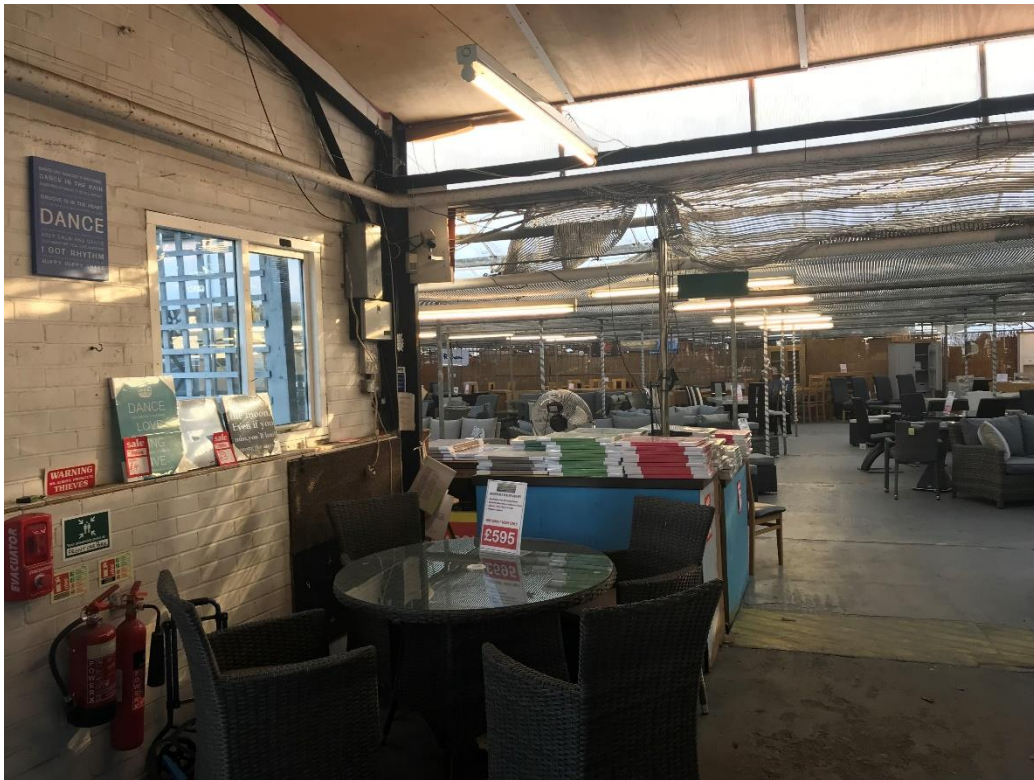
Photo 25: View of the interior of the Warmerdam's and its large retail sales area

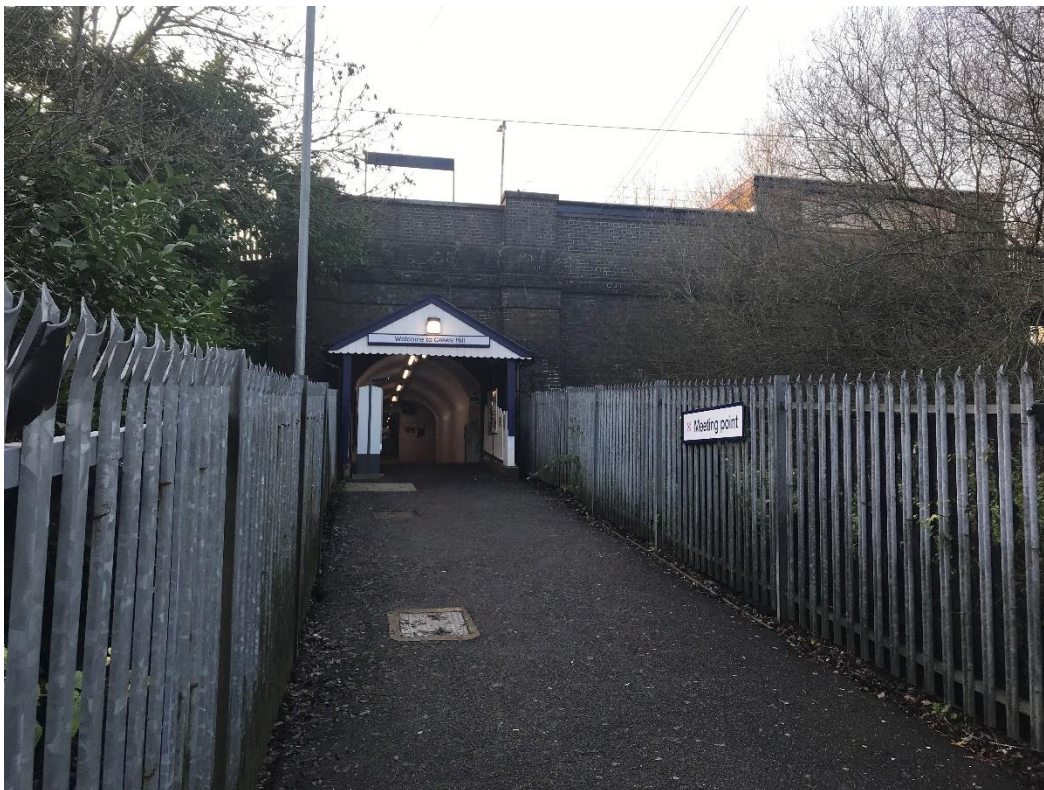
Photo 26: View of the entrance to Crews Hill Railway Station
