Montagu Road Cemeteries Conservation Area

Character Appraisal

Approved
Sept. 2016

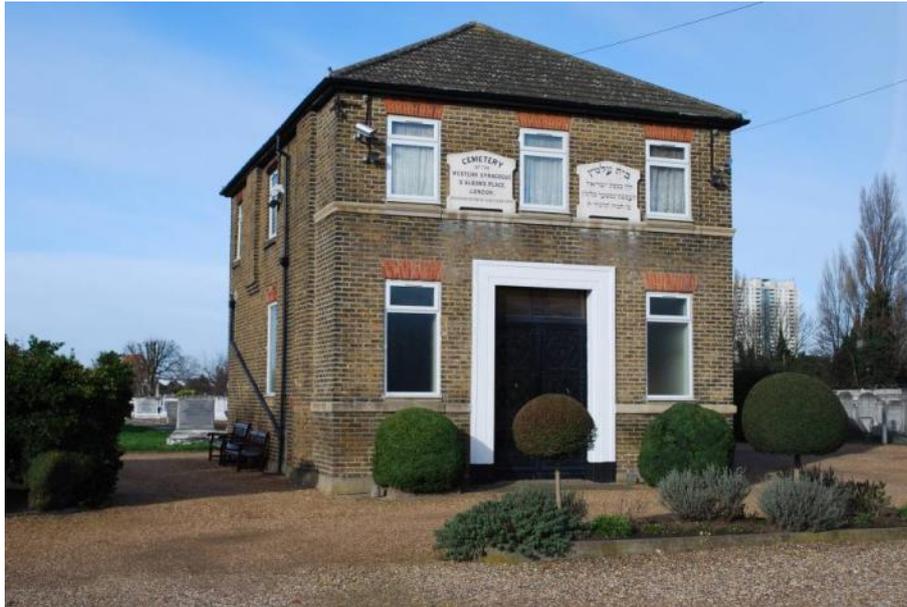
Figure 2: Western Cemetery, Western Synagogue Prayer Hall

The Western Synagogue prayer hall (*obel*) (*see Figs. 2, 3*) is of historic interest, but is architecturally plain and four-square, and has had its windows changed. The gravestones are almost universally of white marble, machine-made and lettered, and are placed so close together that it is barely possible to walk between the rows. This and the uniformity of appearance - in material, size and design - mean that the cemetery has very little visual appeal, although from this burial pattern it has a very distinctive character. Kadish notes that: 'The density of tombstones reflects the density of the living population in the East End, which was the most overcrowded quarter of London. The mass of gravestones materially expresses the crowded conditions and intense community life experienced by Jewish immigrants in the East End'²⁴. The fact that it is an extensive open space within a busy urban area, overlooked by multi-storey housing, is a characteristic that is positive rather than negative

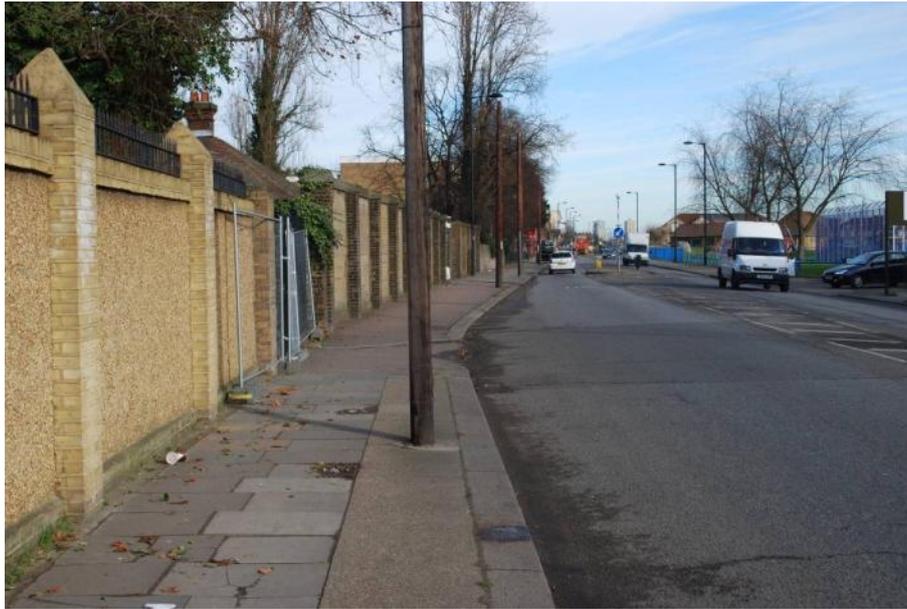
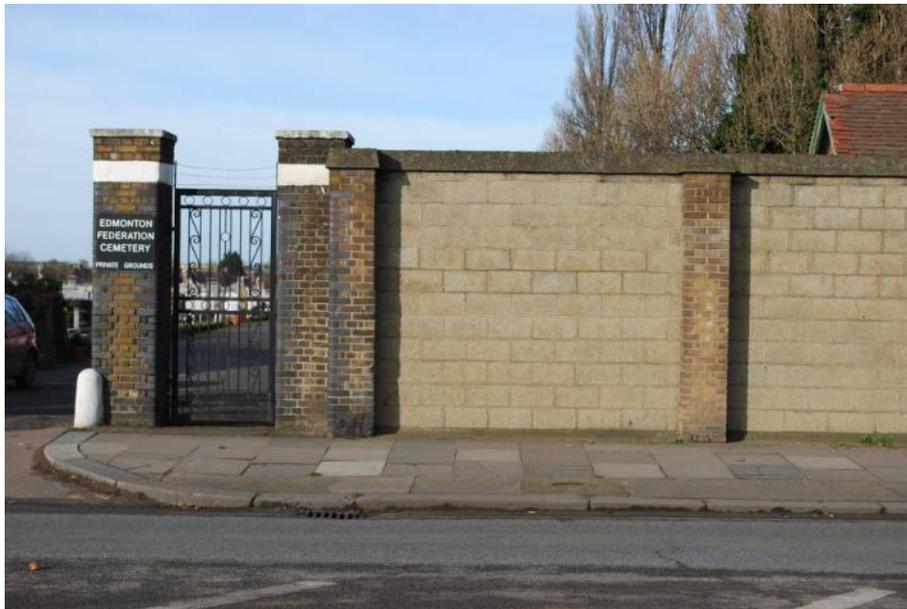
Figure 9: Boundary walls to Montagu Road

- 2.5.4 The external boundary wall is of concrete block, and the boundary between the two Jewish cemeteries is a low mesh fence. A tall concrete block and brick wall, topped with barbed wire, divides the Federation Cemetery from the Tottenham Park cemetery. These boundary treatments do nothing for the character of the Area, although different treatment of the brick walls to open views into the cemeteries could significantly enhance it, whilst improving natural surveillance. Paths other than the central access roads are unmade; there is little grass and surfacing is predominantly shingle.

- 2.5.8 More attention could be given to the creation of attractive entrances.
- 2.5.9 If vandalism is a major problem, the present solution of barbed wire and CCTV cameras needs reconsideration.
- 2.5.10 A long-term strategy needs to be prepared and adopted for the replacement of the concrete block, high walls.

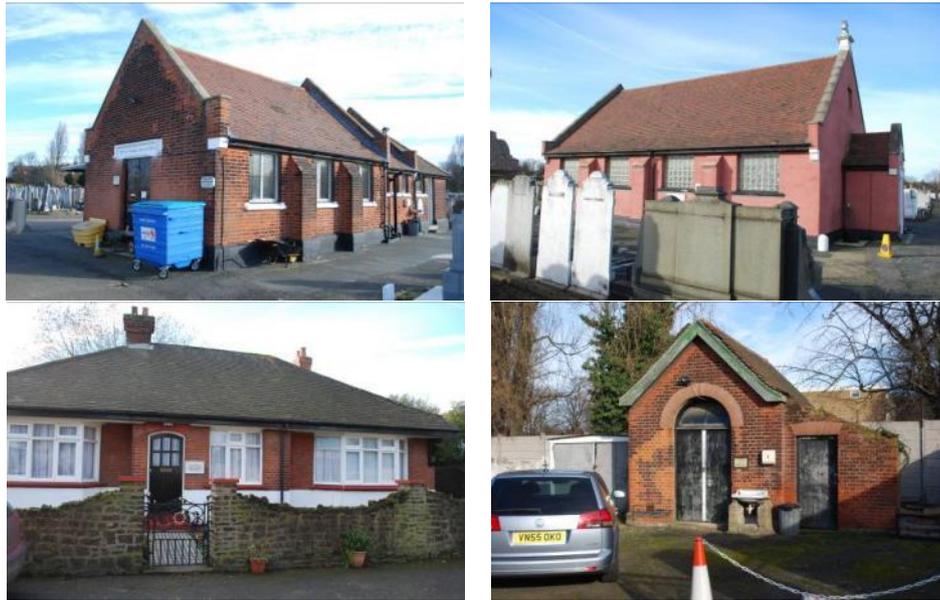
Figure 10: Buildings in the Federation cemetery

acreage (8.81 ha) and the density of burials²². The architectural/aesthetic interest of the area is primarily as open space with a remarkable expanse of consistent, regularly spaced graves, which offers distant views and a contrast to the densely-built and mainly post-war residential areas and industrial landscape around; it also provides a setting for Salmon's Brook Walk. The two cemeteries contain few architecturally distinguished memorials, other than a cluster of granite chest tomb to Federation notables (like Samuel Montagu himself, his daughter Lily Montagu, a founder of Liberal Judaism and a number of Hasidic rebbes are buried at Edmonton). In this they are typical of Jewish cemeteries where the emphasis is on equality in death²³. The only buildings are: a brick prayer hall (*obel*) at the entrance to the Western site; a small brick, former mortuary (*Bet Tabarah*) and lodge (a caretaker's house) at the entrance to the Federation site and two larger structures in the centre of the site - a former mortuary hall (*Bet Tabarah*), a rendered and pink-painted structure; and a red brick, office building with public toilets. Epigraphical evidence from tablets affixed to the two prayer halls (*obalim*) situated in the middle of the site (one of which is now used as the cemetery office and the other disused) established that these were built in 1916-17.

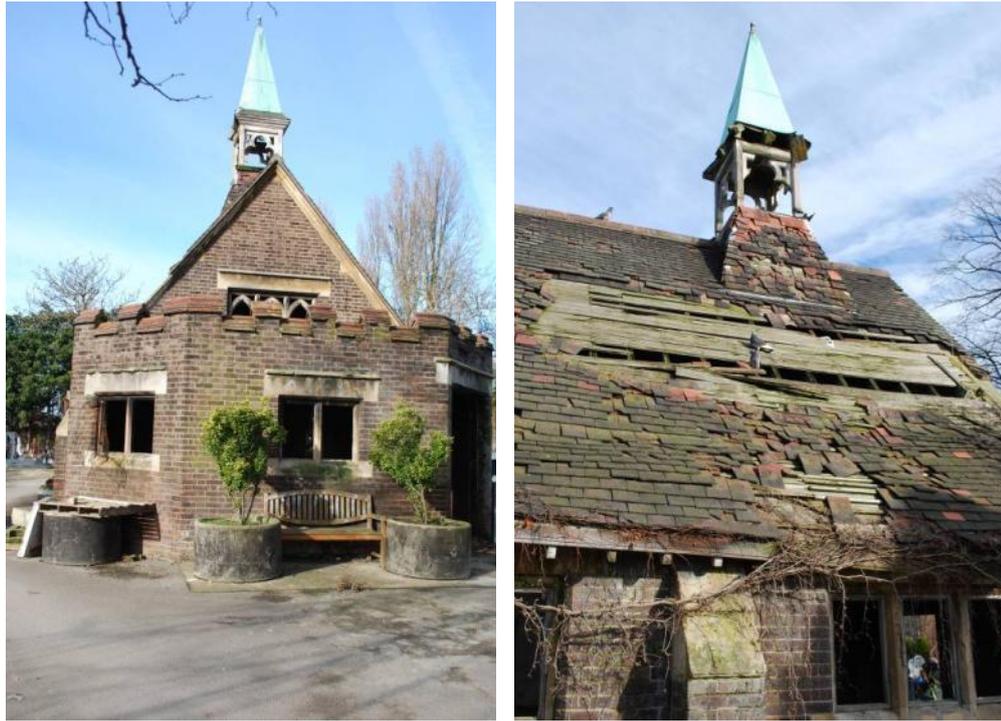
Figure 13: The chapel, east end and south side)

2.6.2 The chapel upon which the cemetery is focused makes an important contribution to the character of the area. It is the only substantial building, and, although now in a derelict state, is well detailed and well-sited. Approached along a generously wide access path and with a circular path around it, the chapel is in brick and has a symmetrical design. Its central part is gabled at both ends and has a central bell-tower with fretted timber framework and a tall copper spirelet. The lower parts at front and rear have castellated stone copings and a flat roof. All the windows have stone lintels with hood-moulds, cills and mullions, and the upper storey windows have tripartite gothic arched heads

- The most dramatic instance of this is the chapel, through long-term neglect of its fabric, lack of security and lack of care for its appearance. The interior has suffered a fire and access remains open to vandals. The roof and rainwater goods are in a serious state of dilapidation, leading to water penetration and plant growth within the fabric, and the brickwork has large cracks and is moving. The building appears to be totally neglected and is in very poor condition, to the point of requiring fencing off.

- *The chapel at Tottenham Park is a building worthy of repair and enhancement;* it is of modest but sound design and its well-detailed belfry and spire are a focal point in the cemetery. Reinstatement would be appropriate should the existing fabric be beyond repair.

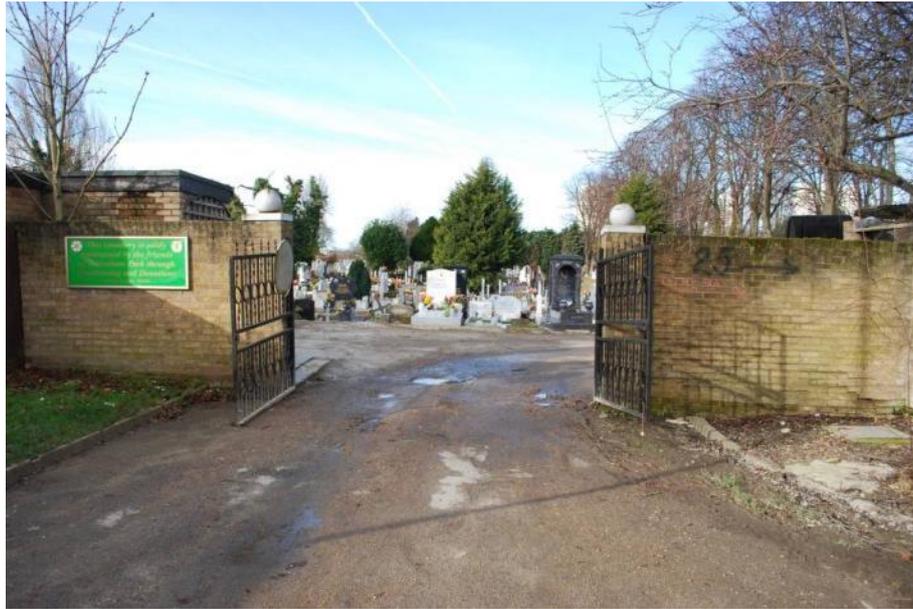
Figure 15: Tottenham Park cemetery, entrance

- Ugly steel paladins for waste are left at the entrances facing the main approach; they spoil the careful arrangement of bedding plants in two concrete planters flanking the wooden seat on the east elevation (see the photograph on the next page). Paladins are also prominently displayed next to the entrance area, as is a dismal shack with a vandalised door.

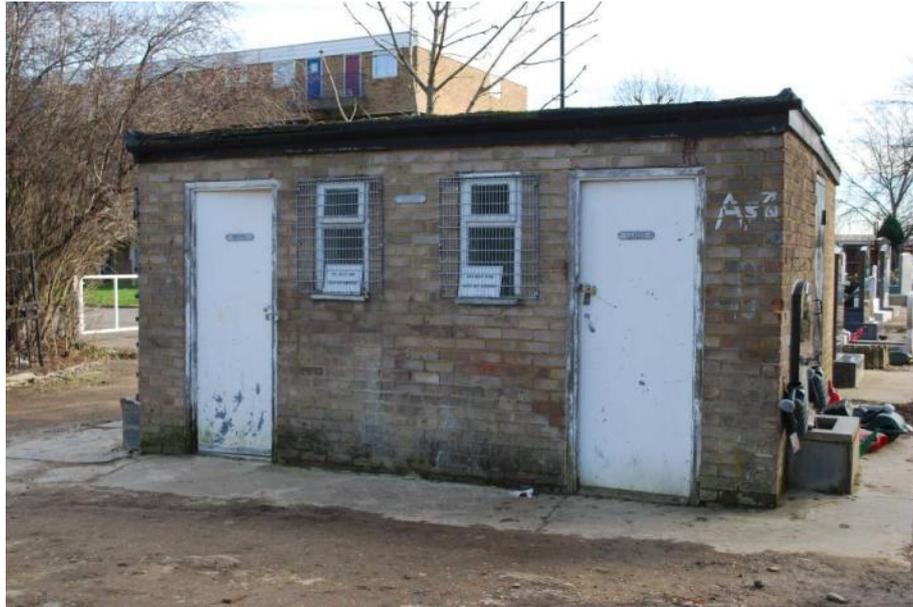
Figure 17: Tottenham Park cemetery, disused lavatories

- The structures at the entrance – a store and a toilet block – are in poor condition.
- The pathways are formed of different finishes and, in places, are poorly constructed and/or in poor condition.

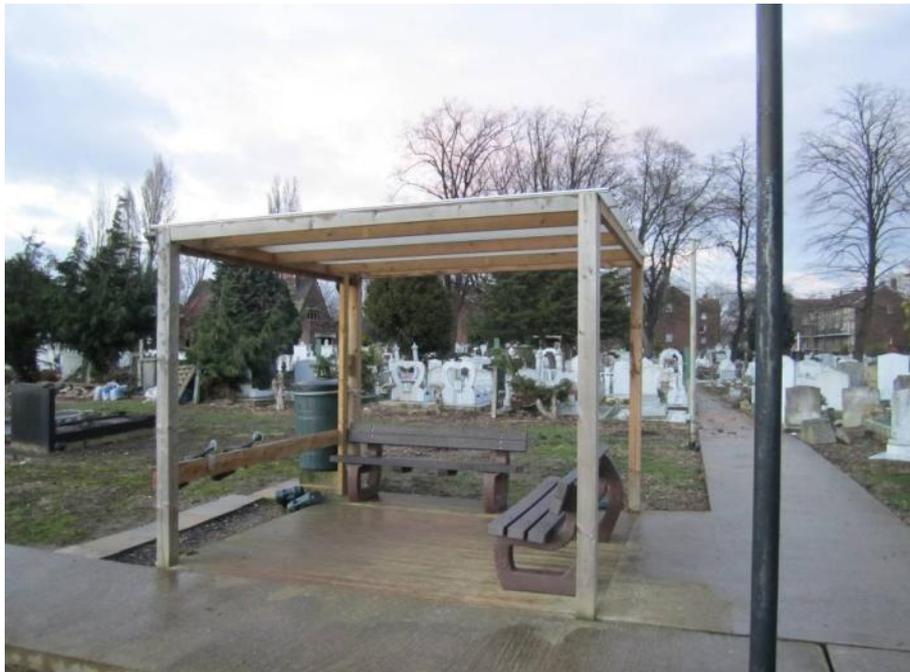
Figure 18: Tottenham Park cemetery, shelter constructed since previous review

- There appears to be a growing tendency to erect shelters, mostly over graves although one has been erected for general use. The structures, albeit of utility value and relatively small, are generally speaking, intrusive in terms of form, design and materials. Other structures, such as a board with pegs for watering-cans have been erected in prominent locations on utilitarian concrete bases.
