# Turkey Street Conservation Area Character Appraisal

Approved February 2015

Reviewed and updated February 2014

**Drury McPherson** Partnership  
*Historic environment policy and practice*

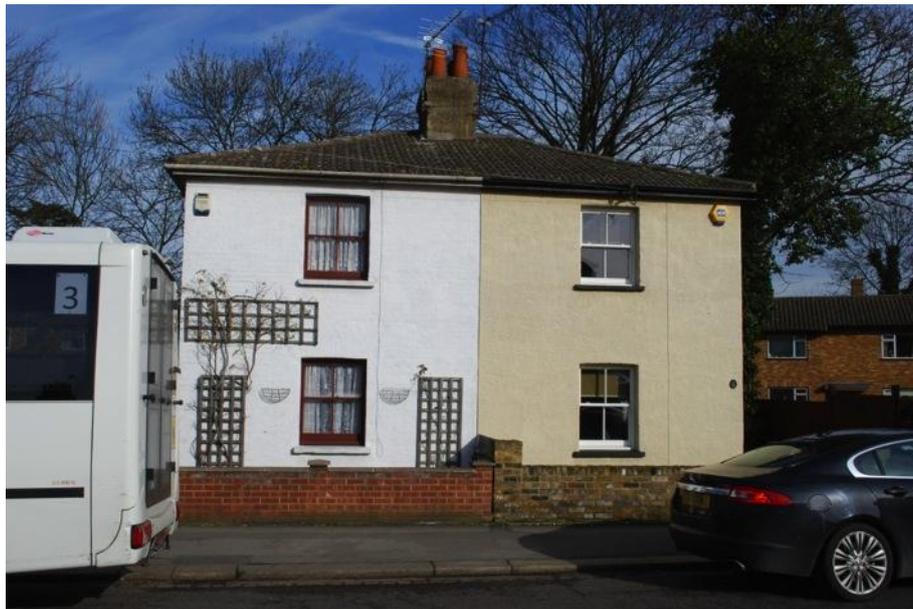
Figure 8: 1 and 3 Turkey Street, street elevation

- 2.6.3 Nos. 1 and 3 retain timber two pane sash windows, one to each floor at front and rear. The roof to the pair has been re-tiled with concrete pantiles. No. 1 has had a rough-cast render finish applied and the brickwork of no 3 has been painted. A single storey pitched roof extension at the rear of no. 3 may be the original scullery, but the rear on no. 1 has a full-width modern extension. There is also a collection of several *ad hoc* timber or brick sheds to the rear. Despite this, the fact that the pair remains in an approximation of its original state makes an important contribution to the Conservation Area on both front and rear aspects.

- *There is a need to protect the remaining relatively unaltered cottages on Turkey Street (nos. 1 and 3), to prevent this pair losing its character as the rest of the group has done. Any such action, however, will only be worthwhile if there is a serious intention in future to protect the character and quality of the Conservation Area more carefully than has been the case so far.*

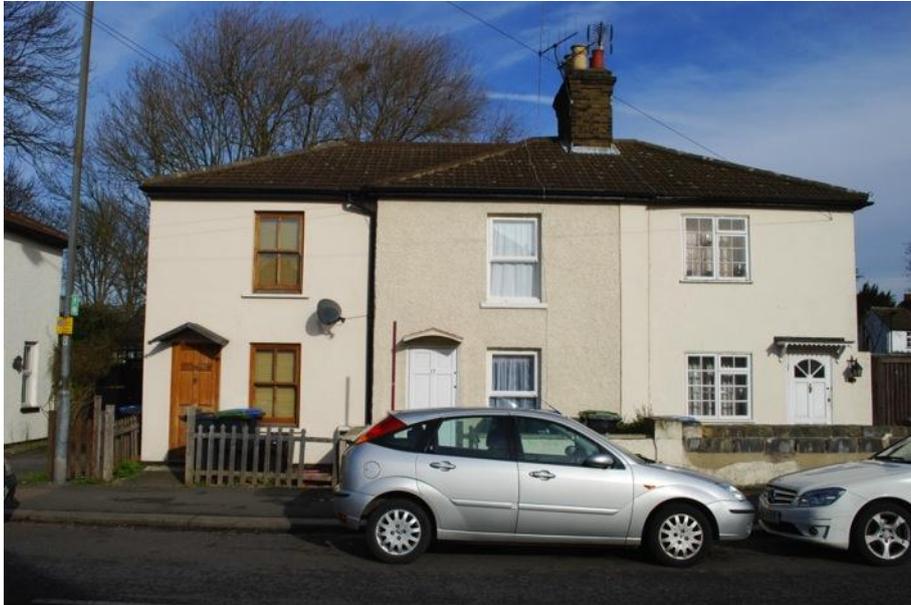
Figure 9: 19-15 Turkey Street

- 2.6.5 The two pairs to the west of The Turkey have been rendered, and have concrete tiled roofs, but have not been treated as pairs; no. 15 has replacement casement windows with small panes, and a standard integral-fanlight door inserted on the front elevation, while No. 17 has replacement windows with top-lights. The single storey, former shop extension to the left of no. 17 has been replaced by a new dwelling, which, while its form and some of the details are ‘in-keeping’, unbalances the semi-detached pair. More importantly the row of three doors – all of which are of

inappropriate form and details - to the front has upset the rhythm of the elevations of all the cottages, one of the distinctive features of the Conservation Area. Nos.19 and 21 have uPVC sashes and no. 19 has a two storey side extension.

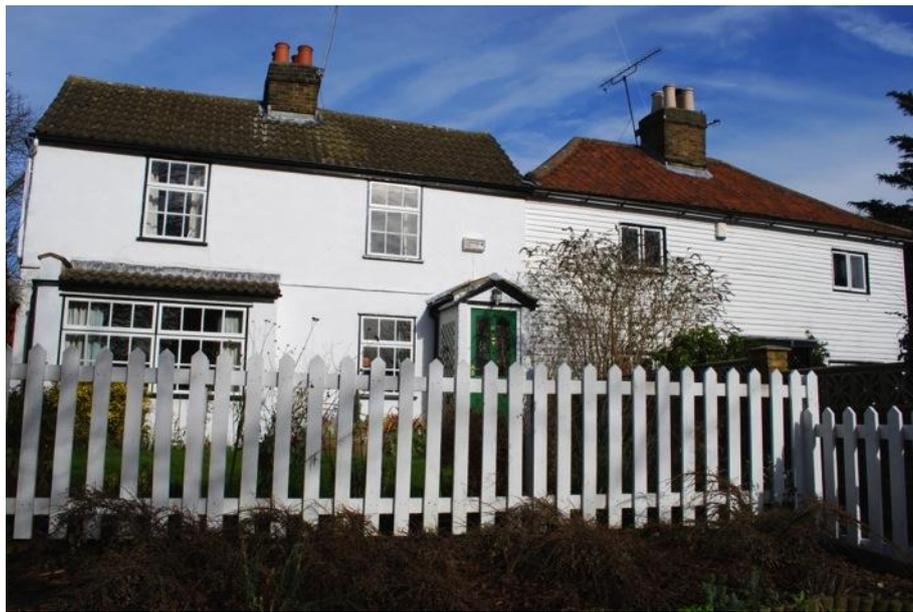
Figure 11: 41 and 43 Turkey Street from Turkey Brook

- 2.6.6 The other group contributing to the character of the Conservation Area is the pair of cottages at 39 and 41 Turkey Street, on the footpath. They are the only survivors of a scattered group of houses on the land north of the brook, most of which lasted until the middle of the 20<sup>th</sup> century, when they were replaced by bungalows, or by road access to new development. The two cottages are attached: no. 41 has a hipped roof and no. 39 does not. Both have substantial central stacks. No. 41 has painted weatherboarding and small plain timber casements, while no.39 is smooth-rendered and painted white. Its poorly-designed replacement windows have fixed lower sashes and top-hung upper lights, all with small panes, accompanied by a modern square bay and brick porch. But the total effect of the two cottages is pleasantly rural and complements the brook-side setting, emphasised by the white picket fence, hedges and gardens. The cottages can also be glimpsed from the rear path along the boundary of the Conservation Area, but this view is considerably less attractive.

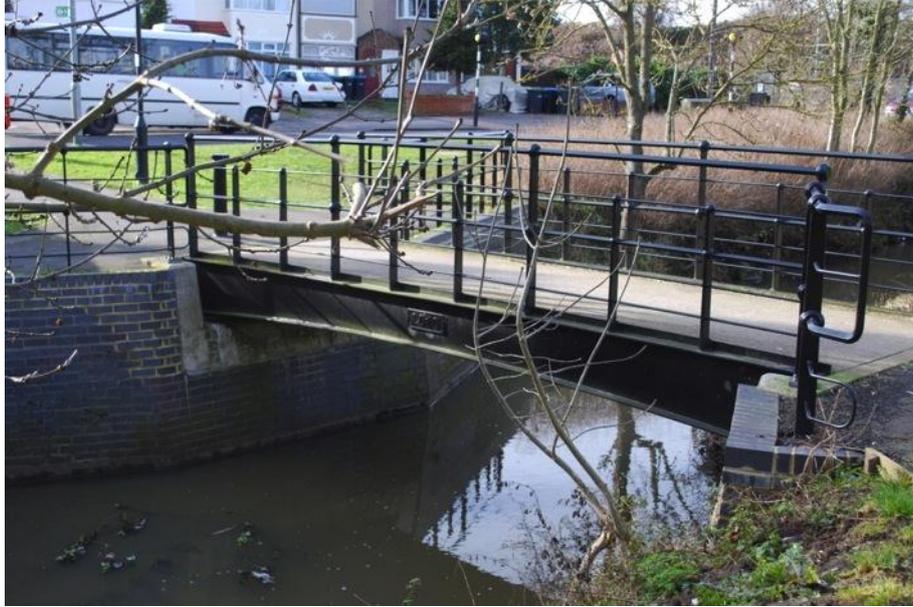
Figure 12: Footbridge over Turkey Brook (2010)

- 2.6.7 The surviving railway structures built in the late 19<sup>th</sup> century by the Great Eastern Railway Company make an important contribution to the Conservation Area. Although the arch carrying the railway line over Turkey Street has been replaced by a flat steel bridge, the abutments and adjoining arch remain, as does the road bridge over the brook (see Fig.13). The

construction is in blue engineering brick and the arches are four rows of headers, with walls having bull-nose copings. There are also painted steel footbridges over the brook at either end of the Conservation Area. The eastern bridge was rebuilt in 2003 and one at the western end was replaced in 2010. The style of each reflects 19<sup>th</sup> century design, and the bridges have enhanced the character and appearance of the Conservation Area.<sup>12</sup>

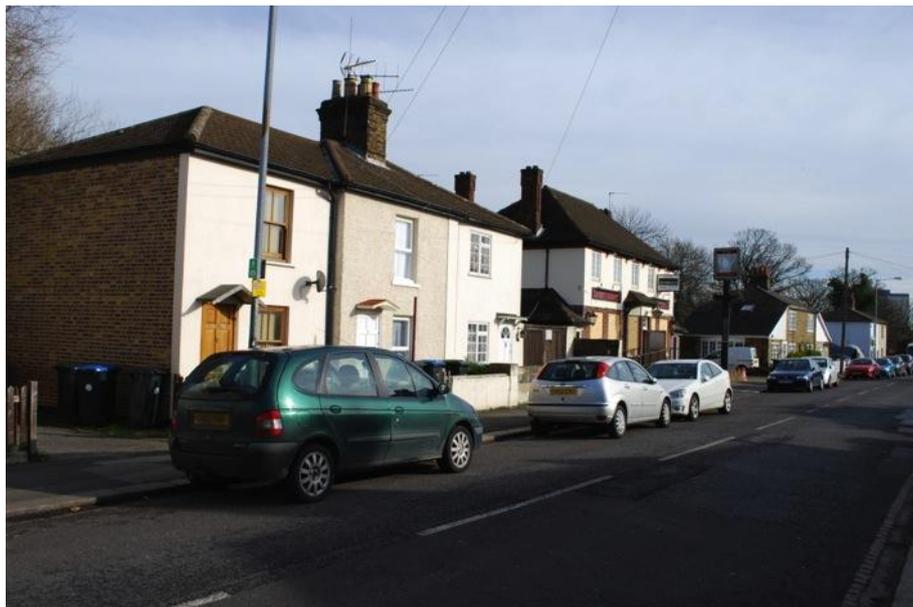
Figure 14: houses in Turkey Street and the Turkey PH

- 2.6.10 The Turkey public house, a stolid four-square edifice in the road-house style, was built by 1939; the building's overall design is neutral, but its total effect borders on negative with large bland uPVC windows to the ground floor, a poor relationship with its setting and low-quality hard landscaping and boundaries. Otherwise, damage to the building frontages of Turkey Street and the brook footpath is in the details; replacement windows with poor proportions and materials, concrete tile roofs, and inappropriate extensions and rear boundaries to the brook, especially the concrete wall of the public house.

- *The setting of The Turkey public house is unattractive, and detracts from the appearance of the houses on this frontage, which collectively are of some historic interest despite alterations.*

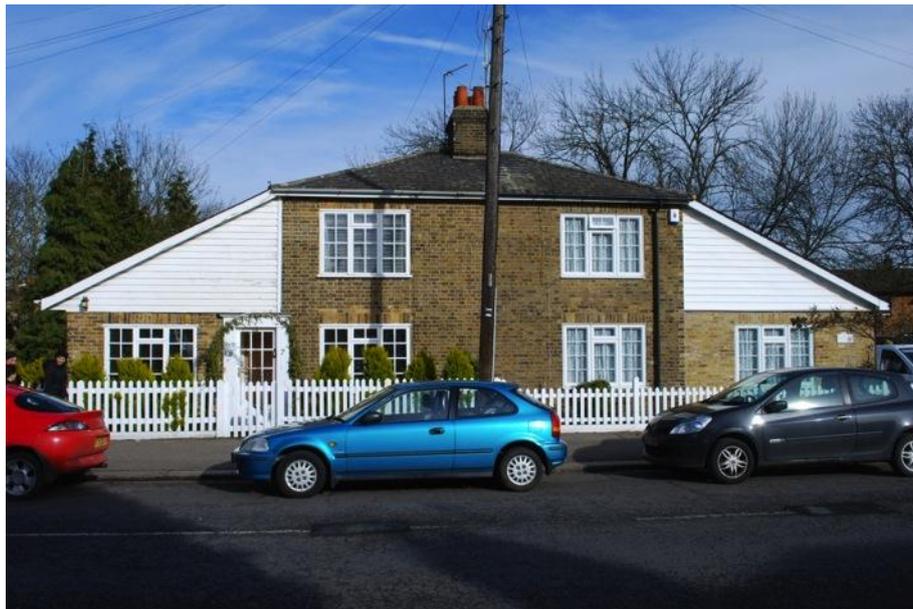
Figure 15: Extended 19th century cottages, 5-7 Turkey Street

- 2.6.4 The remainder of the group have all undergone major and unflattering "cosmetic surgery" in the late 20<sup>th</sup> century. Nos. 5 and 7 have been treated as a pair in the changes they have undergone. They have identical single-storey side extensions, with a mono-pitch roof up to the house eaves level and modern casements in square openings, which have been repeated as replacements to the cottage windows. All have unfortunate soldier arches, and casements and top-hung vents with inappropriate small-pane glazing. The overall effect is out of scale and proportion with the modest front

elevations, and the addition of front doors is a further inappropriate change. This pair, however, does retain its slate roofs and its stock brick walls are not painted or rendered.
