BROOMFIELD HOUSE

Gazetteer

March 2016

GAZETTEER – HOUSE AND STABLE YARD CURTILAGE BUILDINGS

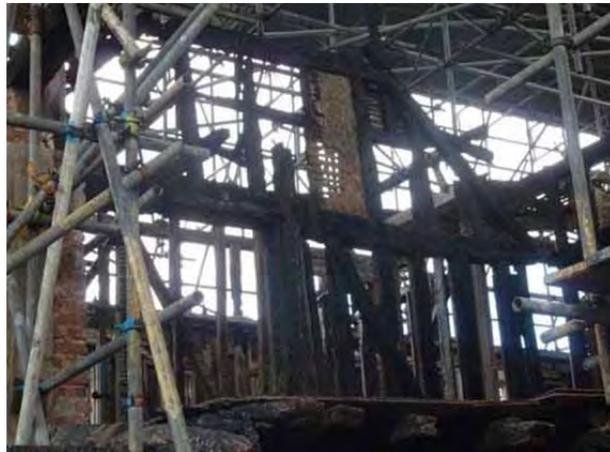
- ii. **The Tudor timber gabled cross wing**, with decorative gable and quadrant bracing below. This is dealt with in more detail in the section addressing room F12 later in this gazetteer.

Significance: Considerable significance, relative to the evidential and illustrative historical values which the timber represents. The Tudor core illustrates an important step in the development of the house from a humble farmhouse, to a more imposing form. This gable, sat centrally in the current plan form, suggests the previous building's outer footprint, whilst also demonstrating a construction type which is rare in this locale.

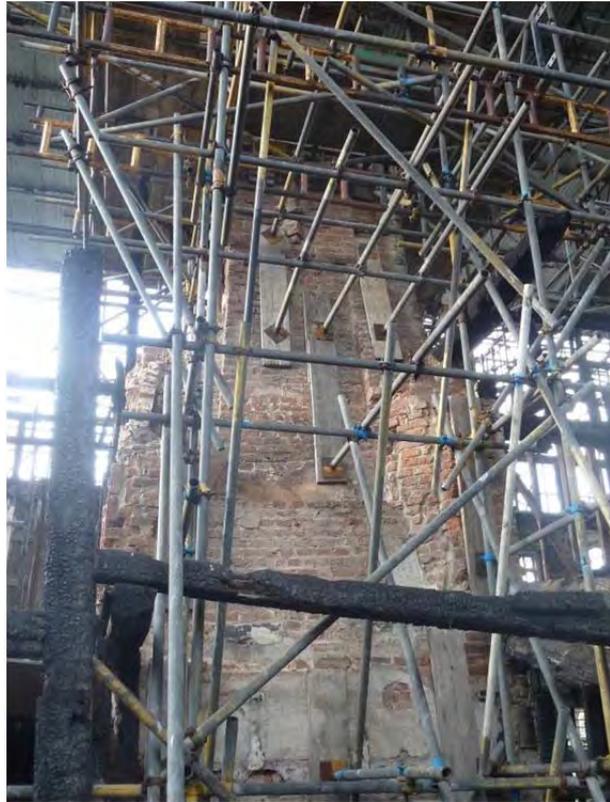
- iii. **The brick chimney adjacent to room G12** and its chimneystack, give clues to the historic narrative of the house's development, its fireplace relates to room G12 to the south, which was one of the principal rooms of the Tudor iteration of the house. Its relationship to the Tudor crosswing suggests the building may have been aisled, or that there may have been a (now lost) hall to the north. More recent investigations have revealed the presence of wall paintings on this stack in room G8

Significance: **Considerable** significance, relative to the evidential and illustrative historical values which the chimney represents. The Tudor core illustrates an important step in the development of the house from a humble farmhouse, to a more imposing form.

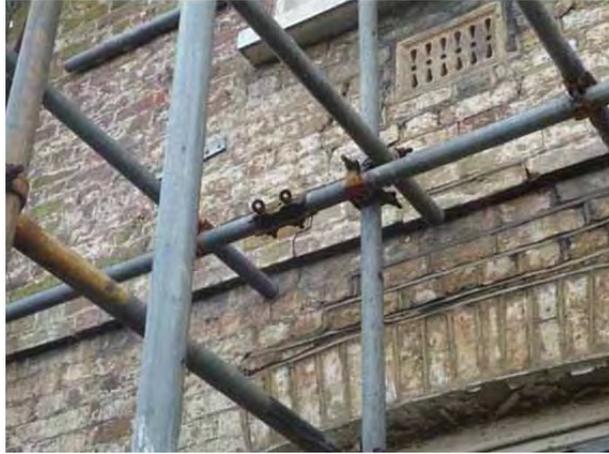
- ii. The façade is of Flemish bonded brickwork, with a two course high string course above the ground and first floor windows. Remnants of paint exist on the brickwork, and some of the joints appear to have been repointed in cementitious mortar.

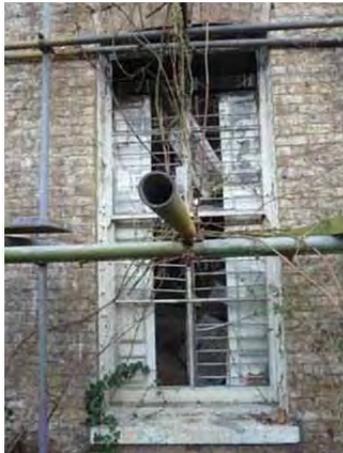
- iii. The ground floor painted timber sash windows are of two sashes, each with four panes. The glazing of the panes is missing or damaged throughout, though the timber mullions generally survive. There are no external architraves present, only shallow (timber?) boards to the cheeks and head, and timber cills to the base. The heads of the openings are arched, with un-gauged brick arches above.

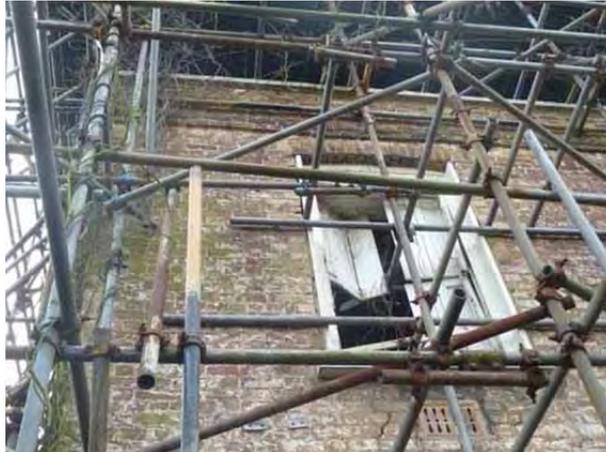
- iv. The first floor painted timber sash windows are of two sashes, each with six panes. The glazing of the panes is missing or damaged throughout, though the timber mullions generally survive. Square edged timber boards, thicker than those of the ground floor sashes sit to either side of each sash, with a shallow timber board to the head. The heads of the openings are arched, with rubbed and gauged brickwork to the head, directly below the top brick string course of the façade.

Condition: Generally, in relation to the whole building, this façade is in the best condition and consists of the most historic external built fabric. The sash windows are in fair condition, though they need some minor timber repairs, easing and redecorating, and reglazing. The brickwork is of fair quality with little spalling, although there are movement cracks in places. Cementitious mortar repairs have been carried out in places which are poorly matched to the size, colour and finishing of the original lime mortar pointing. The painted finish of the brickwork is patchy and of inconsistent coverage. There is some moss growth to the north-east corner of the brickwork caused by plant growth on the east elevation, beyond the arris. The brick string courses do not appear to have any flaunching.

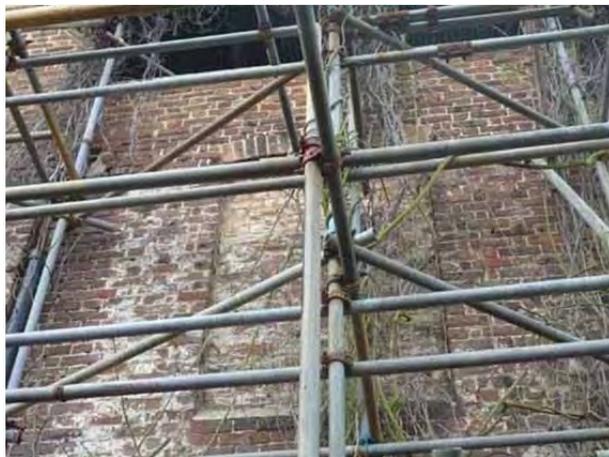
- iii. The first floor window to the north end is blind with mortar flaunching to its cill.

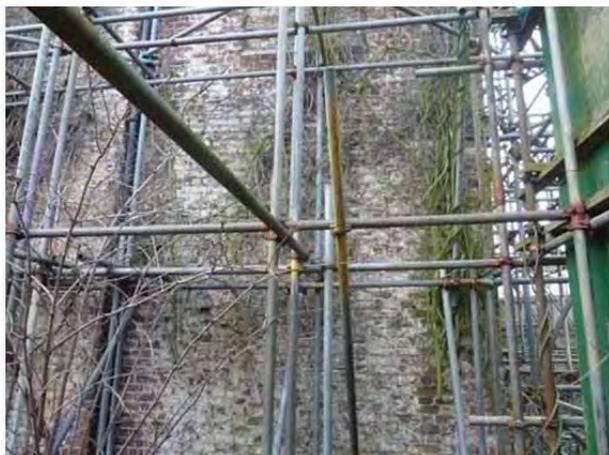
- iv. There is creeping plant growth up the façade, helped by the temporary scaffolding.

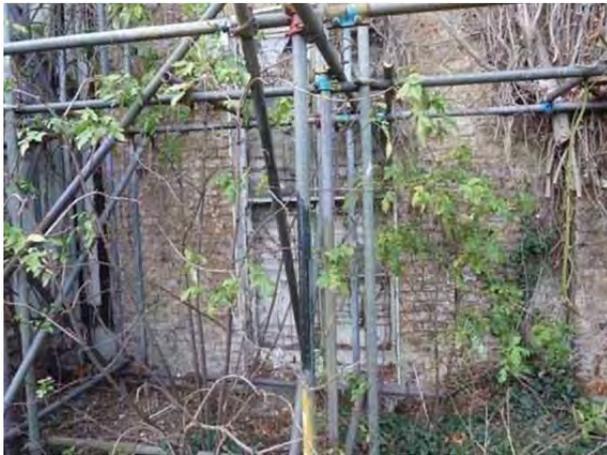
- vi. The ground floor painted timber sash window is of two sashes, each with four panes. The glazing of the panes is missing or damaged throughout, though the timber mullions survive. There are no external architraves present, only shallow timber boards to the cheeks and head, and timber cills to the base. The heads of the openings are arched, with un-gauged brick arches above.

Condition: As with the north elevation, this section of façade is generally in good condition, though both of the sash windows require timber repairs and replacement of their glazing. It would be good and useful to clear the detrimental plant growth from the façade to fully assess the condition of the brickwork and associated pointing fully. The brickwork is of fair quality with little spalling, although there are movement cracks in places. Cementitious mortar repairs have been carried out in places which are poorly matched to the size, colour and finishing of the original lime mortar pointing. The chimney breast is generally in good condition with some recent repairs and repointing evident at its head.

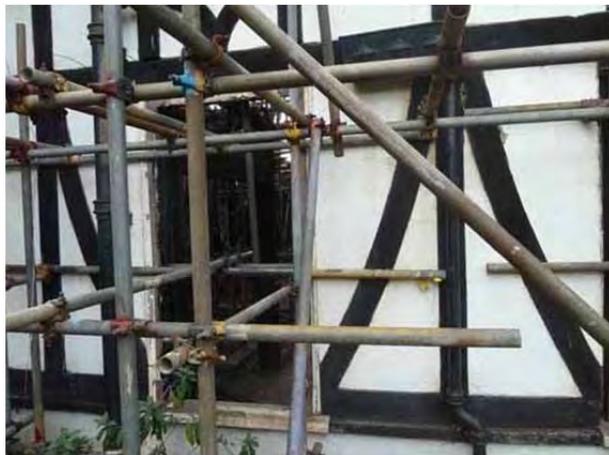
vii. Sash windows are missing and no window architraves are present (over most of this elevation). Several sections remain at ground floor level.

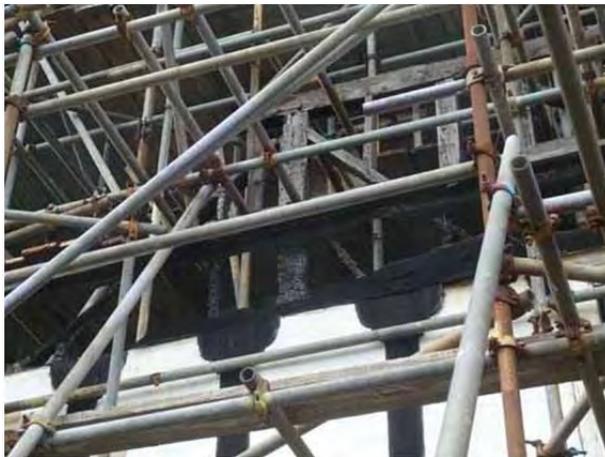
ix. Parapet façade missing, there is no coping and the early-19th century studwork is visible beyond.

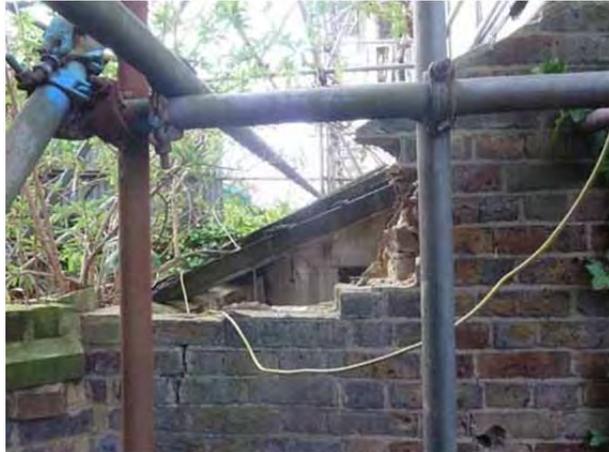
- xi. Lean to missing roof, bastard bond brick pattern.

Condition: Generally this façade is in a poor state of repair.

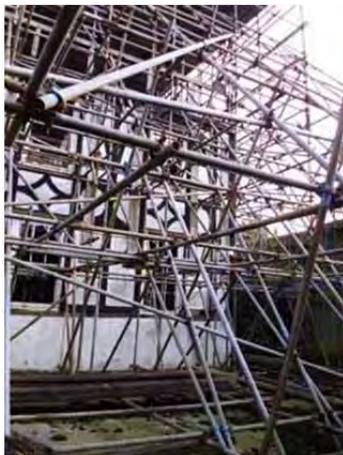
- iv. The oak timber boarding mimics the quadrant bracing found in some of the earlier internal timber framing. In places the façade has failed and the fire charred remains of the earlier studwork is visible externally.

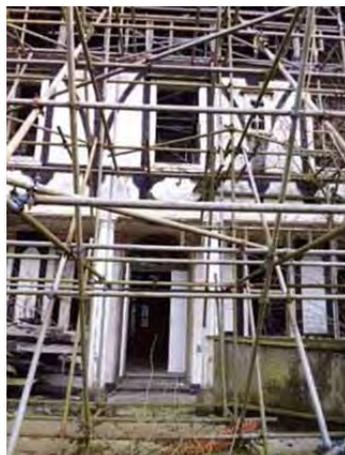
- v. The sash windows are missing and the architraves are missing over the majority of the elevation.

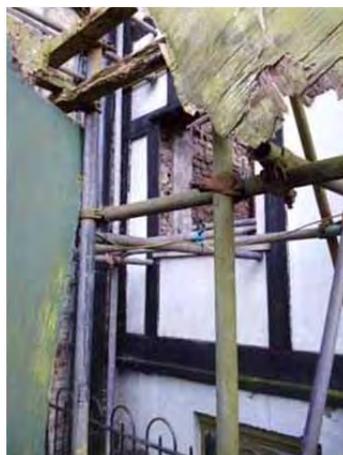
- iii. Ground floor, off centre window opening. Cill and part of frame remain, no evidence of casement/sash.

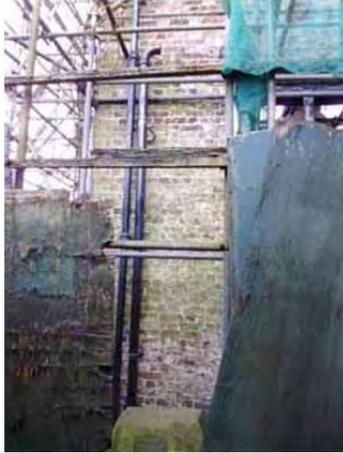
v. Remnants of rainwater pipes remain on façade.

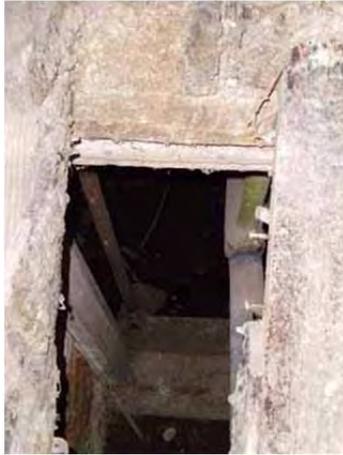
- i. General example of interior condition, photograph taken from above as no safe access could be gained.

Condition: Inspection of the basement revealed the ceiling of the basement room B6 is formed of corrugated steel sheeting supported on steel beams, supported on a mixture of steel posts with adjustable legs or timber posts. There are steel bracing poles between the steel posts.

Comment: The steel flooring was noted to have surface corrosion of both the posts and corrugated sheeting.

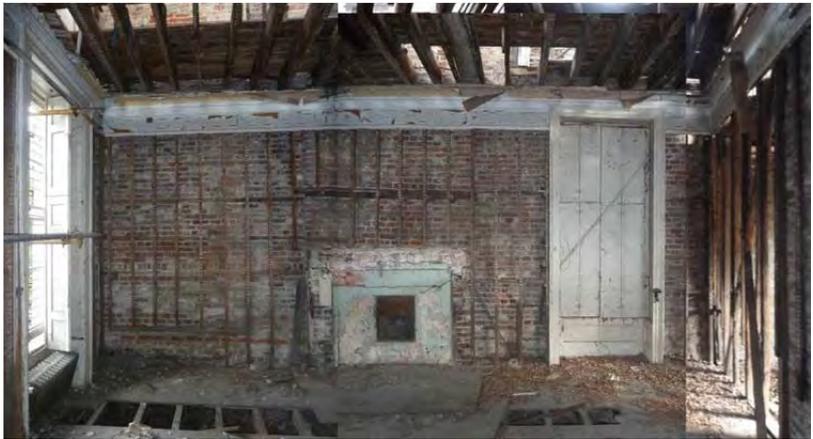
iii. East elevation.

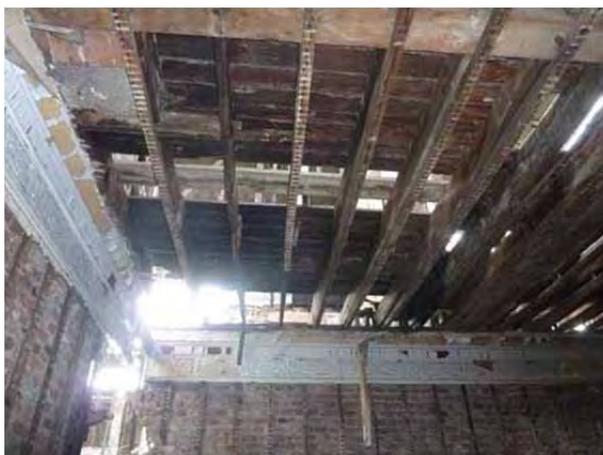
v. Ceiling.

Internal Brickwork: The main bonder above the fireplace in G1 has failed. There are several bricks with blown faces to the interior behind the remaining timber studs of each elevation of the room. Some rebuilding of brickwork around the jambs of the sash windows of this room is necessary. The internal brick wall to the south end of G1 is in poor condition, a collapse of the adjoining structure has dislodged part of the wall, and this is causing the deterioration of surrounding masonry.

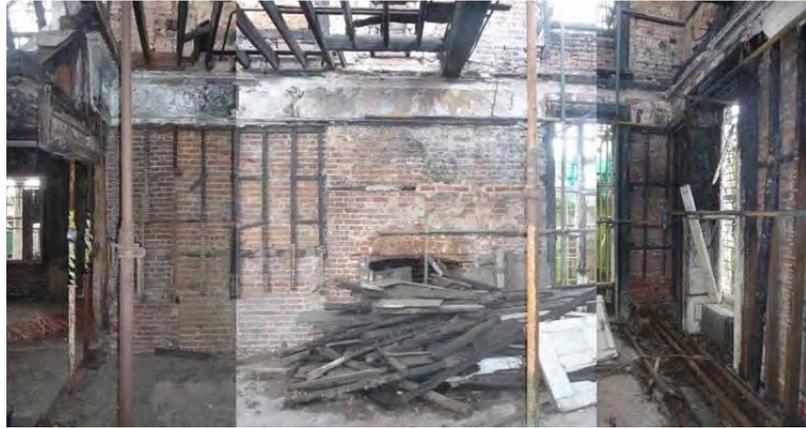
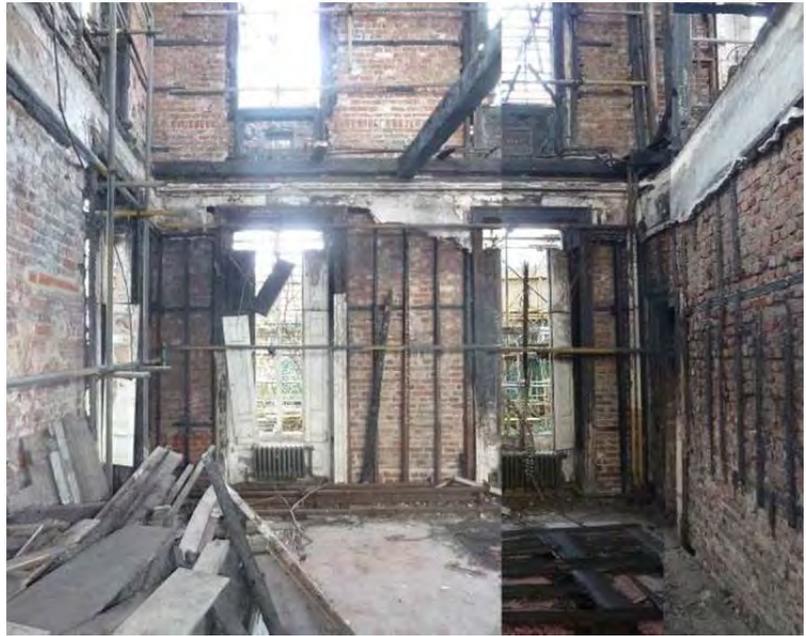
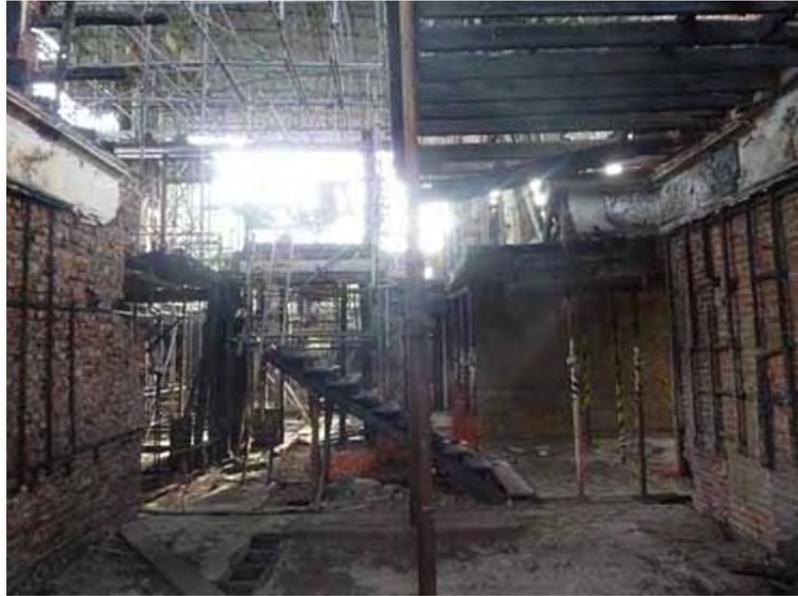
Condition: Walls: As in room G1, the main walls of G2 are propped with modern acrow props, to substitute for the support previously afforded by the first floor structure, the external brick walls remain apparently sound though the top brick courses are in poor condition. The external walls are formed of a 225mm solid masonry wall, with another 112mm brick wall immediately to the exterior of this. Curiously, these two skins are not structurally tied together.

The bonding timbers visible longitudinally to the inner face of the brickwork are in poor condition and are considered no longer fit for purpose.

Brickwork: There are several bricks with blown faces to the interior behind the remaining timber studs of each elevation of the room. Some rebuilding of brickwork around the jambs of the sash windows of this room is necessary. The east wall of room G2 is suffering from collapse along the line of the adjacent upper bonding timber. The collapse of the adjacent section of wall to its southern end has dislodged a section of brickwork and this is causing the deterioration of the remaining unsupported built fabric.

Windows: The damage is more substantial than in G1 and will require replacement of shutters. In addition parts of the dado panelling will need extensive making good for re-use. The timber framed glazed double door to the West end of the room has collapsed on its hinges and has lost sections of its framing.

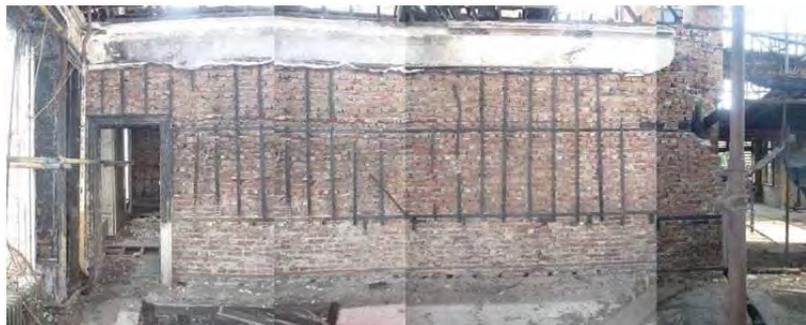
iii. East elevation:

The south end of the east wall has been damaged beyond repair, while other elements could be repaired.

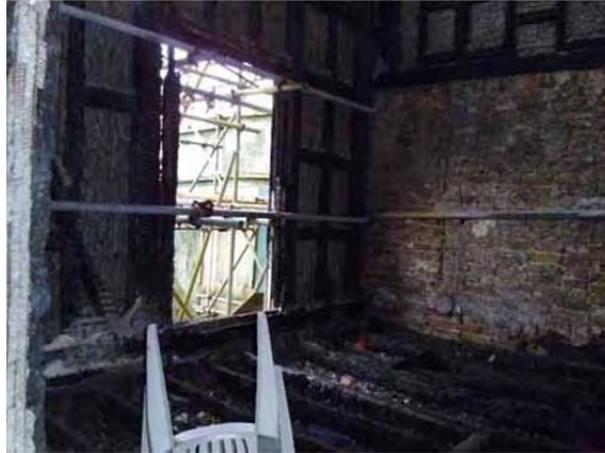
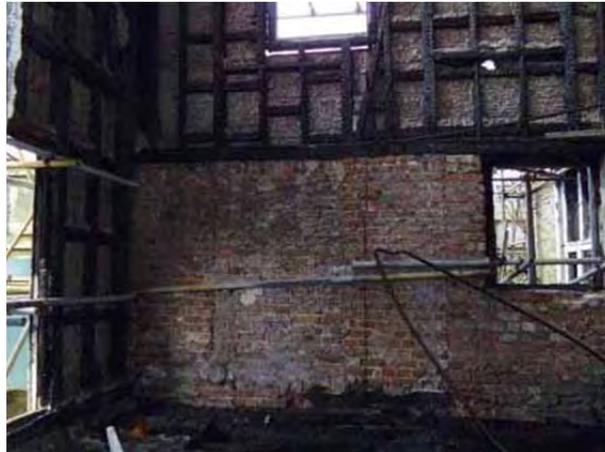
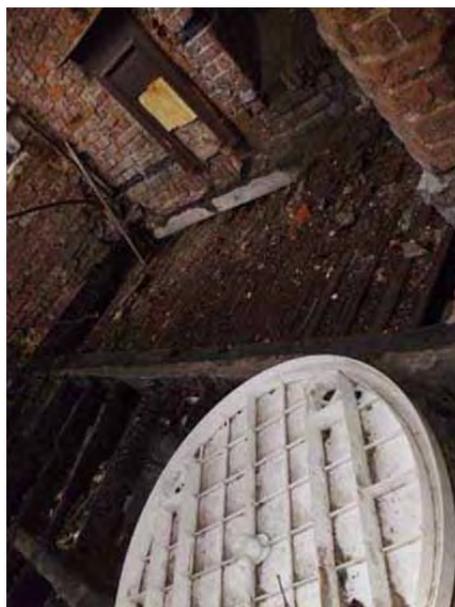
Condition: Room G3 is thought to be of early 17th Century origin, it was more seriously damaged than some of the other brick faced rooms to the North end of the house. The ground and first floor are missing, as are much of the timber side wall framing. The floor level differs from the surrounding rooms and this room's walls are of several periods indicating it was formed from existing elements of the building envelope. As noted elsewhere, the large adjacent chimney stack between this room and G2 has been repaired and repointed.

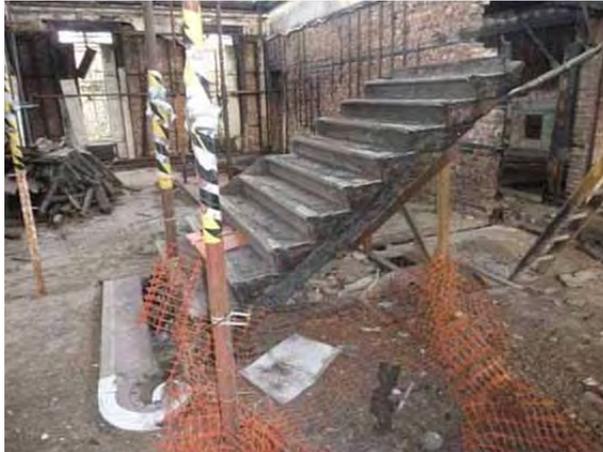
vi. Staircase.

Timberwork: Little of the decorative timberwork to room G4 proper remains in situ, the staircase is incomplete and most decorative elements including spindles, handrail, decorative panelling, skirtings, dado rail, picture rail and cornice mouldings have been lost to the 20th Century fires or removed subsequently and put in storage. The retained handrail and staircase elements have recently been inspected at their store at Clavering in Essex, and were found to be in good condition.

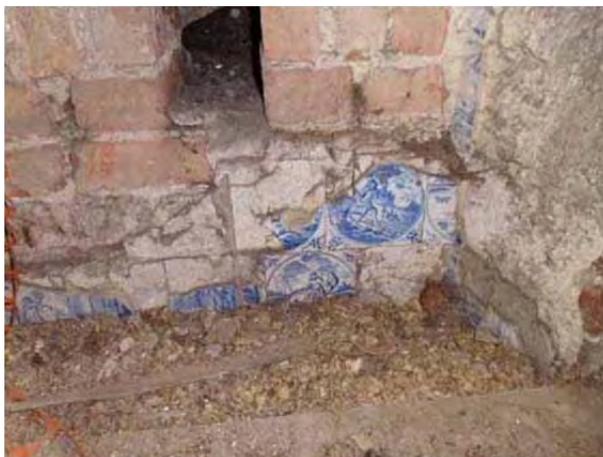
vii. Tiles to the foot of the fireplace.

Internal Walls: The internal walls to the North and South of G4 partially survive, though they are missing all of their surface finishes, except for the fragmentary remains of what appear to be blue and white Delft tiles within the fireplace.

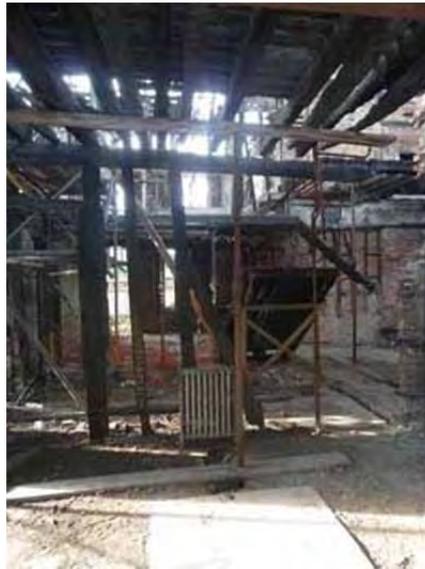
- i. Room partitions stripped by fire, presently a single volume. (photo shows volume which previously contained G5 and G7).

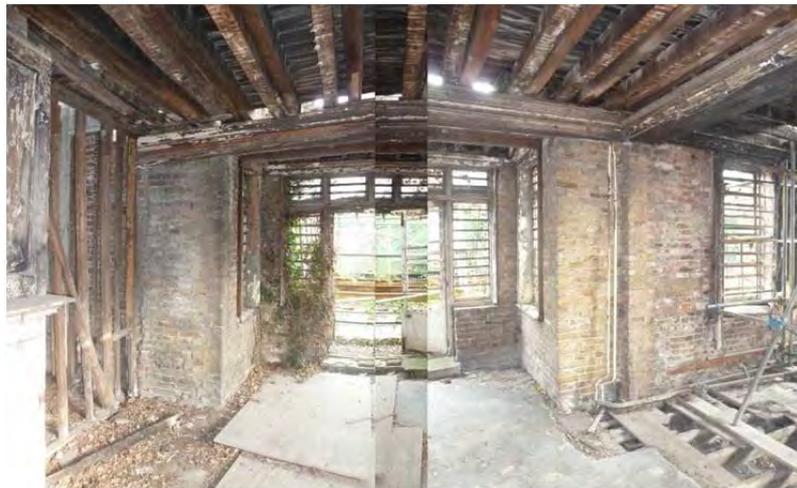
iii. East elevation, incorporating timber bay window.

Above the masonry wall there is the early 20th Century expanded metal lath with a cementitious covering and decorative half timbering externally. This is tied to the extant timber framing from earlier timber framed walls, which are now severely damaged and charred by fire. It is thought that the metal lath is now providing structural support to the timber framing, where prior to the fires the opposite would have been the case.

The windows set into this wall are thought to be contemporary with the early 20th Century wall into which they fit, and they are thought not to be in a salvageable condition.

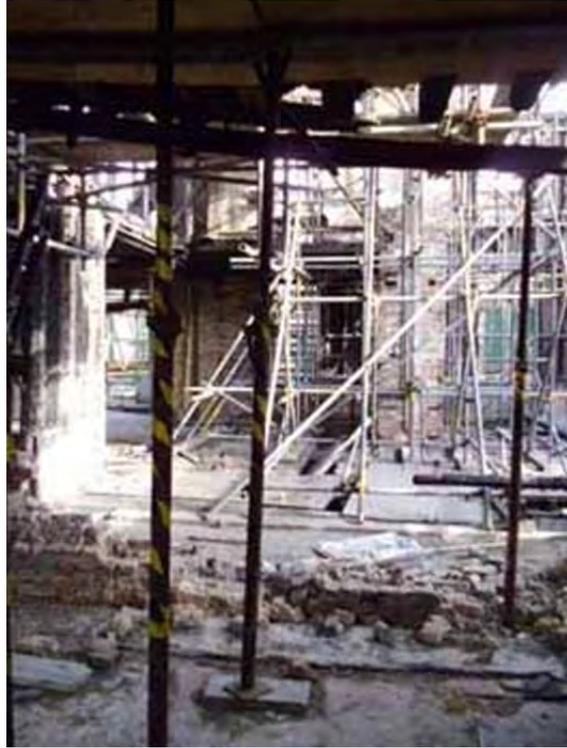
iii. East elevation.

The East wall of G8 may have been the external wall of the Tudor house at one point, as the decorative gable end framing sits directly above this at first floor level. There is also the rubble of a low level brick wall below the lost timber framing noted above. Though much of this wall is in a poor state of repair, it may be consolidated and/or rebuilt from a mixture of existing fabric (seen scattered about it in the photograph of the East elevation in this gazetteer) and new bricks to match.

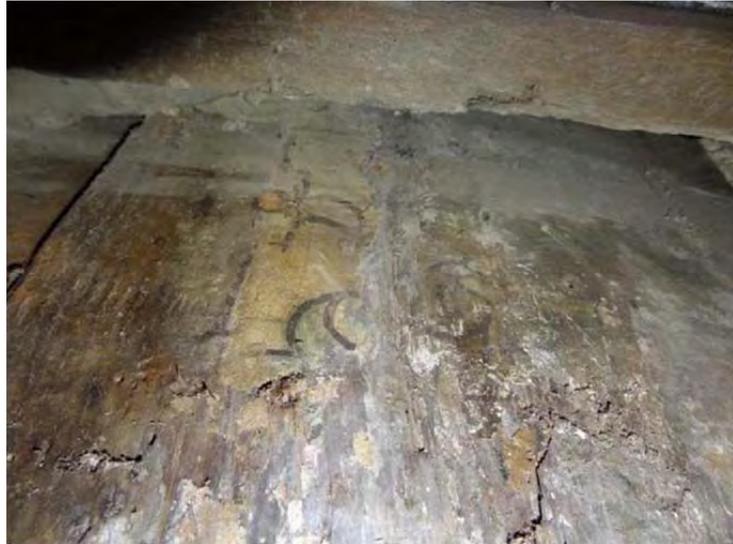
At the heart of this area is the Tudor chimney stack to the South of G8, the product of several building periods and now stabilised with the injection of grout and the insertion of a new beam to the fireplace opening into this room. More recently, and as reported separately by Hirst Conservation, wall painting dating from c1550 has been found on this stack. Enfield Council hold a copy of the report.

Wall painting on stack in G8

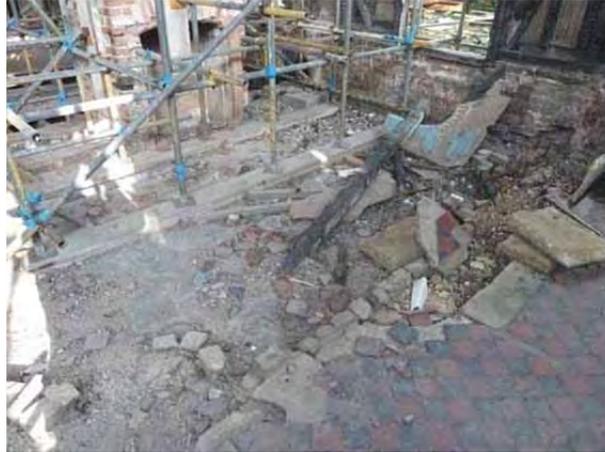
- i. Room partitions stripped by fire, presently a single volume. (photo shows floor surface change between G6 and G9).

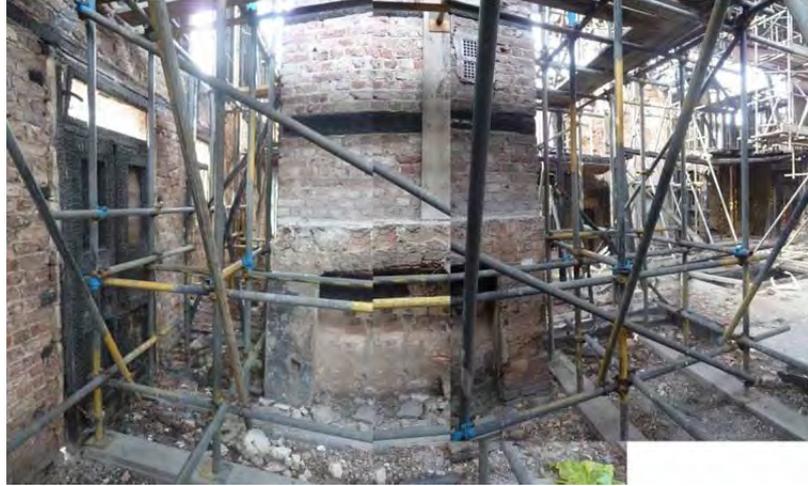
- i. Room partitions stripped by fire, brickwork chimney breast remains centrally (photo taken facing west).

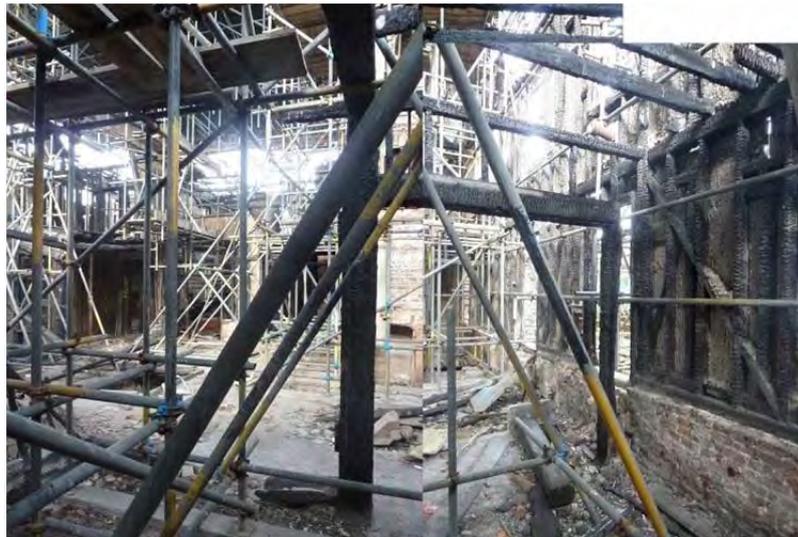
- ii. Room partitions stripped by fire, rooms G5/G7 visible beyond (photo taken facing north).

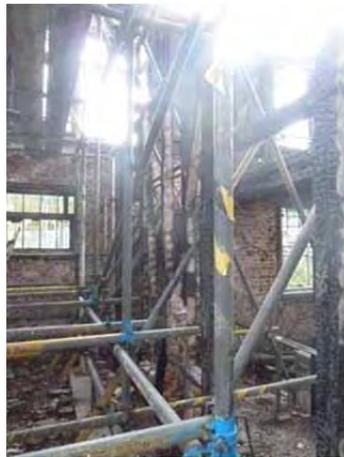
iii. East wall studwork exposed and surfaces missing.

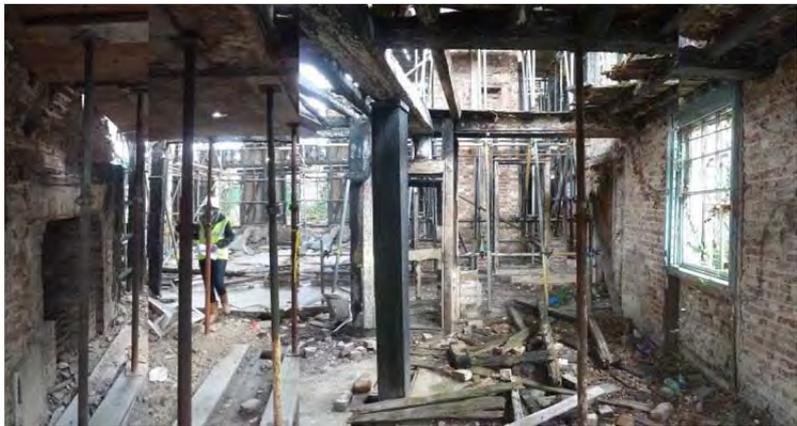
iii. East elevation.

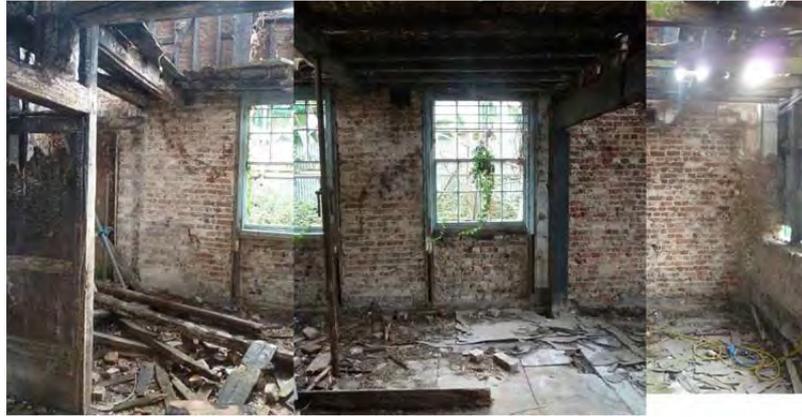
iv. South elevation.

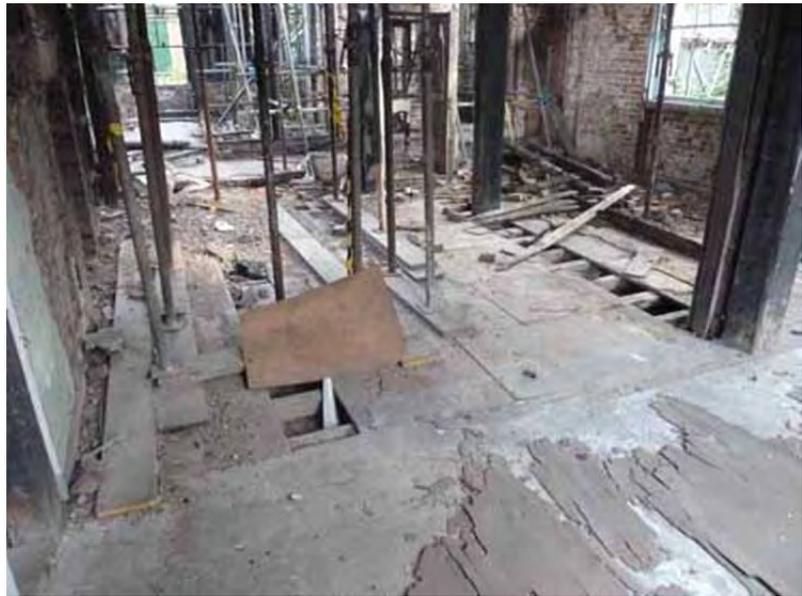
v. Floor.

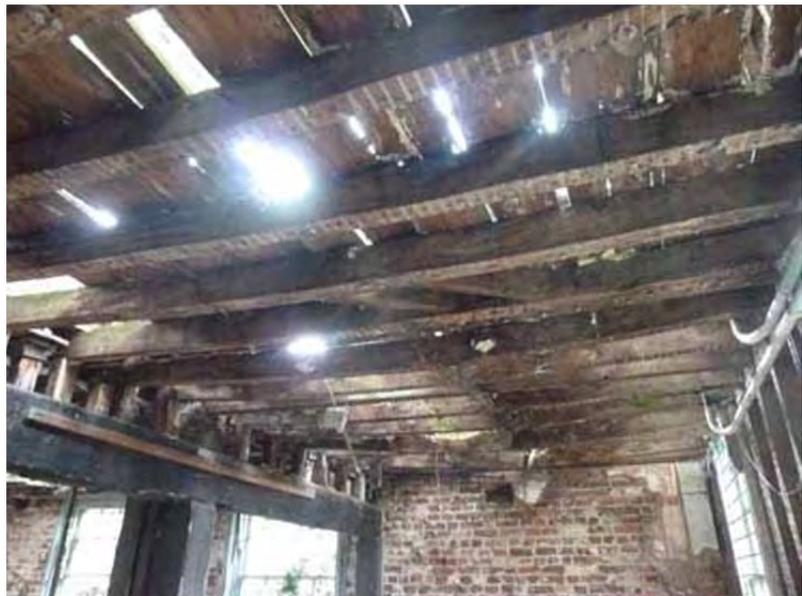
vi. Ceiling.

Ceiling: The ceiling structure survives, though it is held up by acrow props to the centre of the room. It is presumed that this indicates that the extent of the fire damage to the ceiling is such that the structural ability of the remaining joists is insufficient to hold the first floor partitioned rooms above.

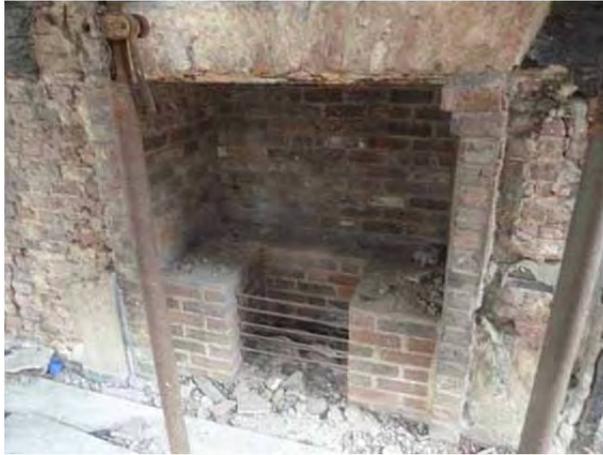
vii. Brick fireplace.

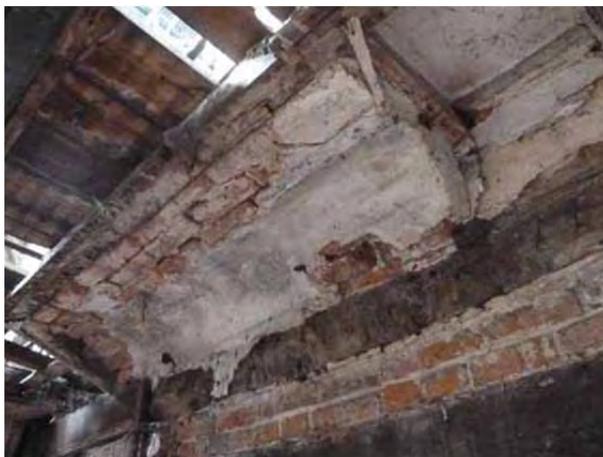
viii. Corbelled brickwork supporting fireplace hearth of first floor room F21.

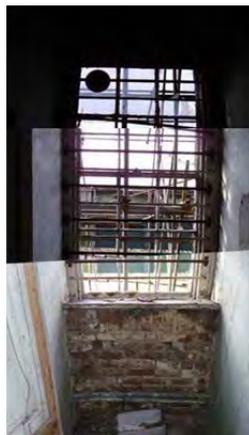
- i. Small partitioned rooms, with single sash serving south-western most room.

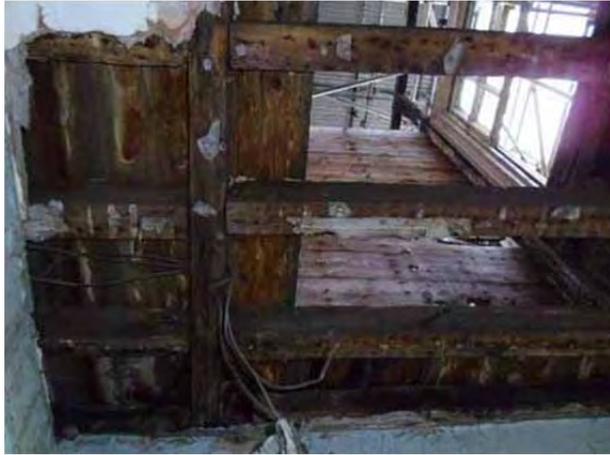
ii. Ceiling (missing).

Ceiling: The principle timbers of the ceiling appear to be in fair condition and are visible above G13, though the ceiling finish itself has been lost, as have some of the first floor floorboards above.

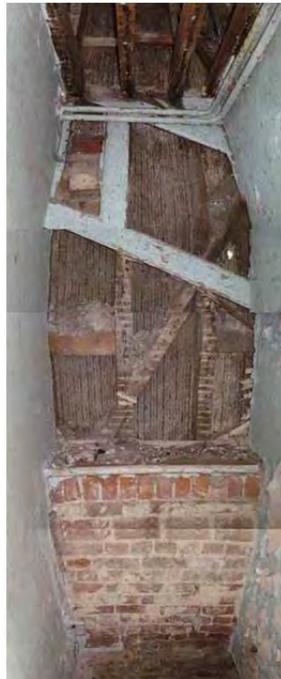
iv. Outer wall section facing west.

Condition: External Walls: The West end of the rooms of G13 is formed by 112mm low walls from floor to cill level. Above the masonry wall there is an early 20th Century expanded metal lath with a cementitious covering and decorative half timbering externally. This is tied to the extant timber framing from earlier timber framed walls, which are now severely damaged and charred by fire. It is thought that the metal lath is now providing structural support to the timber framing, where prior to the fires the opposite would have been the case.

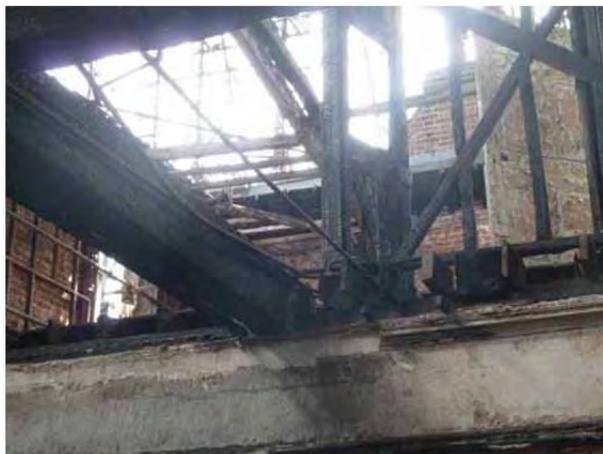
i. East internal elevation, partially visible through charred stud partition remains of the west internal wall.

Condition: Walls: The external walls are of brickwork, the top courses of which are failing. Generally they seem to be in reasonable, repairable condition. The internal partitions have been largely burnt out, though enough remains to delineate the rooms from one another in this area.

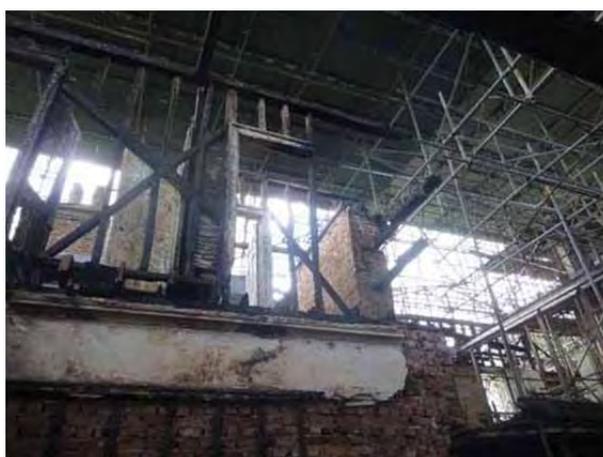
ii. Remaining brick chimney to the south elevation of room F2.

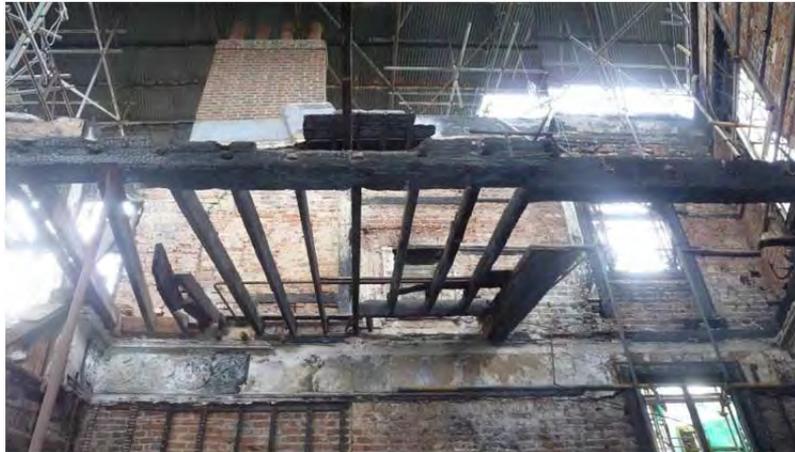
i. West elevation.

Condition: Walls: The external walls are of brickwork, the top courses of which are failing. Generally they seem to be in reasonable, repairable condition. The internal South partition has been largely burnt out, whereas the partitions to the East remain to enough of an extent that the volumes of the spaces can be delineated from one another.

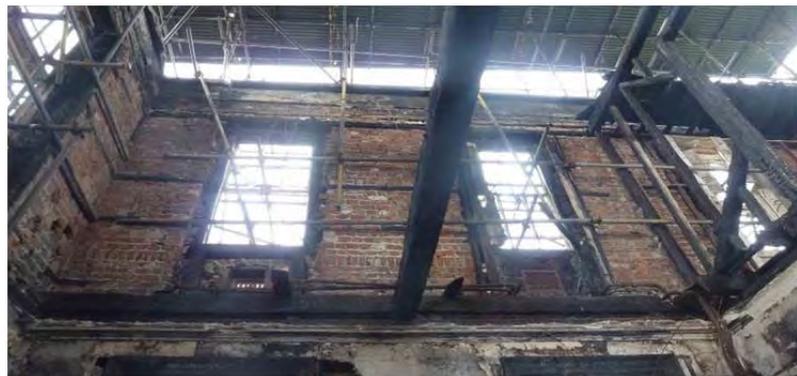
ii. North elevation.

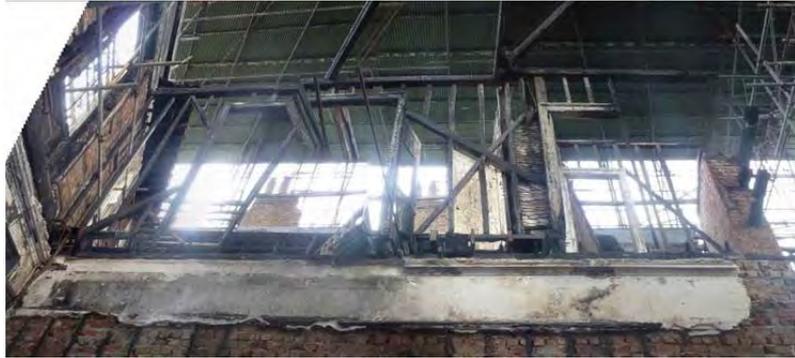
iii. East elevation.

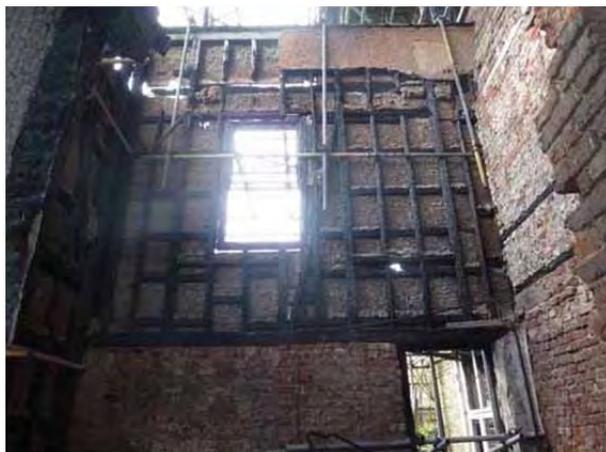
i. North elevation of F4. The section of the wall corresponding to the floor level of F4 is that which has internal timber studs.

Condition: Room F4 has lost its floor and is now a single double height volume open to parapet level above. This room is possibly early 17th Century in origin. It has an adjoining chimney stack to the East side internally, which is of several periods. The chimney stack was weakened by fires but grouting and mortar repairs are evident.

Comment: The expanded metal lathe external walls can be seen to be failing in places, with sunlight visible through holes in the cementitious render.

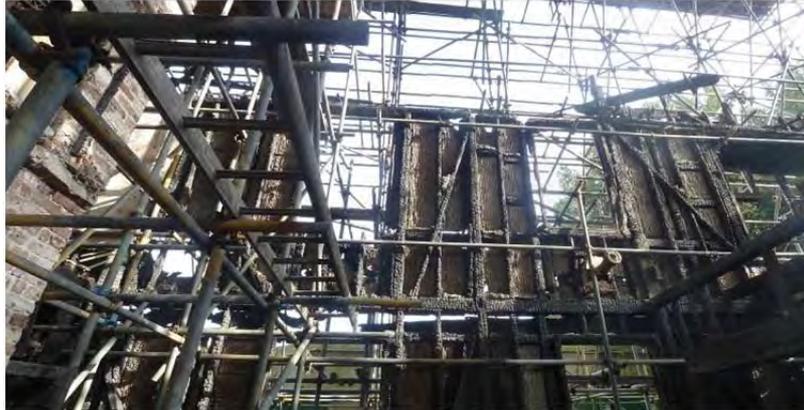
i. East elevation.

Condition: Rooms F5, F6 and F23 have lost the majority of their floors and are now generally a single double height volume open to parapet level above. The rooms are enclosed by an early 20th Century expanded metal lath and cementitious render façade to the East, tied to earlier timber studs. Room F5 has an adjoining chimney stack to the North side internally. The chimney stack was weakened by fire damage but repairs are evident. The western half of the early 17th century floor frame in F5 has been irreparably damaged by fire. The associated floor structure survives.

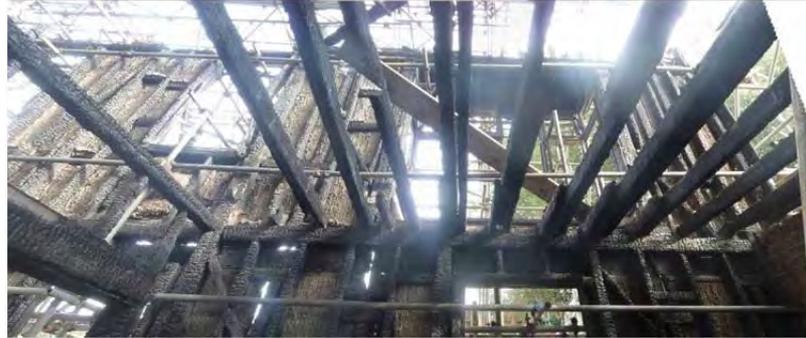
i. East elevation of F9.

Condition: Some elements of the floor structure survives to the East end of room F9, but it is considered that it has been damaged beyond repair by fire.

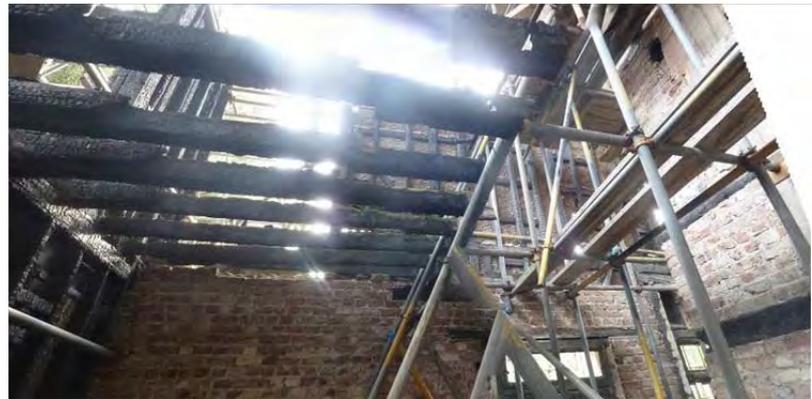
ii. South elevation of F9.

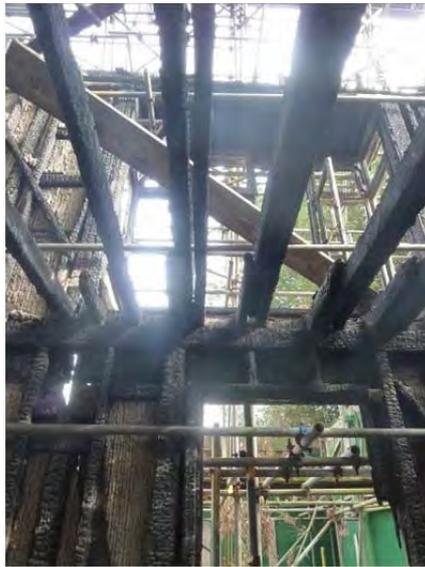
- i. General condition of remaining fabric (note photograph taken looking towards the south internal elevation of room F10, showing oriel window projecting away from the building line).

Condition: The oriel window to the South of room F10 is severely damaged, though as with other high level bays, the full extent of this cannot be known without high level access being gained.

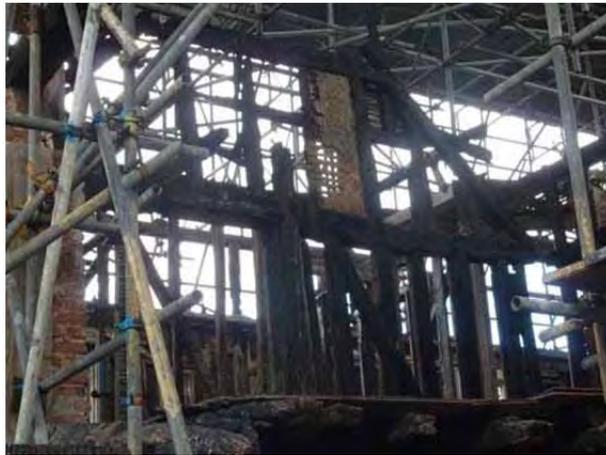
i. Timber framing of East facing first floor cross-wing.

Condition: A full visual survey could not be carried out of room F12, but it is notable as being enclosed on the East end by a previously external timber framed gable end, which was part of the earlier Tudor house. As elsewhere, fire has damaged the cross bracing and panel infill. The timber brackets which supported the timber gable on a jettied cross-wing are visible, but they are severely charred as a result of the late 20th Century fires.

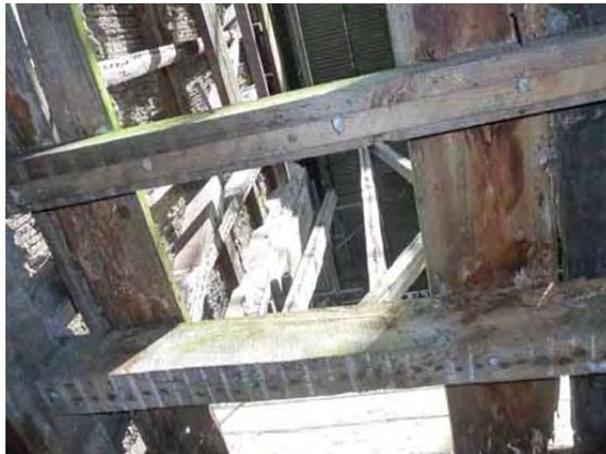
- i. View of external wall of F14 photographed from below, through floor joists above G12.

Condition: Though some floor timbers remain, access was unavailable to inspect them from above. Internal studwork is visible and appears to have less fire damage than elsewhere, but internal finishes have been stripped and either lost or stored elsewhere.

The external walls are of expanded metal lathe with cementitious render and half-timbered infill panels to the exterior, and earlier timber studs to the interior. The internal studs appear to be in better condition here than to the East end of the house.

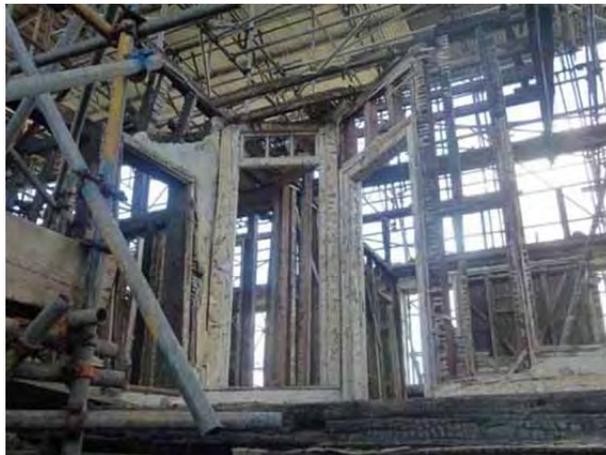
i. Doorway to F18 with remaining fabric beyond.

Condition: The earliest surviving parts of the house are fragments of timberframing for a jettied cross-wing in the centre of the building, of which this room forms a part. At ground floor level (G8) the framing of the west wall of the primary structure survives.

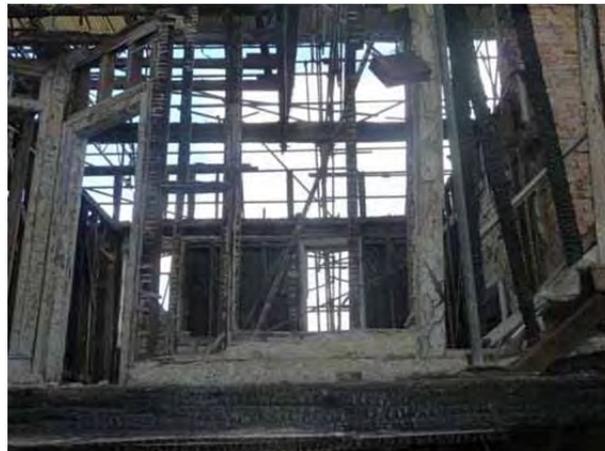
- i. Studwork partitions of F19 missing to East side, revealing remaining fabric.

Condition: The early 17th century floor structure survives to F19, as do elements of the timber stud framing both internally and externally.

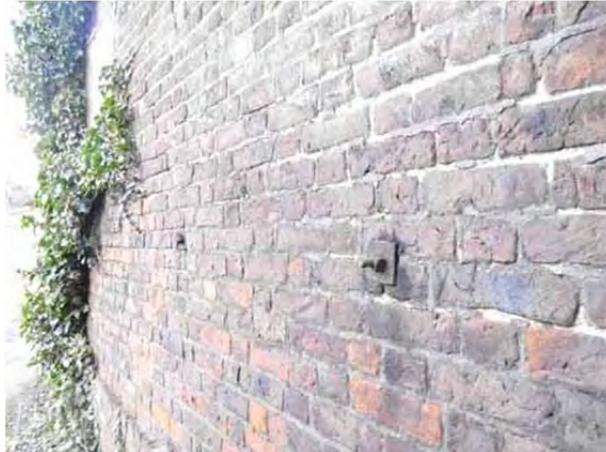
- iii. North-west elevation brickwork, steel structural ties are evident, counteracting the undulations of the wall. Cementitious pointing and overgrown vegetation are also visible here.

Condition: The condition of the building externally is dilapidated with tiled roof finishes removed from the principal and south west wings and replaced with corrugated sheeting and felt respectively, original windows are boarded up and there are large areas of perished brickwork. However, the basic (in part tuck pointed) brick structure is considered by the London Borough of Enfield basically sound and the roof and floor structures (although locally rotten and/or missing) repairable.

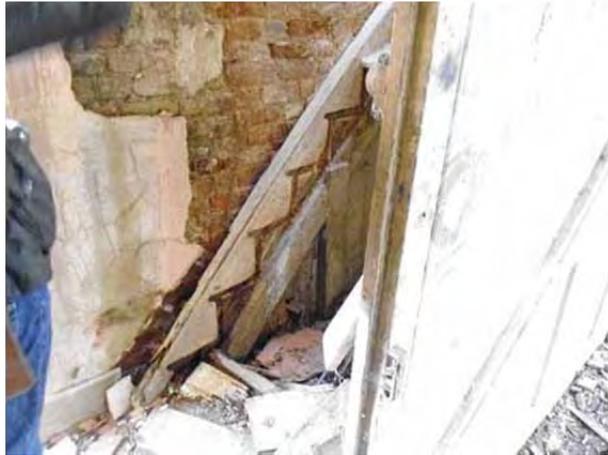
i. Staircase to first floor east end.

The interior of the stables is generally in quite poor condition. The flights of stairs leading away from the entrance to the west end of the range are in a poor state or repair, with one missing its treads and risers. The other was noted to be unsafe for use.
