BROOMFIELD HOUSE

Gazetteer

March 2016

GAZETTEER – HOUSE AND STABLE YARD CURTILAGE BUILDINGS

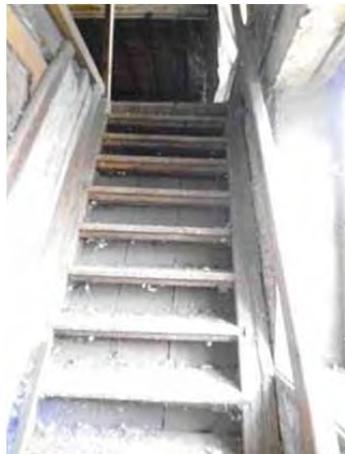
ii.

Staircase to first floor west end.

The interior of the stables is generally in quite poor condition. The flights of stairs leading away from the entrance to the west end of the range are in a poor state or repair, with one missing its treads and risers. The other was noted to be unsafe for use.

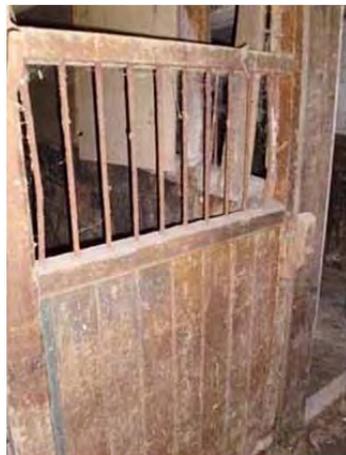
v. Remaining timber stall.

There are some remains of vertical timber slatted stalls to the east end of the range in good condition, along with a room which appears to have been composed of elements of previous stalls. This room may have been formed in the late 19th Century. It has a floor of blue stone twelve inch pammments which are likely to be contemporary to the timber stable stalls. It also has a lath and plaster ceiling with straight jointed laths, set between timber downstands. This ceiling is failing and much of the plaster has been lost, taking some of the laths with it.

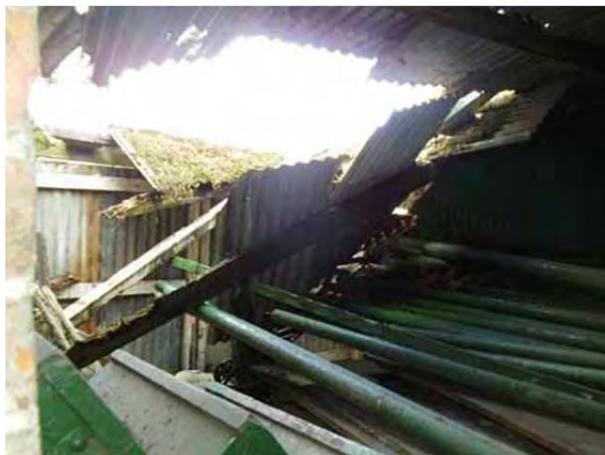
vi.

Lean-to to the north east corner of the stables, the corrugated metal roof has collapsed.

The east end of the range opens through to the range of storage sheds to the eastern edge of the service yard. The corrugated metal roof has failed in places, as in the photograph above.

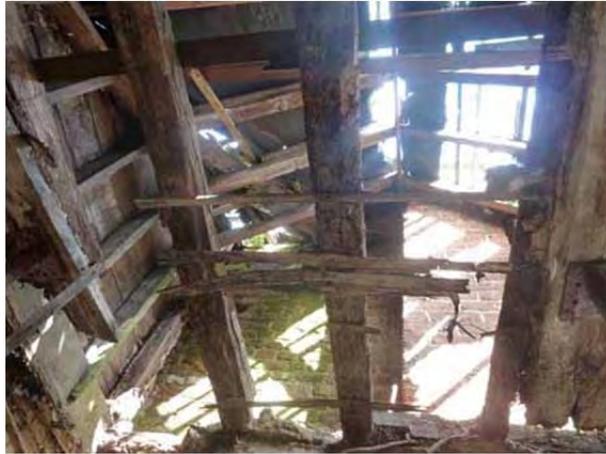
viii.

View through floor joists, large sections of missing roof visible beyond.

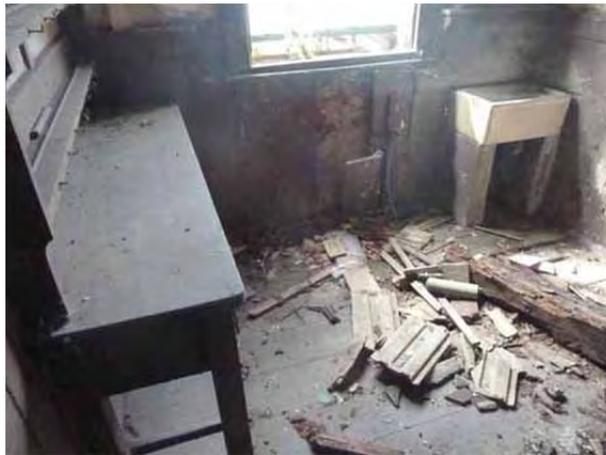
x.

Floor of lean-to room, showing evidence of previous roof and ceiling structure.

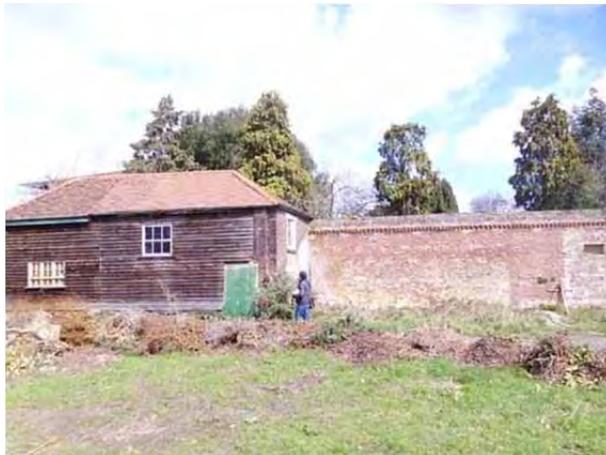
iii.

Build line of previous greenhouse lean-to is visible on south-east elevation.

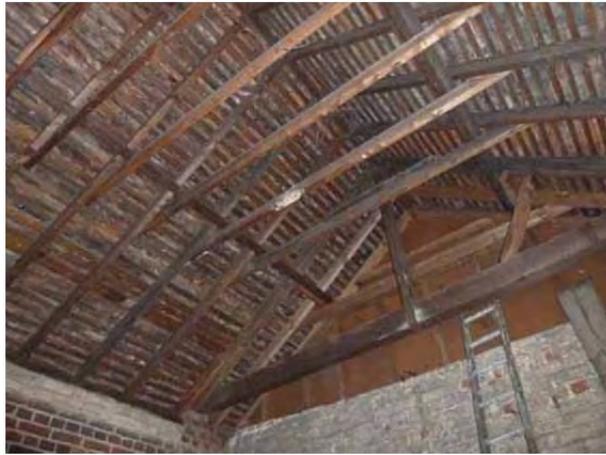
- i. Exposed roof structure; rafters, collar ties and purlins. The tile counter battens and the undersides of the tiles are clearly visible.

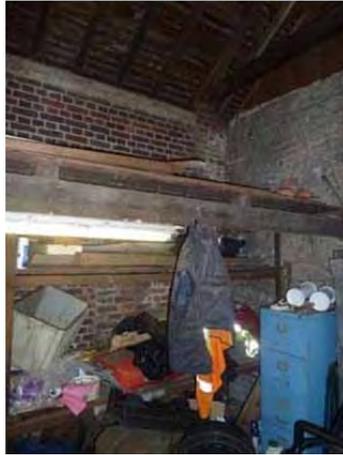
- ii. Limewashed brickwork central partition, separating the two sides of the bothy. Above the brickwork, the triangular roof space is separated with a timber boarded infill.

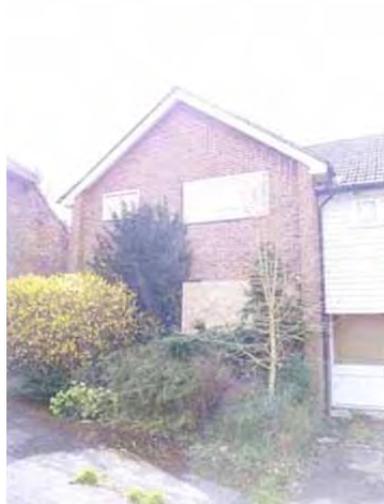
ii.

Boarded-up windows to south end gable façade.

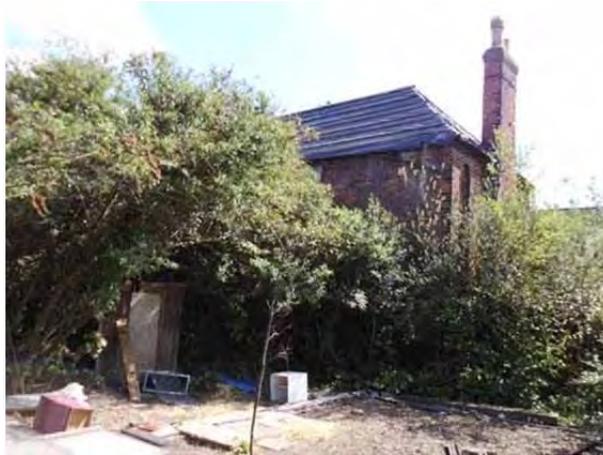
- i. The garden house sits to the south-east corner of the service yard, it is joined to the main stable range at its east end. It is bounded by Broomfield Lane to the immediate east. The roof finish is missing, with an exposed membrane and tile battens visible. There is generally damage to the brickwork of the façade and chimney stack, with blown brick faces and missing pointing. The building is difficult to access and is obscured by thick vegetation.

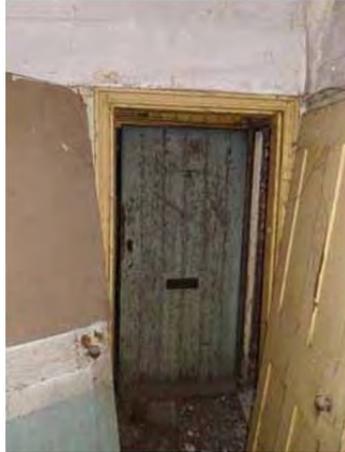
i.

Front door to house (note – at the time of inspection, there was no lock on this door and it was propped open).

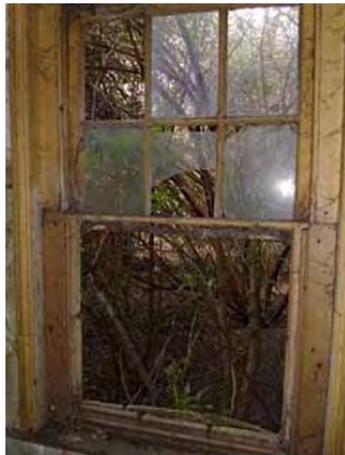
ii.

Remains of sash window to west end.

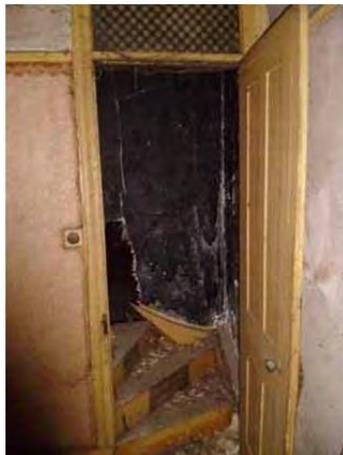
v.

Damage to treads and risers of staircase to first floor.

The interior of the garden house is generally in quite poor condition. The flights of stairs leading to the first floor are in a poor state of repair, with missing treads and risers. It was noted to be unsafe for use.

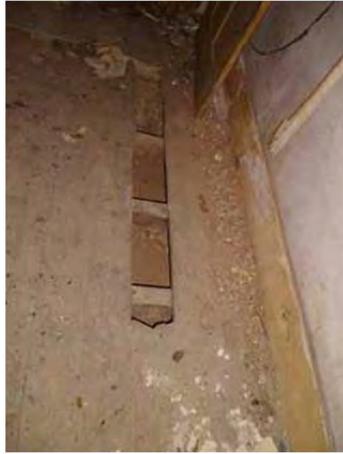
vi. Missing floorboards in living room.

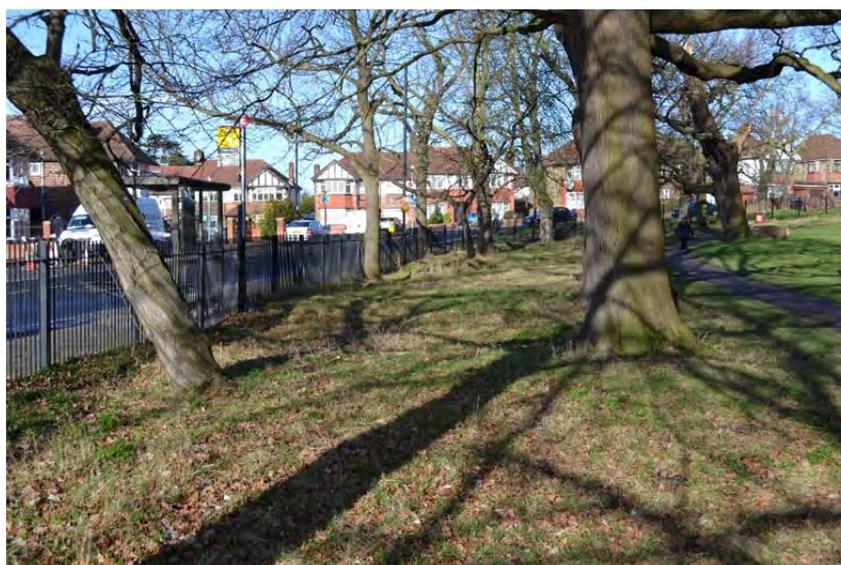
Photo Earthworks on the site of the former stream/pond.

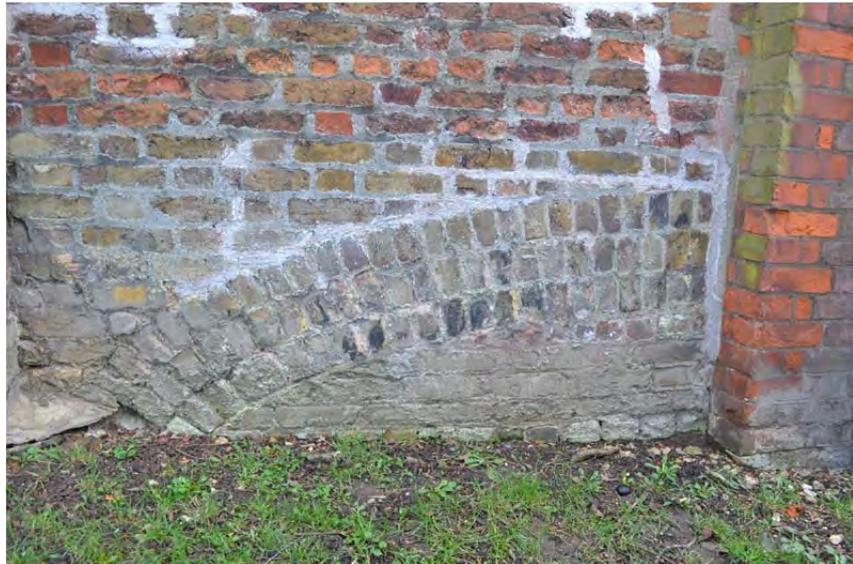
Blocked culvert at the south end of the West Wall.

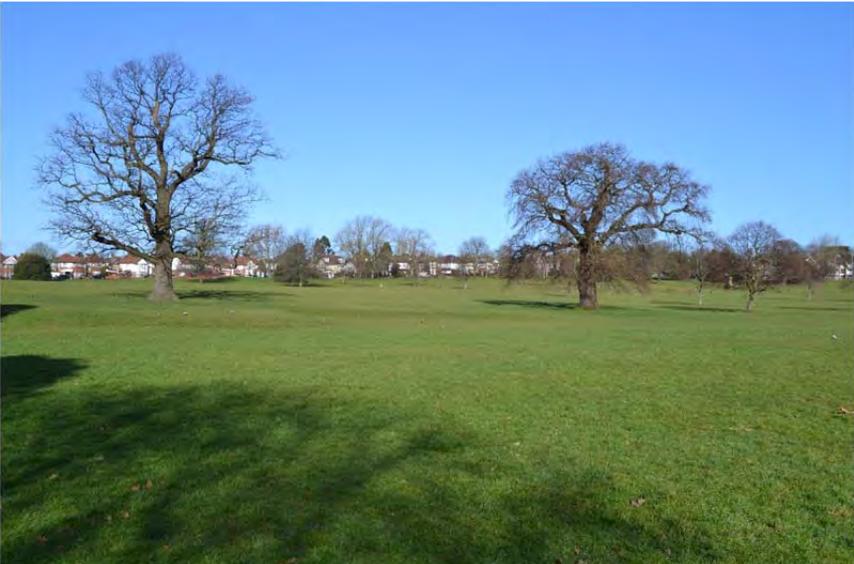
Significance of Asset	The field boundaries were most likely temporary features and are

therefore not significant to the overall history of the parkland. The earthworks in the south-eastern corner however, are quite substantial and there is nothing to suggest their origin in the historic mapping. The history of the parkland is just as important as the gardens and the house (it has been modified and landscaped less so it may contain better preserved archaeological remains) to the history of the Park and the estate.

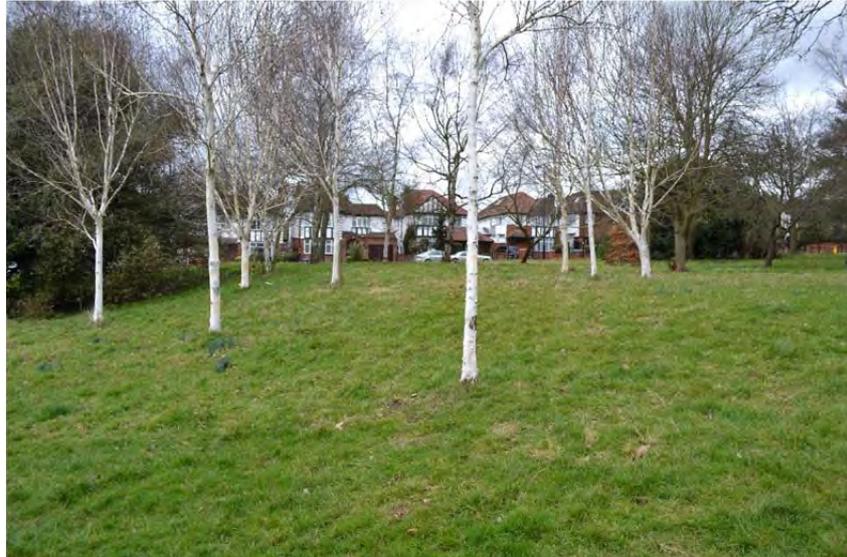
These buildings are interesting as they provide a different element to the parkland; tenant housing. The survival of the level platform upon which they sat suggests that the buildings foundations may survive. Although they have been significantly impacted upon by the later Park Cottages, they may have reused elements of the previous buildings (walls, foundations). Depending on the condition of the foundations and the yard features, this asset may have local significance and would be ideal for community archaeology.

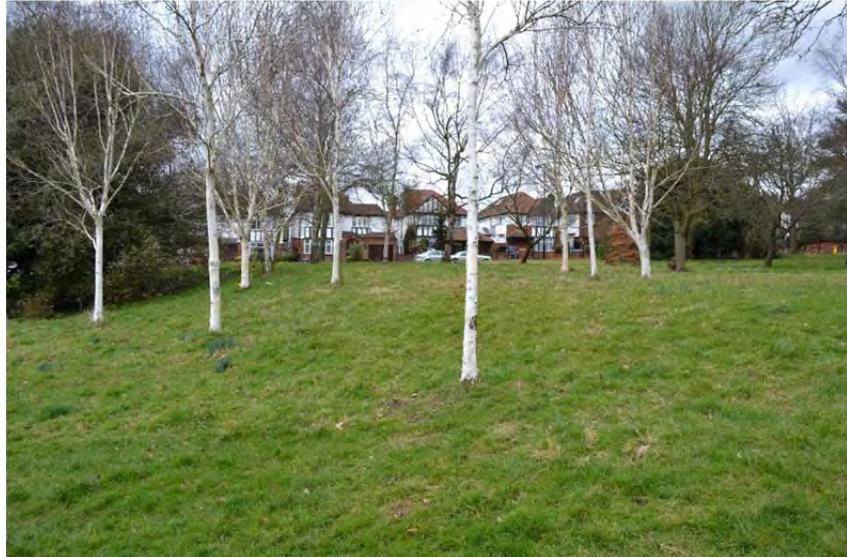
These buildings are interesting as they provide a different element to the parkland; tenant housing. The survival of the level platform upon which they sat suggests that the buildings foundations may survive. Although they have been significantly impacted upon by the later Park Cottages, they may have reused elements of the previous buildings (walls, foundations). Depending on the condition of the foundations and the yard features, this asset may have local significance and would be ideal for community archaeology.

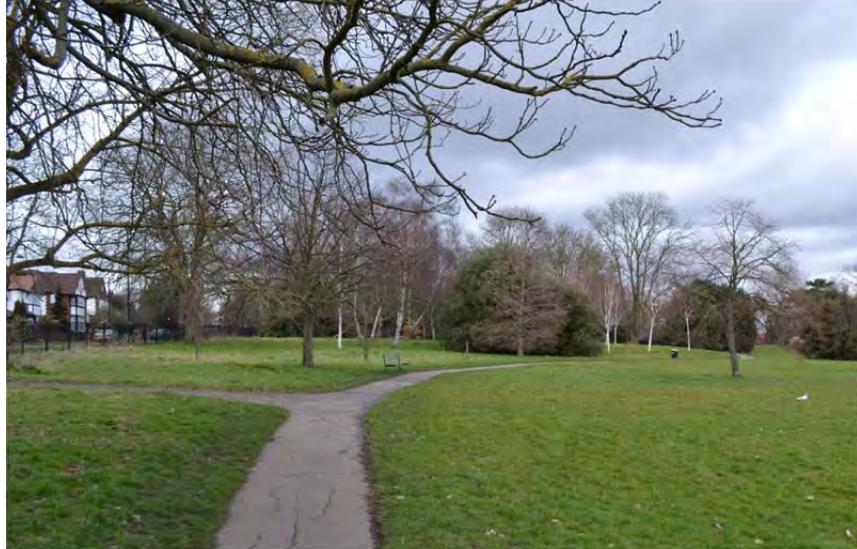
These buildings are interesting as they provide a different element to the parkland; tenant housing. The survival of the level platform upon which they sat suggests that the buildings foundations may survive. Although they have significantly impacted any earlier buildings, they may contain elements of these structures (walls, foundations, surfaces). Depending on the condition of the foundations and the yard features, this asset may have local significance and would be ideal for community archaeology.

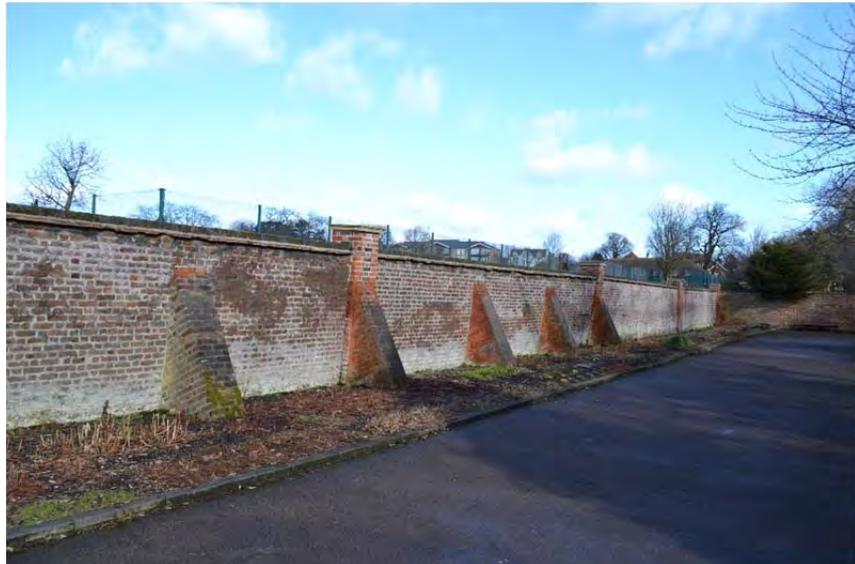
Internal face of the northern end of the West Wall

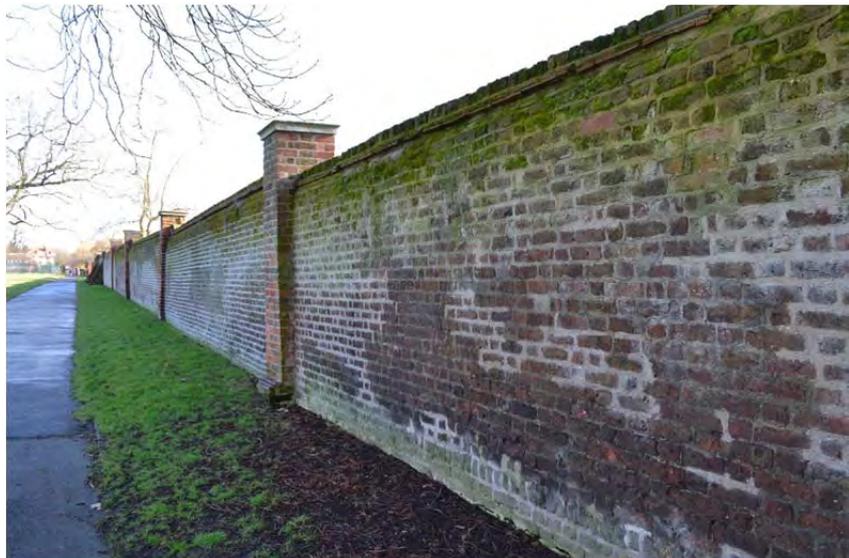
External face of the southern end of the West Wall

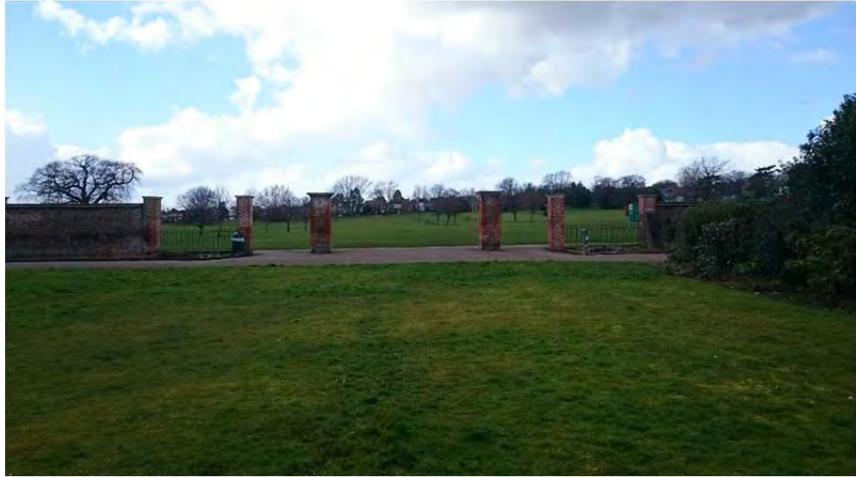
Site of the 1913 new 'Tudor' style archway in the West Wall

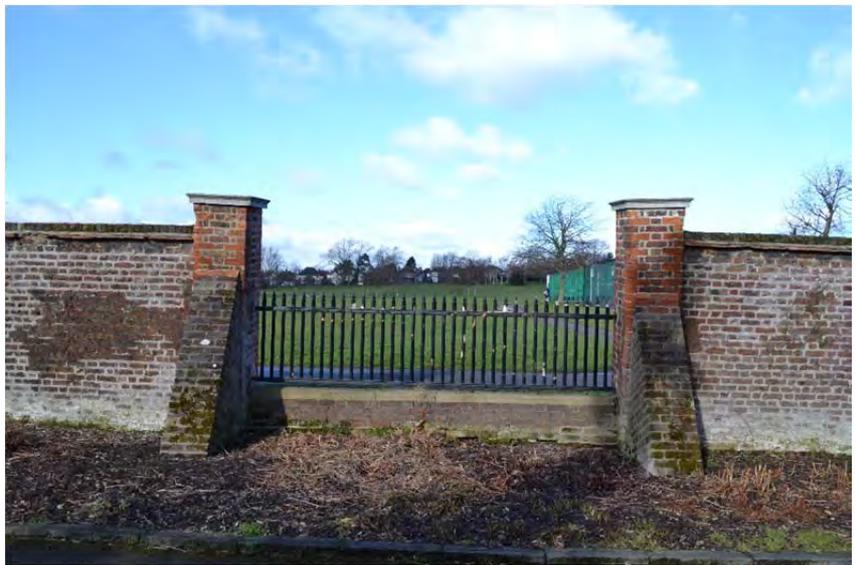
Pre-1965 break to enable a new vista from the drive to the Parkland

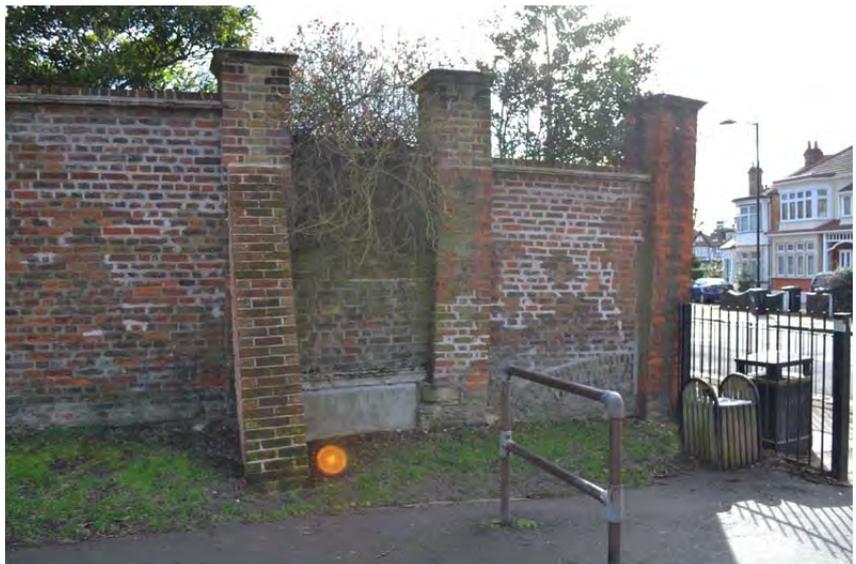
1934-1936 archway and blocked culvert at south end of West Wall.

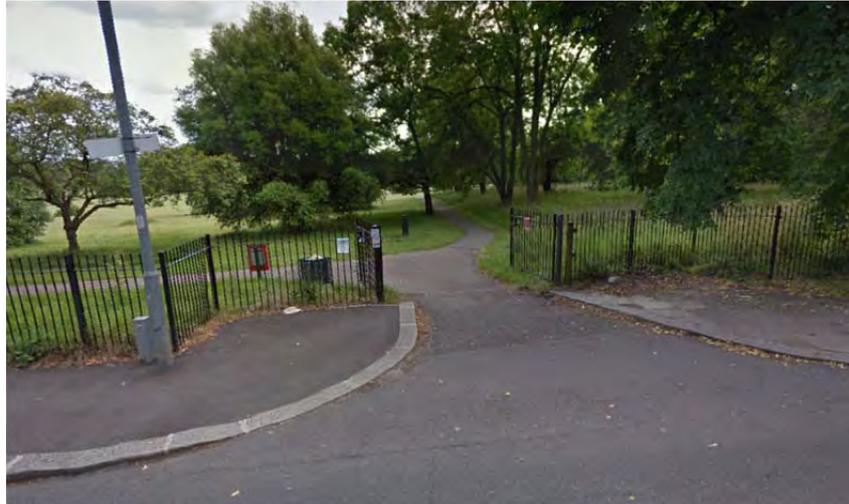
The Village Gates have been removed and what is left is not locally, regionally or nationally significant. The removal of the gates and the footpath across the parkland has increased the setting of the Avenue. The earlier entrance (1754) to the east has more potential significance.

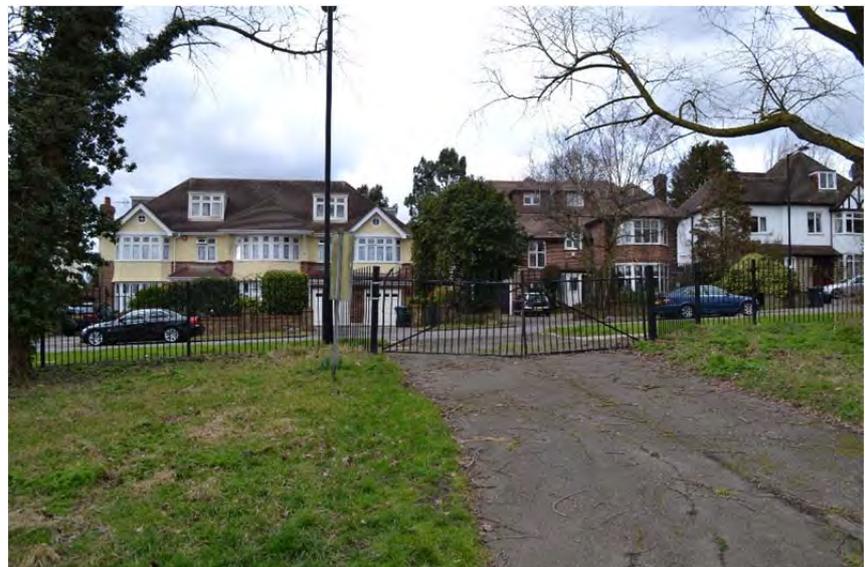
The entrance to the park has no historic or aesthetic significance. However, the site upon which it sits could have some local significance. Its location at the western end of the Avenue and on the site of a former pond could contain archaeological remains associated with the early developments of the parkland.

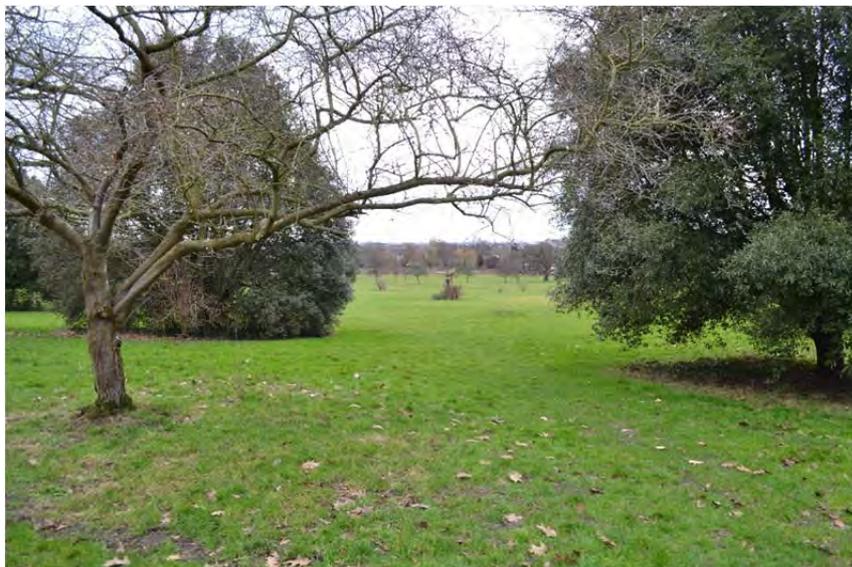
Significance of Asset The gravel was most likely a temporary feature and is therefore not significant to the overall history of the parkland. It may have been associated with the Village Gates, but these have also been removed. The pathway crossed the Avenue, which diminished its setting, so its

removal is considered positive.

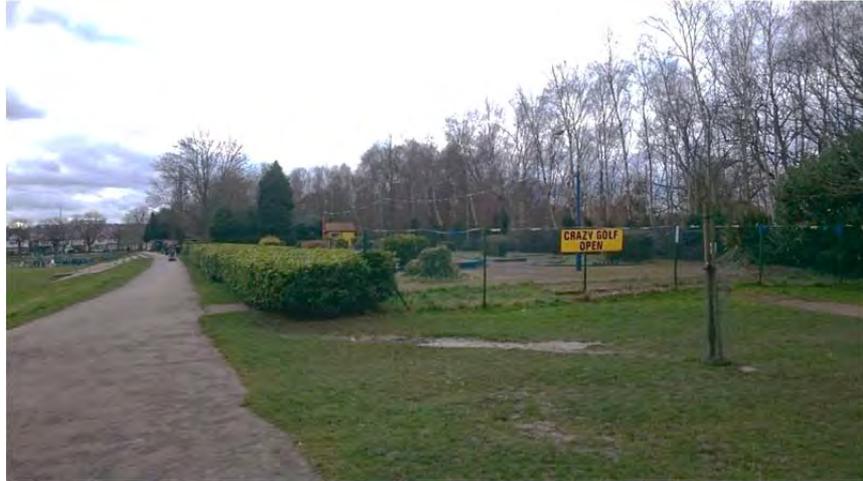
The road is unlikely to survive beneath the children’s play area due to the excavation of the gravel pit, but traces of the T junction and the northern half of the road may survive beneath the pathway on the eastern side of Warren’s field. If the road does survive, this is one of two assets (the other is Broomfield House) we can confirm on the 1599 map as remaining in situ. This would have local significance by enhancing the history of Broomfield Park.

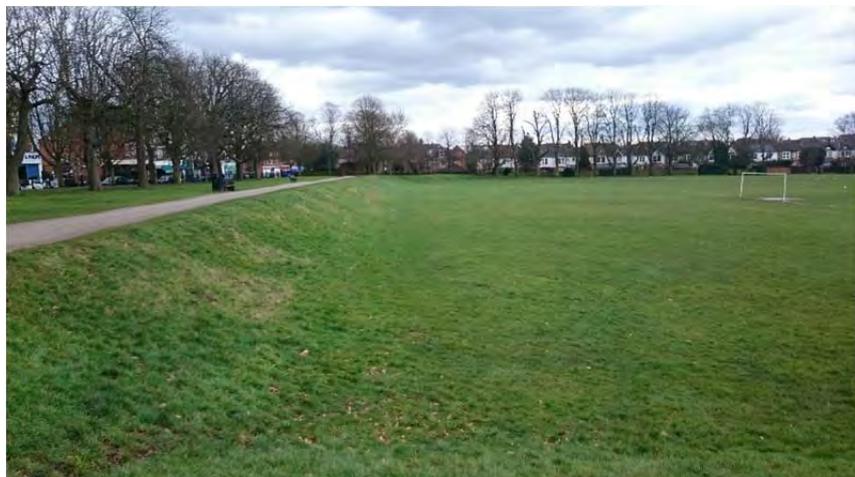
Significance of Asset	The site of Warren's Field is often overlooked when it comes to the history of the Park and there appears to have been a number of garden features and buildings on the site. These may be significant to the history of the Park but unfortunately any archaeological remains would have been destroyed by the Gravel Pit and the levelling of the playing field.
Evidential value	Low – destroyed
Historical value	Low – destroyed
Aesthetic values	Low not visible
Recommended Recording and Management Actions	<p>This asset is one of the suite that comprised the early 17-18th century 'Baroque' Garden, and is this considered one of the most important assets. Conservation of existing elements, or restoration where this is feasible, or depiction where restoration is not possible is considered appropriate. Where restoration is made, the features should be appropriately recorded archaeologically during the process.</p> <p>This asset has been more or less totally destroyed by later garden or constructions and there are no conservation policies judged to be appropriate.</p>

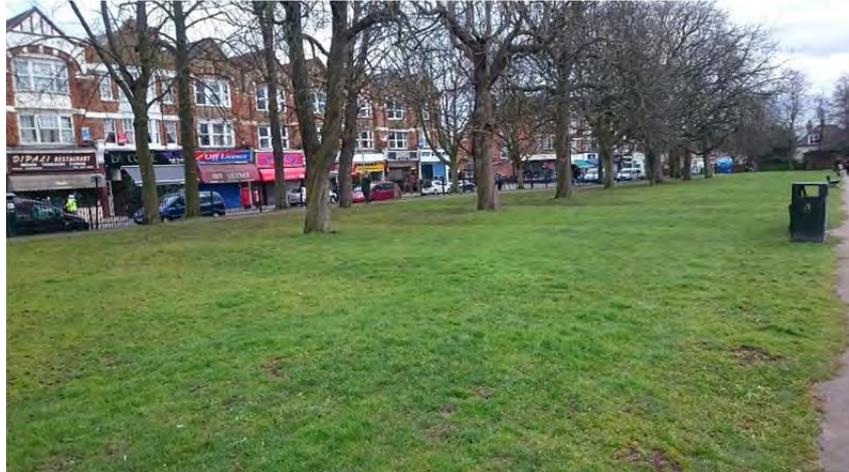
The site of Warren's Field is often overlooked when it comes to the history of the Park and there appears to have been a number of garden features and buildings on the site. These may be significant to the history of the Park but unfortunately any archaeological remains would have been destroyed by the Gravel Pit and the levelling of the playing field.

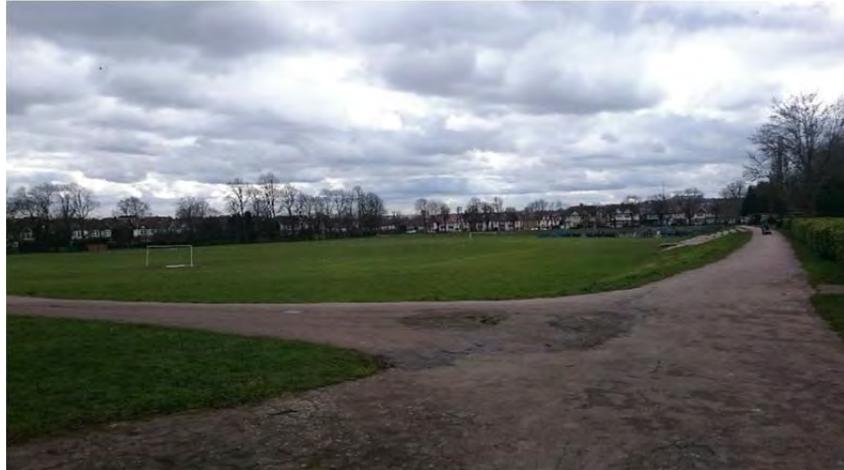
The gravel pit is a significant part of the history of Broomfield Park as it signifies the first major move away from formal gardens/parkland. However, the pit itself is not significant and the creation of the pit has destroyed some potentially important features of the early estate.

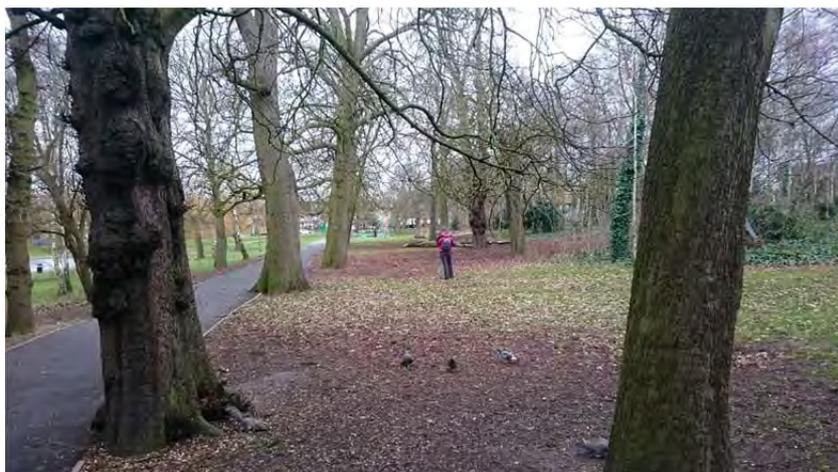
The canal is one of the key historic features of the garden and appears to have originally fulfilled a similar function as a boundary for the formal garden as the Pond/Stream on the southern boundary. The wall to the west of the canal signified the expansion of the parkland in the late 18th, early 19th century but it did not last too long so it is not overly significant.

The earthen dip between the chestnuts suggest that the buried remains associated with the canal and possibly the wall could survive, although potentially damaged by tree roots and the creation of a fairy cycle track in 1937.

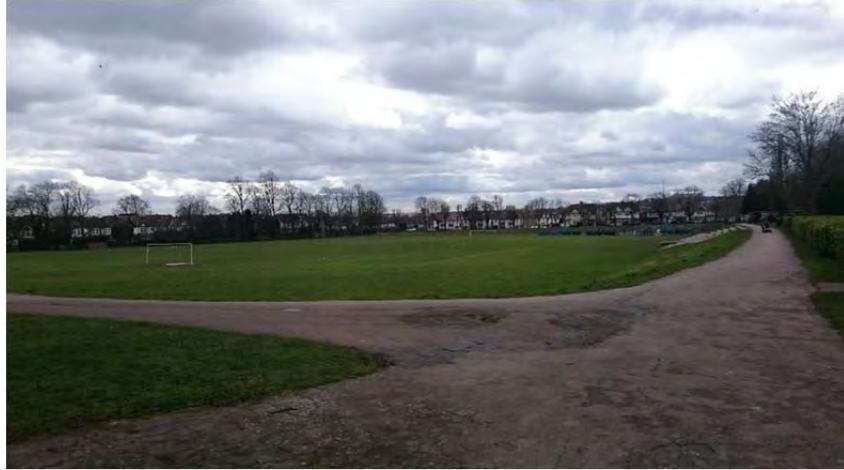
The building in the centre of the former gravel pit epitomises the agricultural land use in the Park at this point. However, the building itself is not considered significant and any archaeological remains associated with it would have been destroyed when the fields were levelled and converted in playing fields.

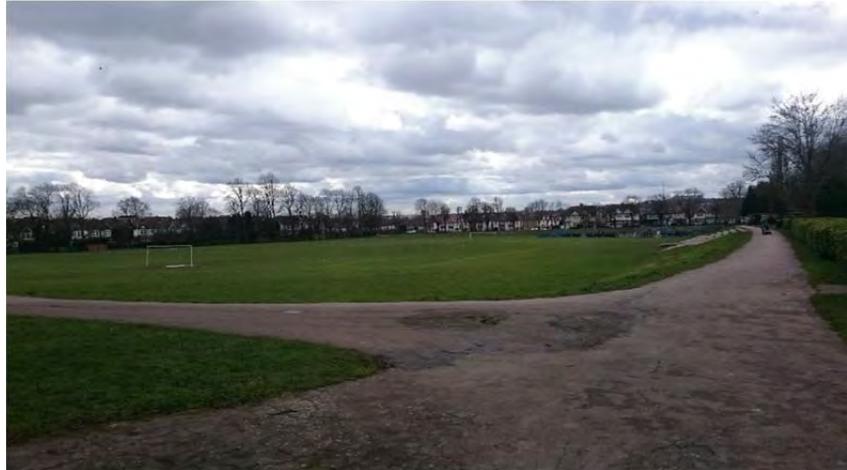
The field boundaries in Warren’s Field epitomises the conversion from the gravel pit to agricultural land, and the importance of agriculture over garden features at this time. The field boundaries themselves are not considered significant and any archaeological remains associated with them would have been destroyed when the fields were levelled and converted in playing fields.

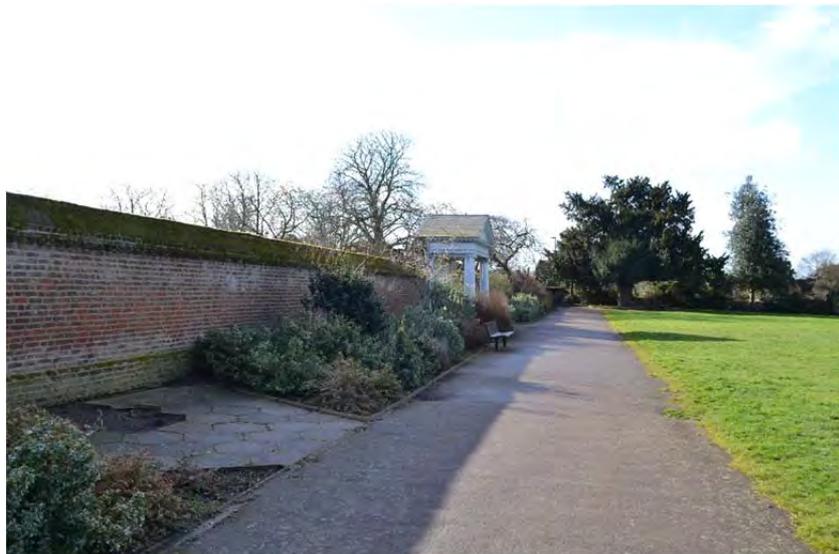
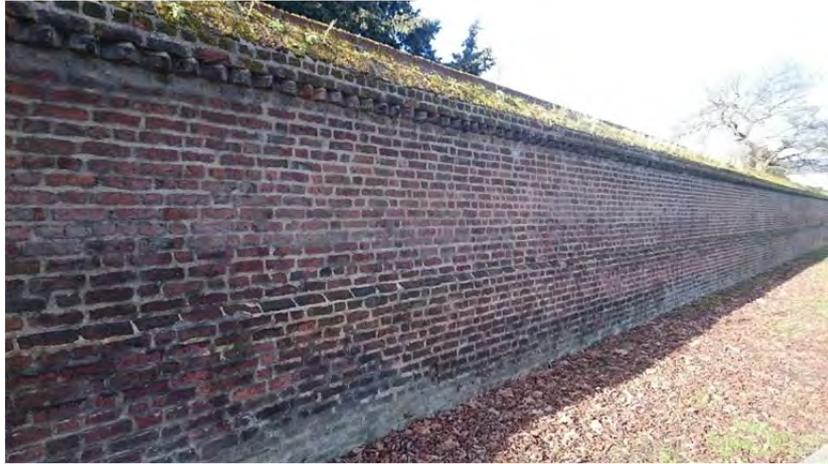
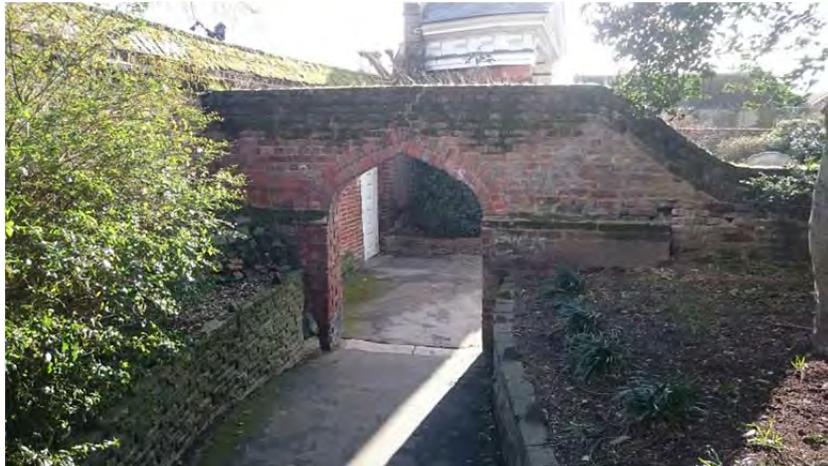
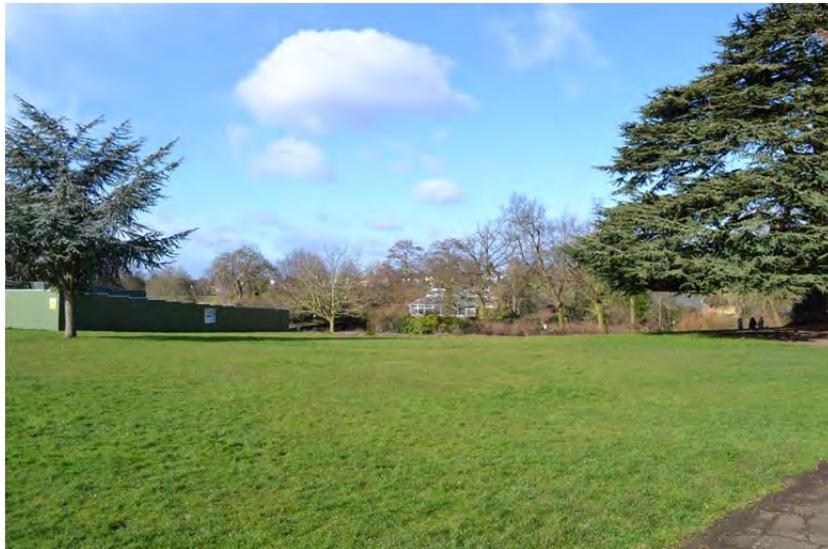
The enclosure around Broomfield House is a main historic feature of the garden and it provides the House with an appropriate setting. The east and remaining south wall appear to be mostly original, although the Pavilion may have been moved from the West Wall. Although most of the originally walls have been removed, the lawn and surrounding trees presents the appearance of the enclosure. With the ponds and the House this enclosure is of national significance. It would be beneficial to investigate the features found in the geophysical survey and compare

This asset is one of the suite that comprised the early 17-18th century 'Baroque' Garden, and is this considered one of the most important assets. Conservation of existing elements, or restoration where this is feasible, or depiction where restoration is not possible is considered appropriate. Where restoration is made, the features should be appropriately recorded archaeologically during the process. . It would be beneficial to investigate the features found in the geophysical survey and compare them to other contemporary gardens in the area to ascertain what was present in the enclosure prior to the lawn.

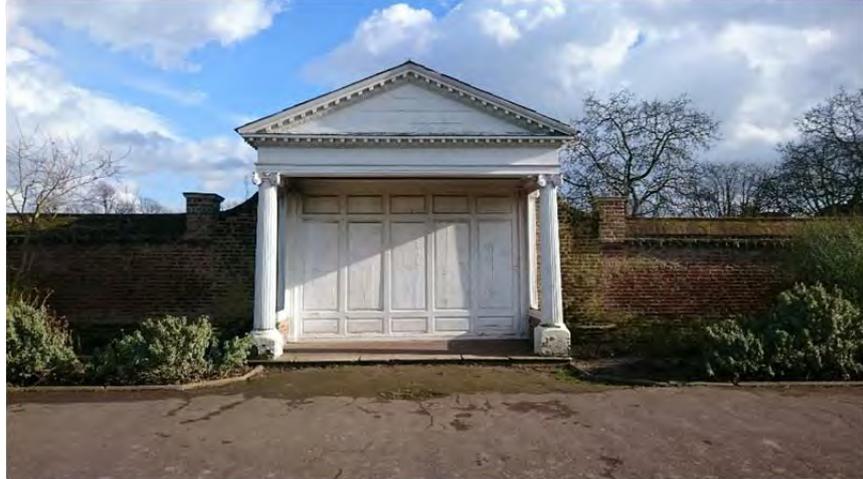
Aside from the brick wall, the Pavilion is the most valuable asset in the East Lawn as it reminds visitors of a grand garden and estate. It is likely that the Pavilion was moved from the West Wall in the late 18th and early 19th century.

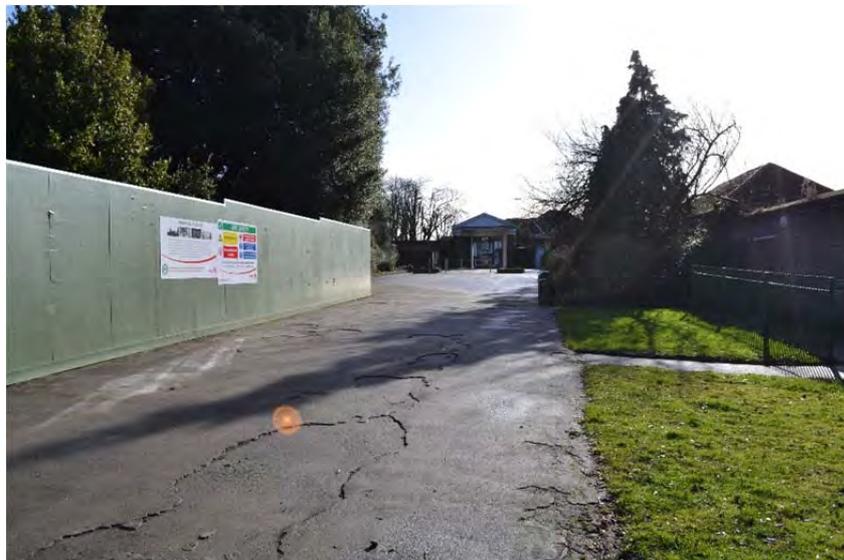
The driveway has been the main route to Broomfield House since 1599 and is therefore a main historic feature of the estate. In the 19th century it was divided to provide room for a building and greenhouse. It is likely to contain a number of structural foundations as well as several road surfaces and artefacts so it has significance above ground and potential significance for buried features.
